QA-37
The Meadows
Sudlersville vicinity
Private

INVENTORY FORM FOR STATE HISTORIC SITES SURVEY

"The Green Farm" or "The Meadows"

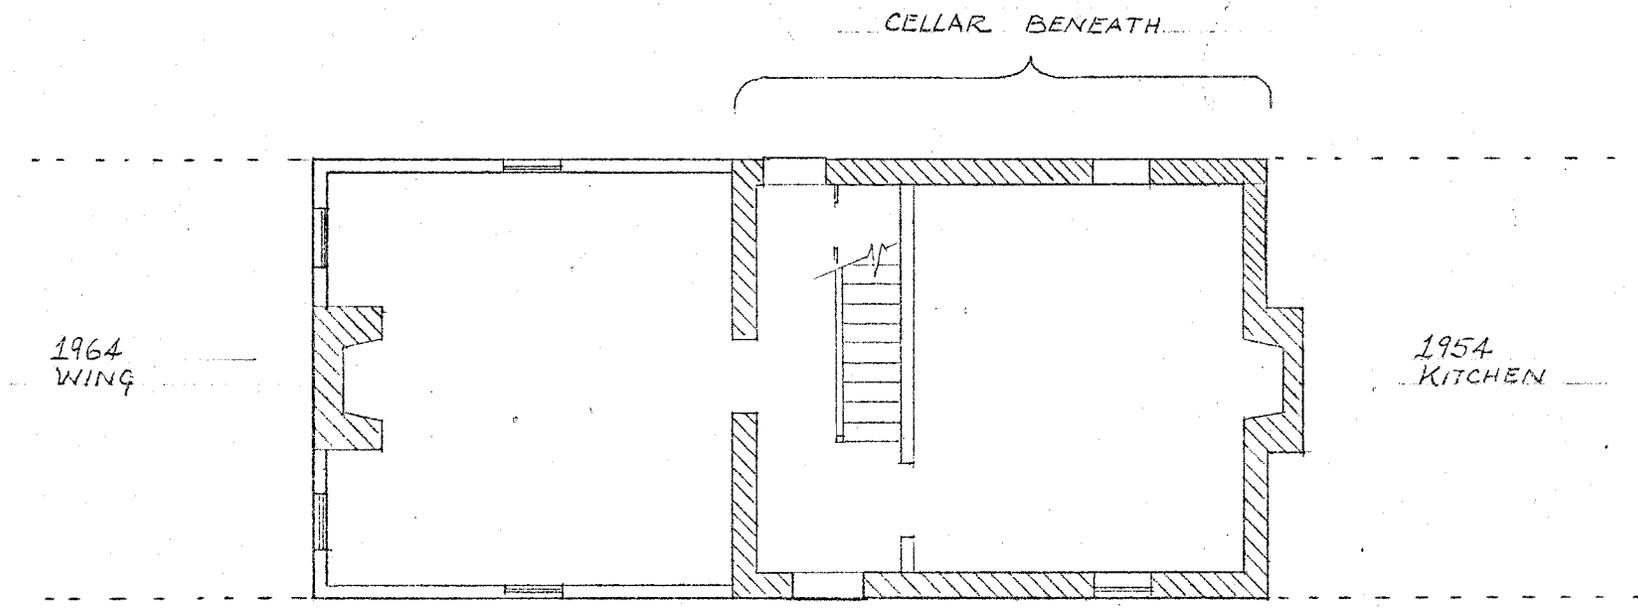
"THE MEADOWS"
FIRST FLOOR PLAN FROM
MEMORY OF MR+MRS. WM. S. ROBERTS
NO SCALE
M. BOURNE, JAN. 1983

The plan of the building consists of a central stair hall with a room on each side. The stair ascends from the west entrance on the south wall of the hall. Beneath the stair is a stair to the basement. The basement was located only under the south part of the house and had a cooking fireplace. The south room, or dining room, has a chimney on the outside of the wall and is contained in the kitchen wing which was built in the '50's. The north room, or living room, had its fireplace within the room, but

was removed and built outside at the same time as the kitchen wing. The living room in that period had two windows flanking the fireplace, so typical of Federal period rooms in this area. The single window on its facade (west) was enlarged to a picture window in the '50's remodeling.

The plan on the second story was the same as the first, but a bath was installed in a portion of the hall in the '50's.

The dining room, or south part of the house, is constructed of brick. The brick section may have included the hall since the stair descends into the basement from the hall. In development it seems similar to Buckingham farm north of Skipton, Talbot County, but the Meadows is a much lower house.

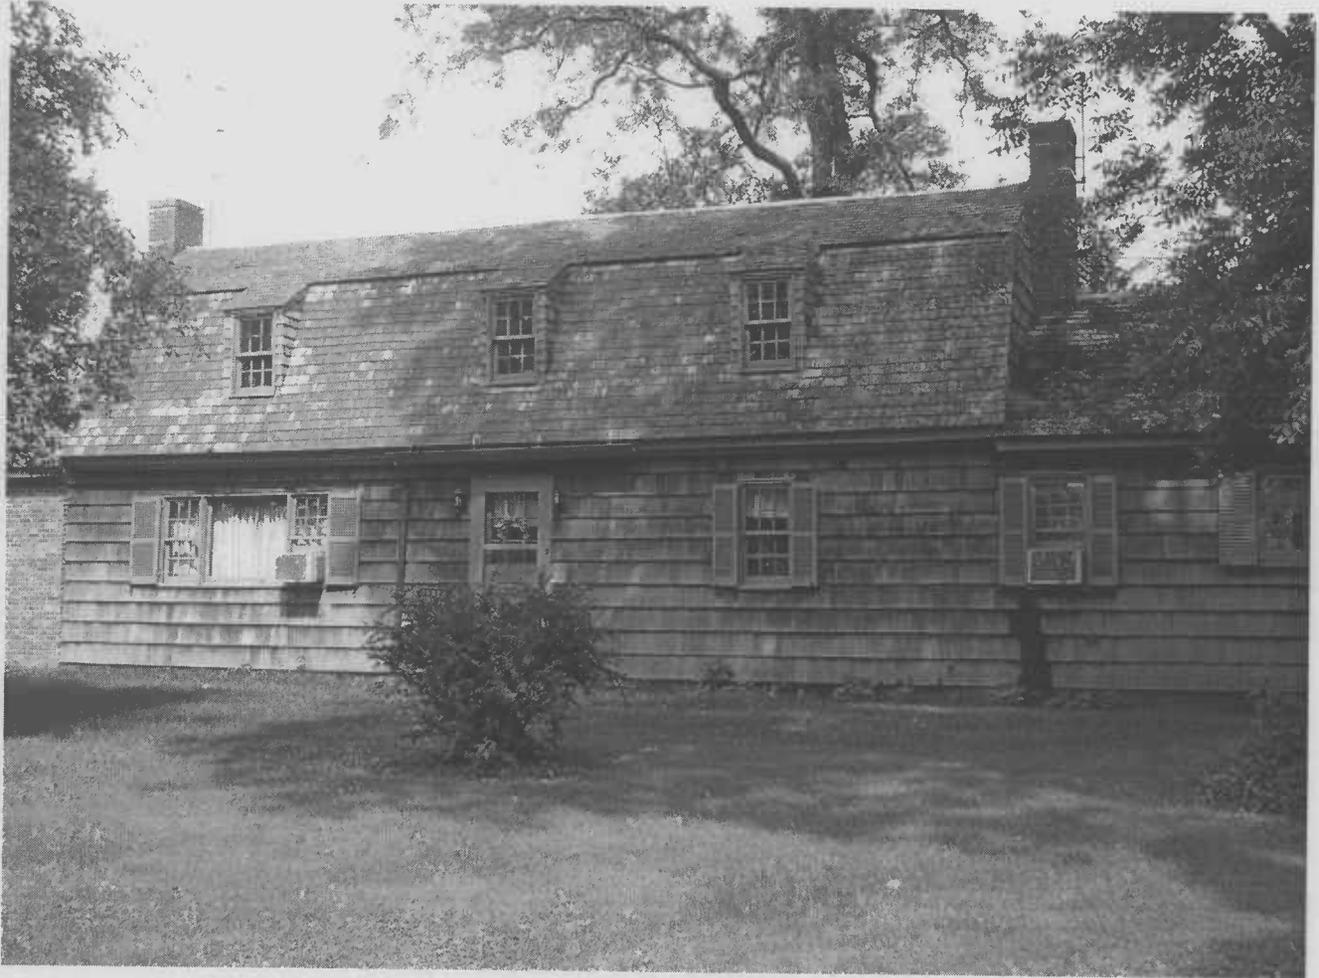
QA-37

the Meadows

Mary McCarthy
Spring/Summer 2003
Digital color photo on file at MHT
