QA-60
Fincastle
Price vicinity
Private

INVENTORY FORM FOR STATE HISTORIC SITES SURVEY

Fincastle

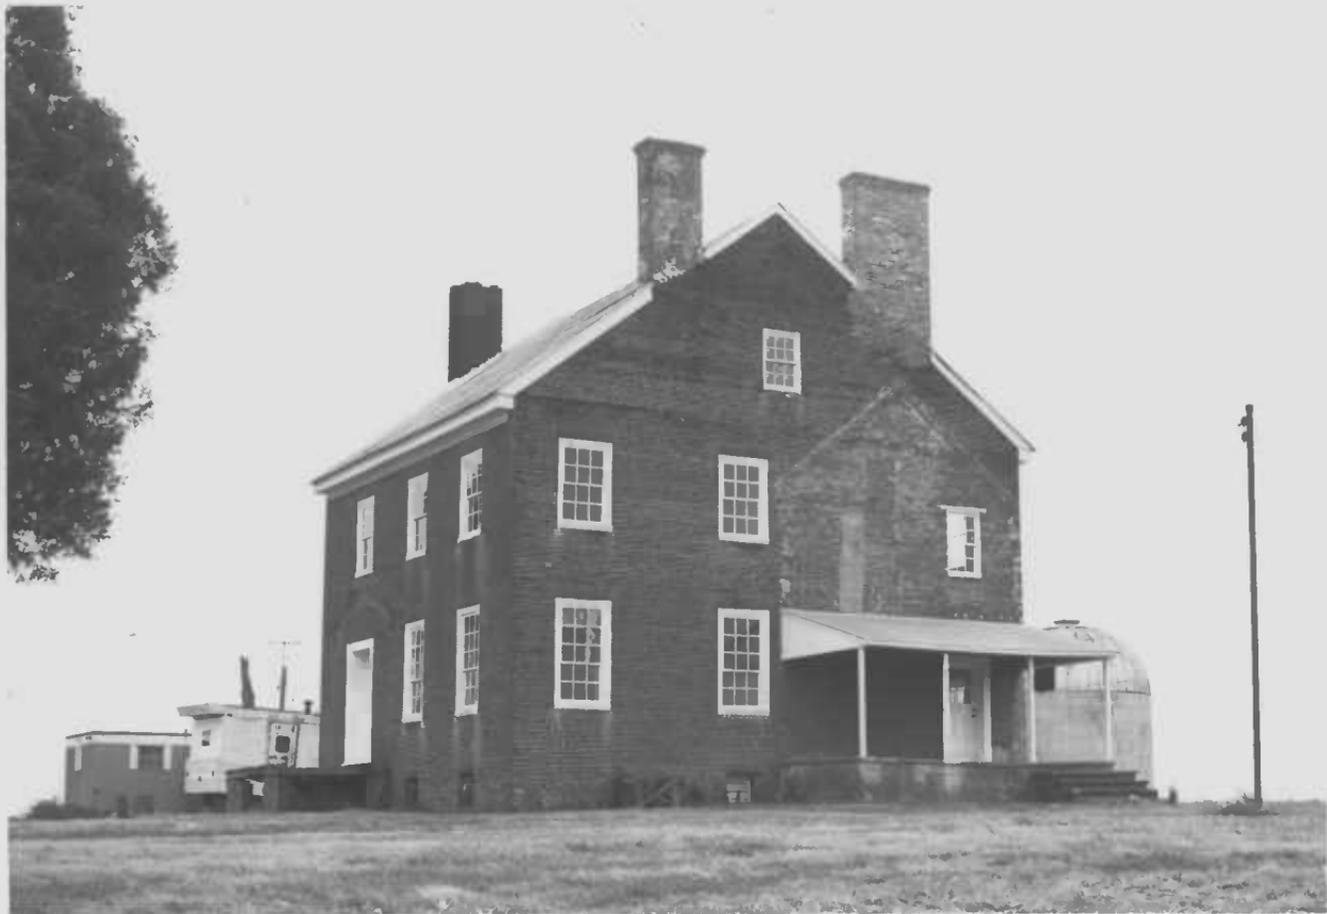
The front facade faces northeast, with the entrance door in the southeast bay and two 9/6 windows to the right. There are three 6/6 windows on the second floor, and no dormers on the roof. Large cellar windows pierce the foundation directly

below the first floor windows. The front entrance is fitted with paired three panel doors below a four-light transom, with paneled soffit and jambs and a crossetted architrave with broken-field fascia and ogee/astragal backband.

QA-60 Fincastle
Price vicinity
Orlando Ridout V 1981
Front (Northeast) facade

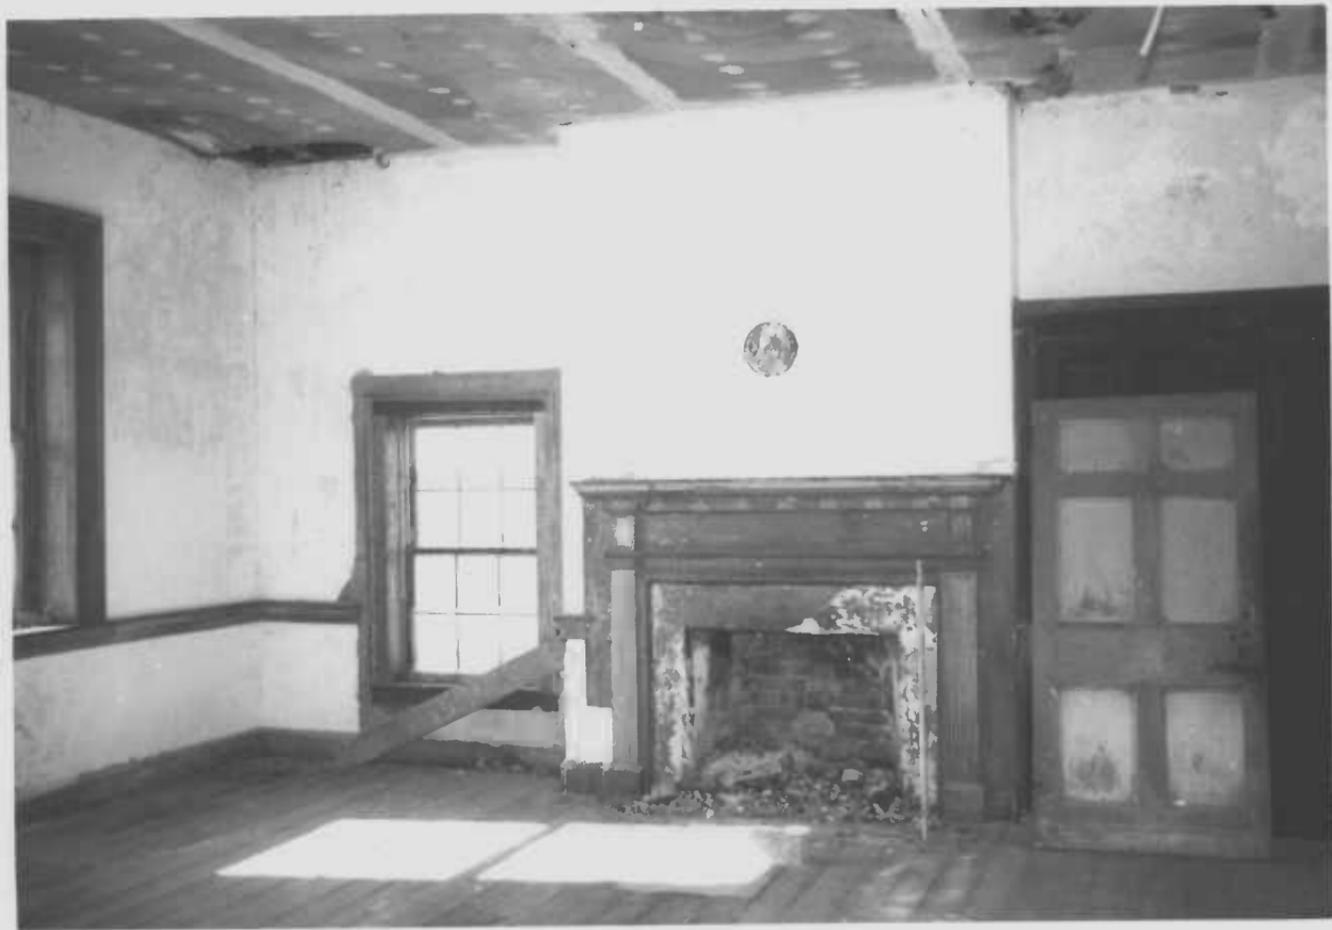
QA-60 Fincastle
Price vicinity
Orlando Ridout V 1981
View from North

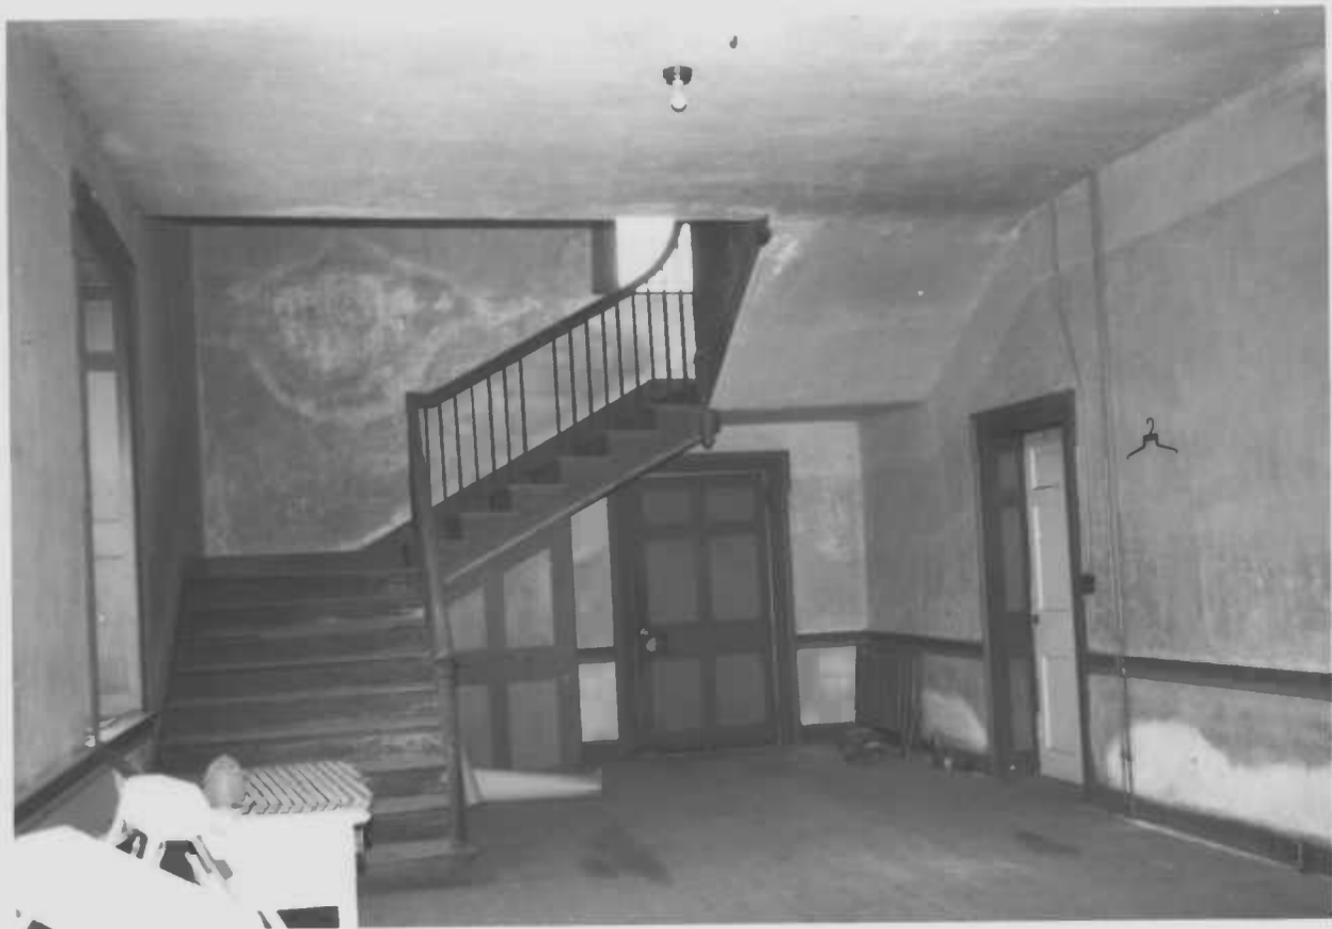
The southwest room is also large, with a fireplace centered on the northwest gable wall. Until recent years there was a door in the alcove to the left of the fireplace that led to the second floor of the wing. When the wing collapsed, the door was converted to a 6/6 window. The mantel is a large board surround with fluted pilasters, paneled sideblocks, a plain frieze, and a complex molded shelf that breaks forward above the sideblocks. The window openings are splayed and paneled and are trimmed with uncrosssetted architraves. The interior door openings are also paneled. A two piece chairrail and molded baseboard survive intact. The trim is now painted olive-grey and grey over an early if not original coat of blue. The doors are painted two shades of grey over the original mahogany graining. The plaster walls are painted beige over an earlier light lime green.

QA-60

Southwest chamber

Second floor

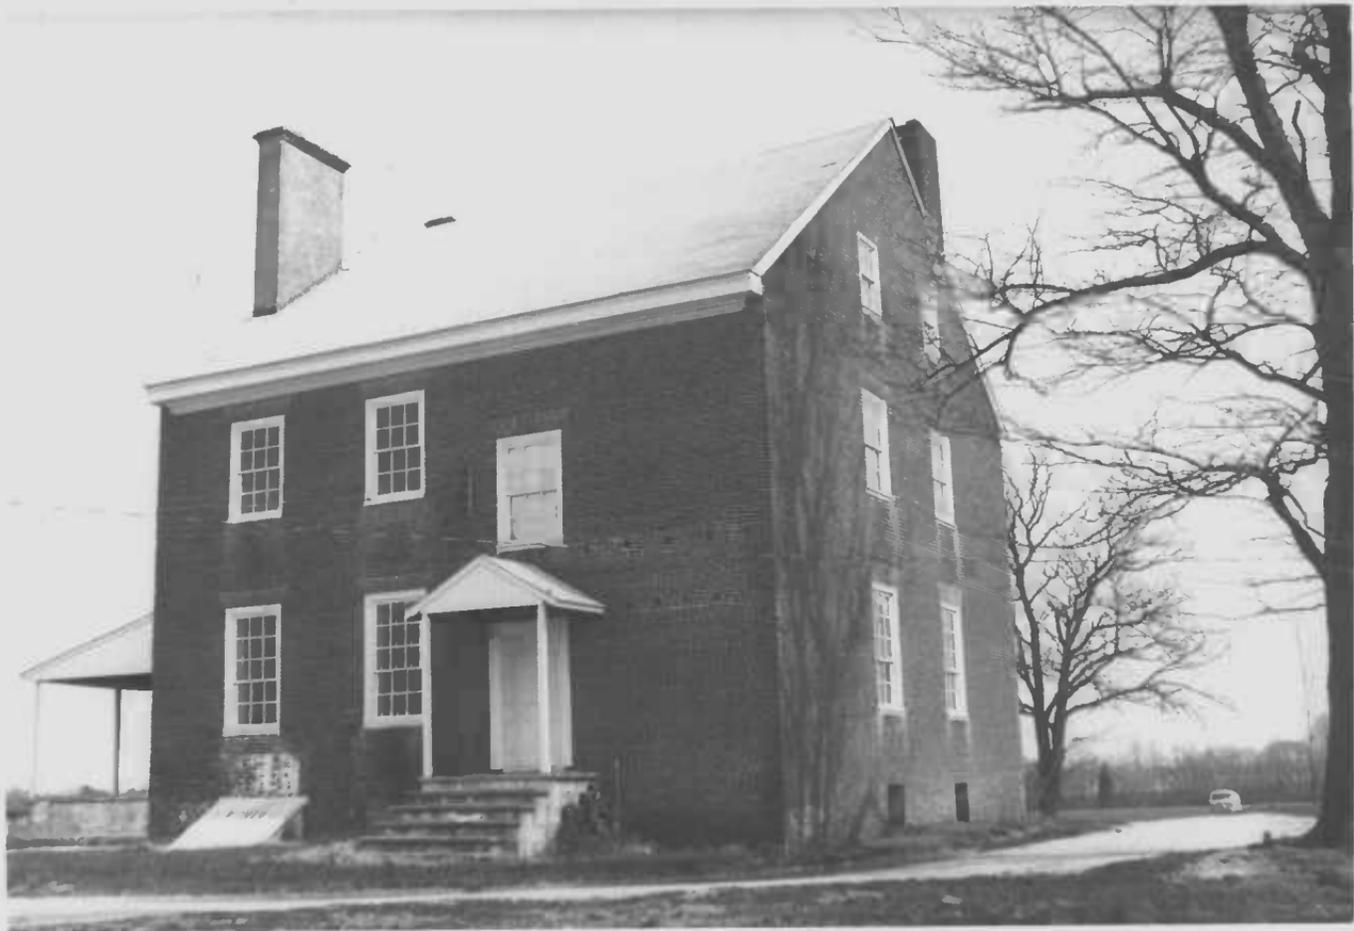
The entire rear facade is laid in five-course bond. The first floor door is in the southeast bay but is offset toward the center of the facade, reflecting the unusually wide side hall across the southeast end of the house. There are two 9/6 windows to the left of the door and three 6/6 windows on the second floor. The window above the door is downset to light the stair landing. There is a cellar window with a barred frame in the center bay and a bulkhead cellar entrance in the northwest bay. The cornice is identical to the cornice on the front facade. A simple 20th century entrance porch protects the rear door, replacing an earlier (but not original) shed roof porch.

Fincastle
Price vicinity
Orlando Ridout V 1980
Southwest facade
