QA-71
Thomas Prickett Farm
Hayden
Private

circa 1800
demolished 1980

INVENTORY FORM FOR STATE HISTORIC SITES SURVEY

AND/OR COMMON
 Thomas Prickett Farm

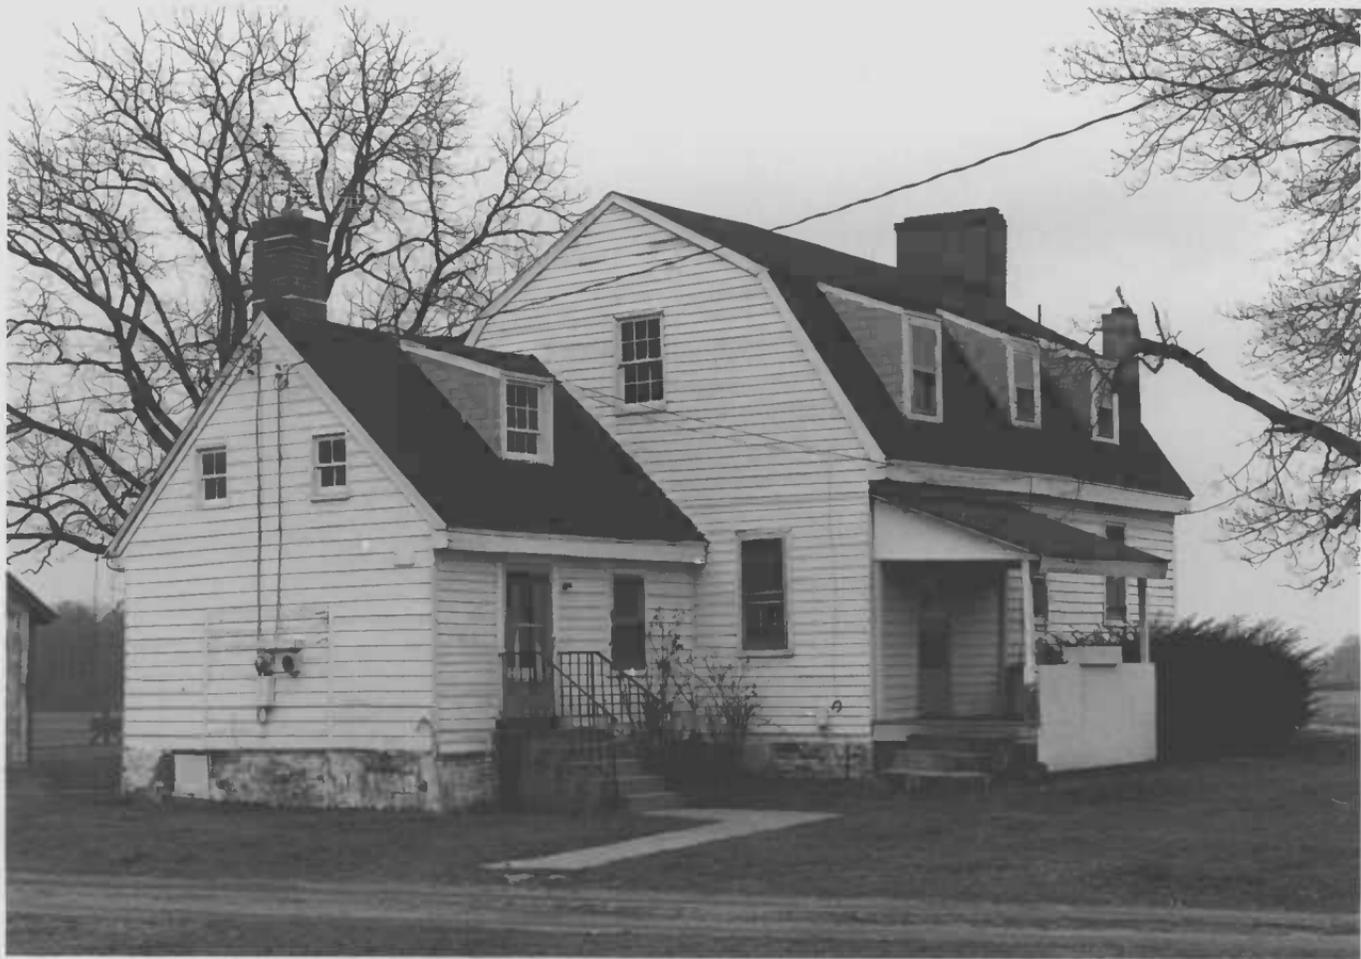
QA-71

The principal facade of the enlarged house faces south, toward the Hayden-Clark Corners Road. There is a door in the west bay, two 2/2 windows to the right, and three 6/6 shed roof dormers on the second floor. The house rests on a high brick foundation, with plain horizontal weatherboards, a plain box cornice, and an asphalt shingle roof. Some beaded horizontal weatherboards survive where they are protected by the eave overhang and by an open 20th century entrance porch in the west bay.

Thomas Prickett Farm
Hayden, Maryland
Orlando Ridout V 1980
Front facade from Southwest

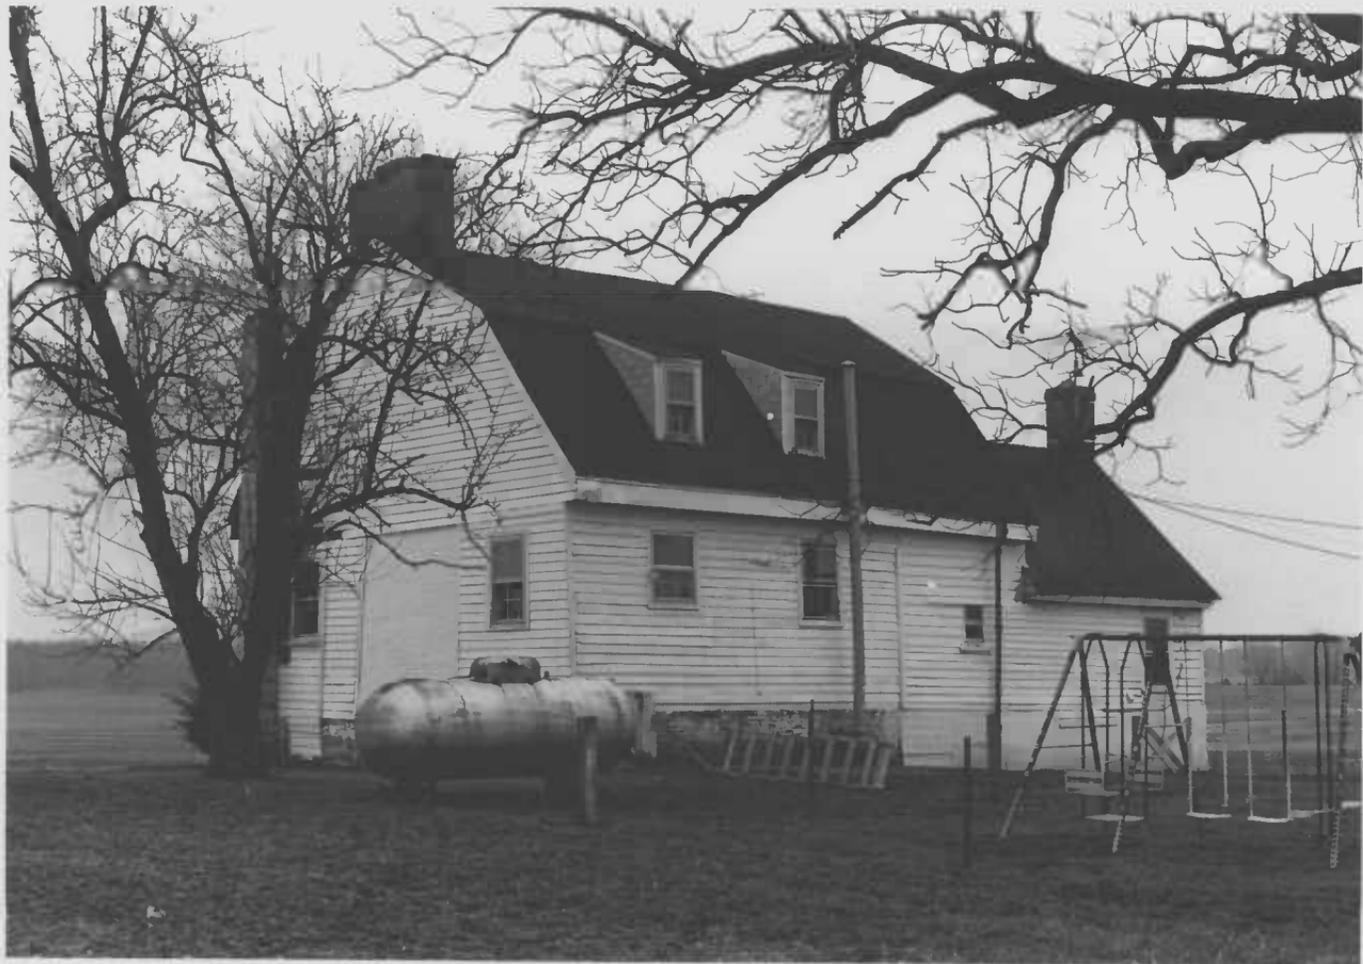
QA-71

On the rear facade, the seam between the two sections of the house is more apparent. There are two 6/6 windows to the left and a single 1/1 to the right on the first floor, and two 6/6 shed dormers on the second floor. The east gable is partially covered by the frame wing. A 9/6 window in the south bay on the first floor and a 6/6 centered on the second floor are the only openings. The horizontal weatherboard siding is 20th century; the rakeboards are tapered.

Thomas Prickett Farm
Hayden, Maryland
Orlando Ridout V 1980
Rear facade from Northeast
