QA-78
Prophecy
Centreville vicinity
Private

c. 1730, 1830
and 1870

INVENTORY FORM FOR STATE HISTORIC SITES SURVEY

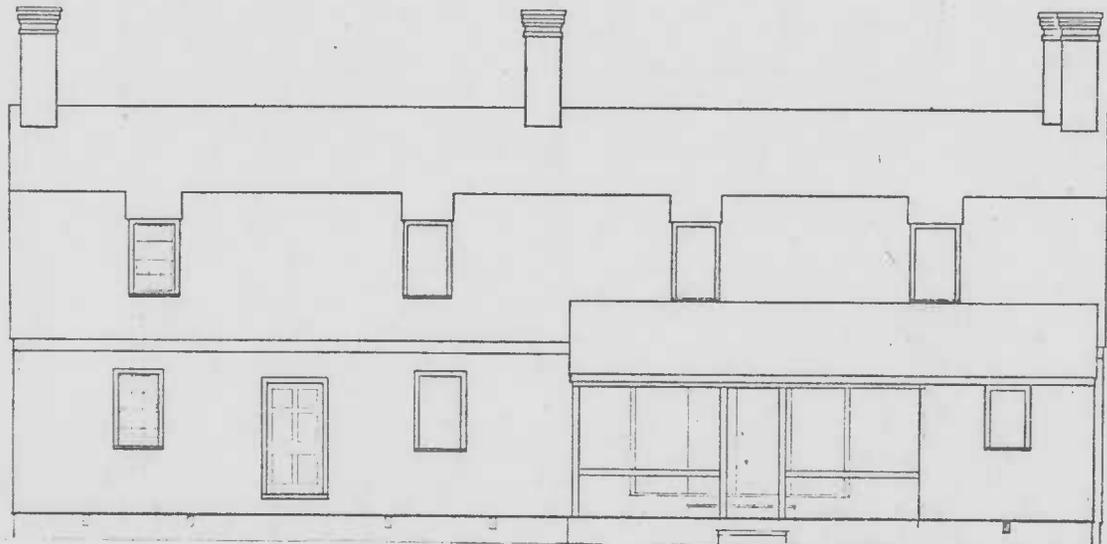
SOUTHEAST ELEVATION

The earlier part of the house consists of a 32' x 18' symmetrical frame dwelling with central entrance flanked by two windows with 6/6 sash. On the gambrel roof, there are two dormer windows the same size as below, with shed roofs. Two brick chimneys pierce the apex of the roof within the 32' dimension. Its southwest gable is plain other than the exposed brick chimney/fireplace back to the height of the second story. The southeast facade of this section is identical to the front.

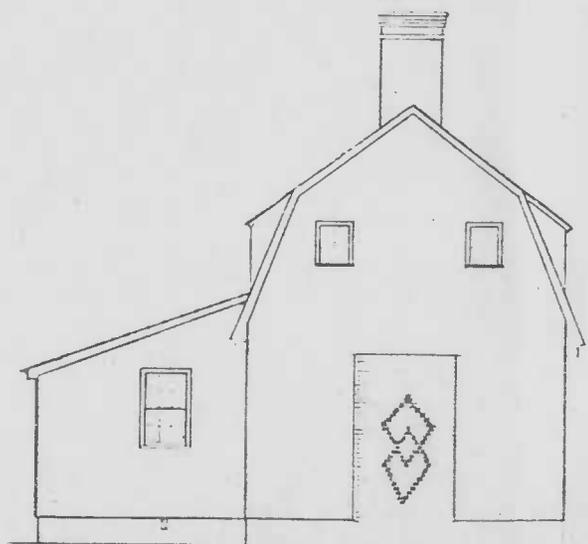
NORTHEAST ELEVATION

A third chimney pierces the roof within the northeast gable. The gable has an exposed chimney back with interlocking glazed diamonds. On the second story are two 4-pane casements. On the southeast side of this section is a 12' shed addition containing a 10' enclosed entry and the rest screened porch, all of which was added in the 1970's.

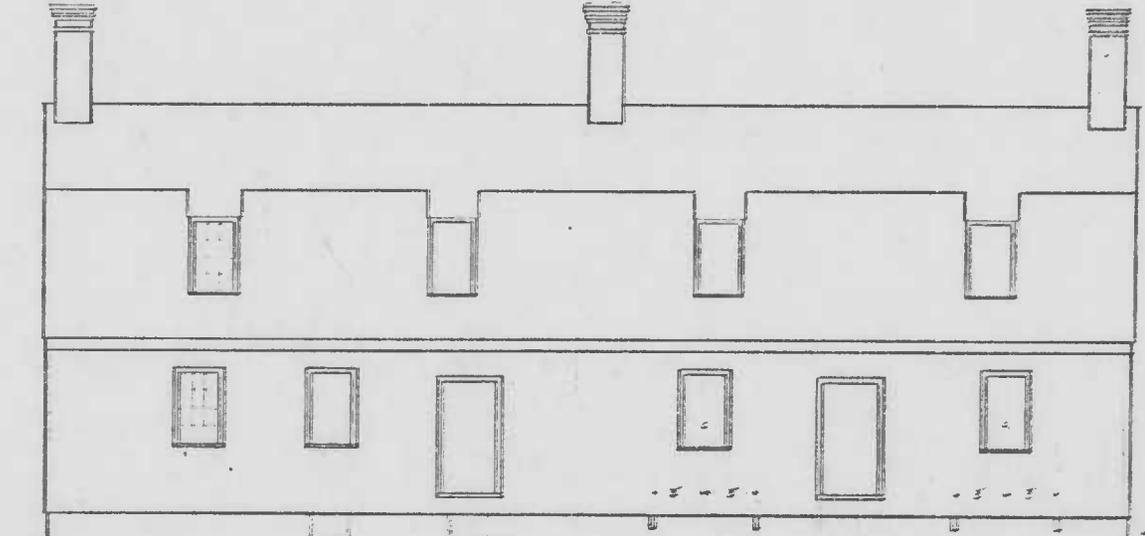
NORTHWEST ELEVATION

Prophecy is located on Wilmer Neck, 5 1/2 miles north of Centreville. It faces northwest, opposite Bookers Wharf Road. The house is a long gambrel roof frame dwelling composed of two sections, the southern half being the earliest and the northern section built around 1870. Both sections were remodded/restored between 1973 and 1979.

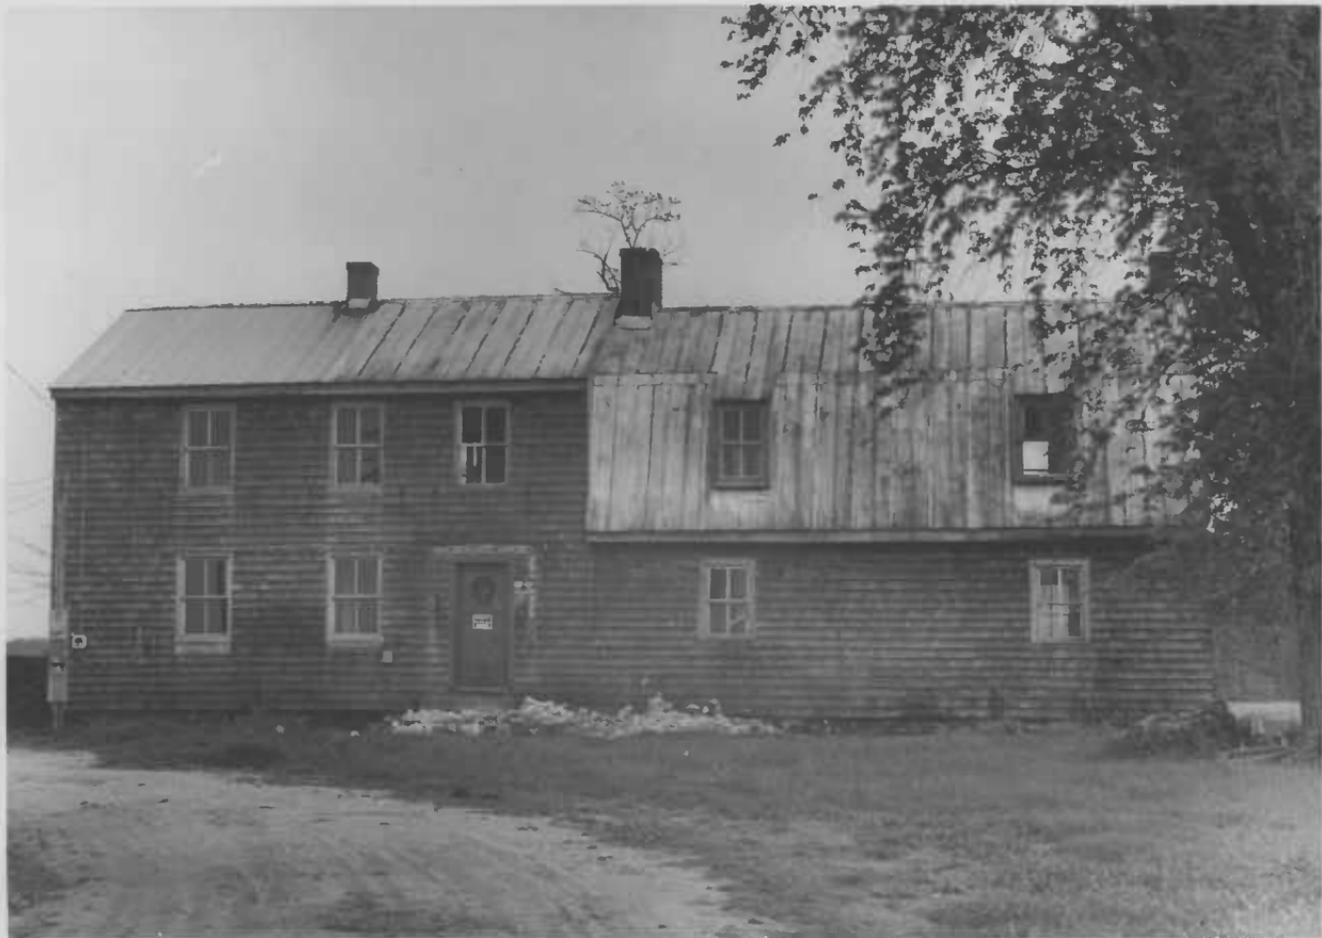
Prophecy
Burrisville vicinity
James M. Kilvington 1974
Northwest facade

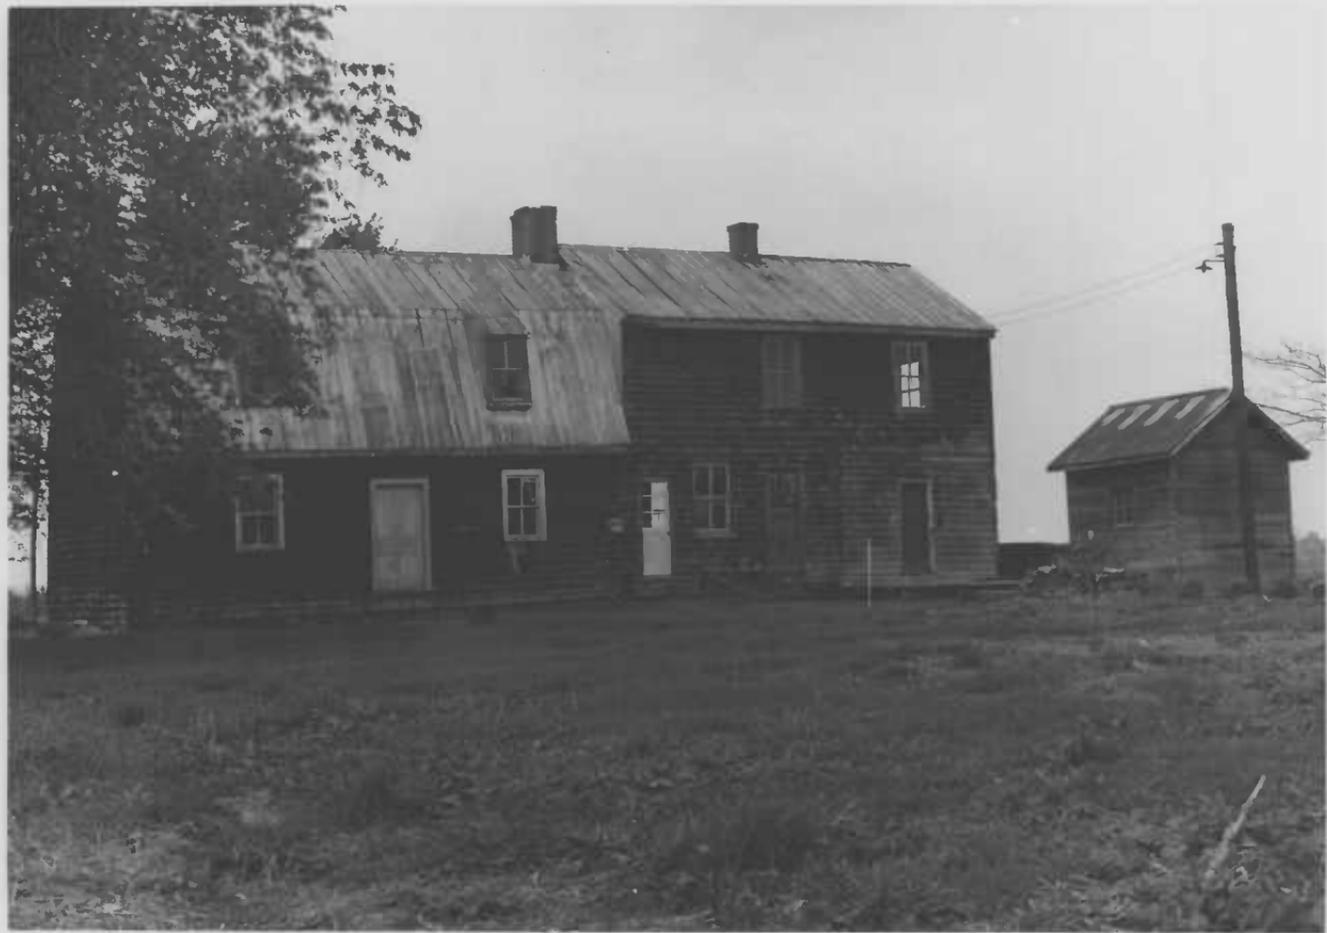
Prophecy
Burrisville vicinity
James M. Kilvington 1974
Southeast facade, ~~early~~
section

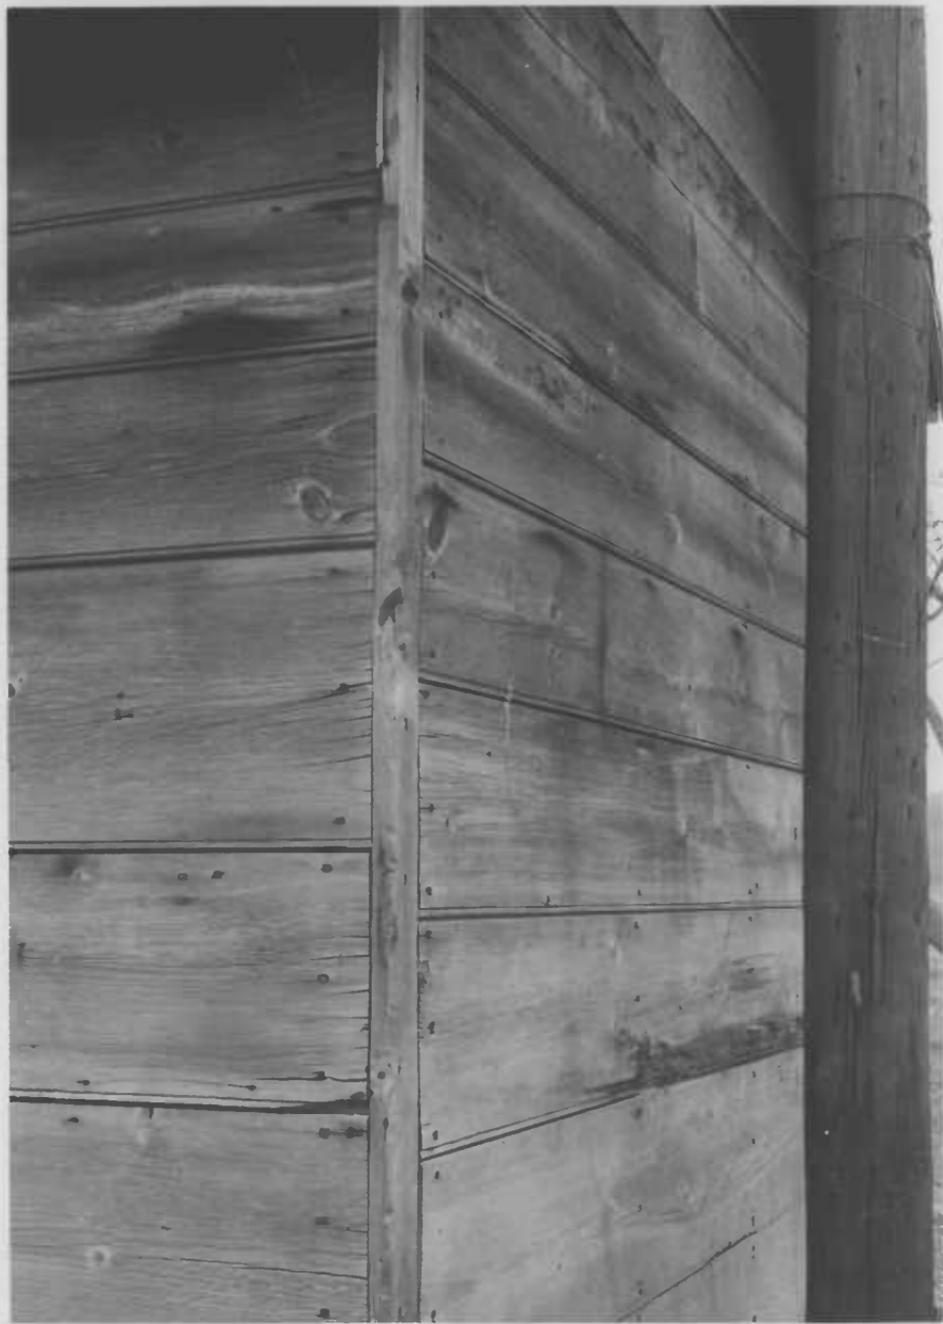
Prophecy
Burrisville vicinity
James M. Kilvington 1974
Detail, outbuilding
