INVENTORY FORM FOR STATE HISTORIC SITES SURVEY

Providence

Mary Brown Farm

QA-104

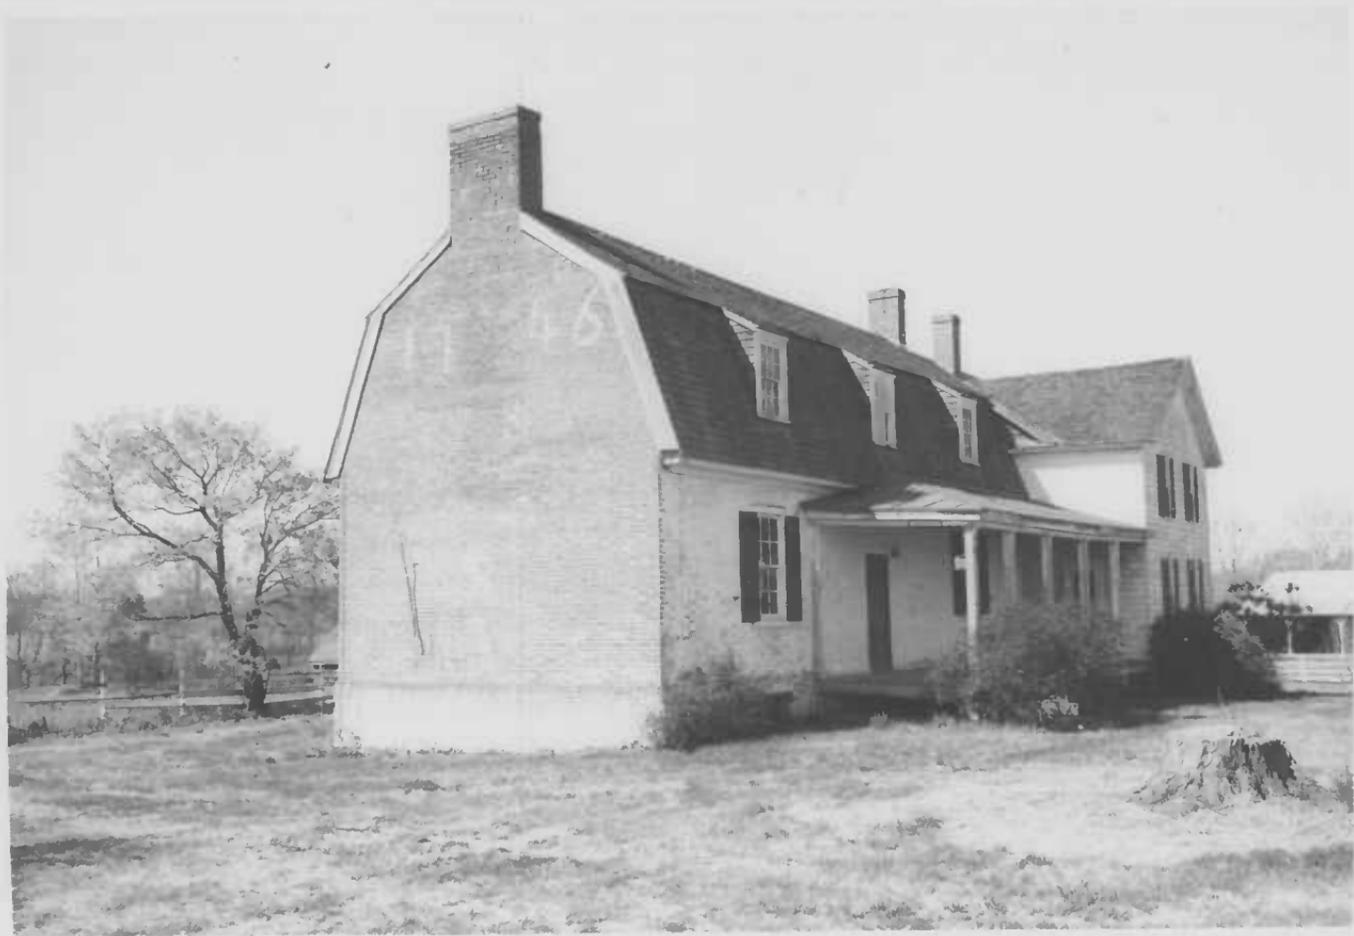
#104

Mary Brown Farm  
Centerville vicinity  
View from NE

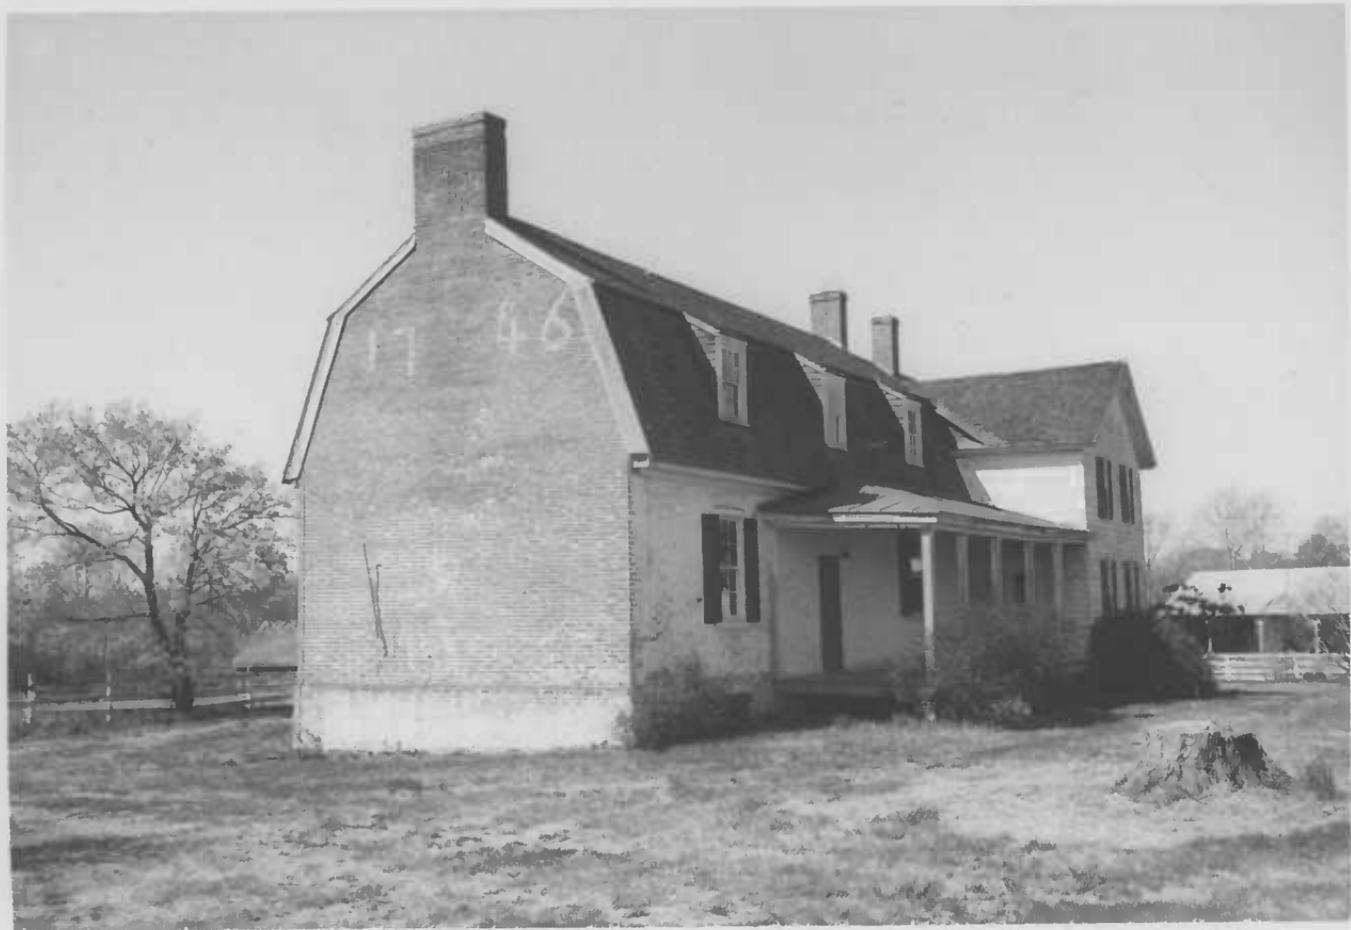
# 104

Mary Brown Farm  
Centerville vicinity  
View from NE

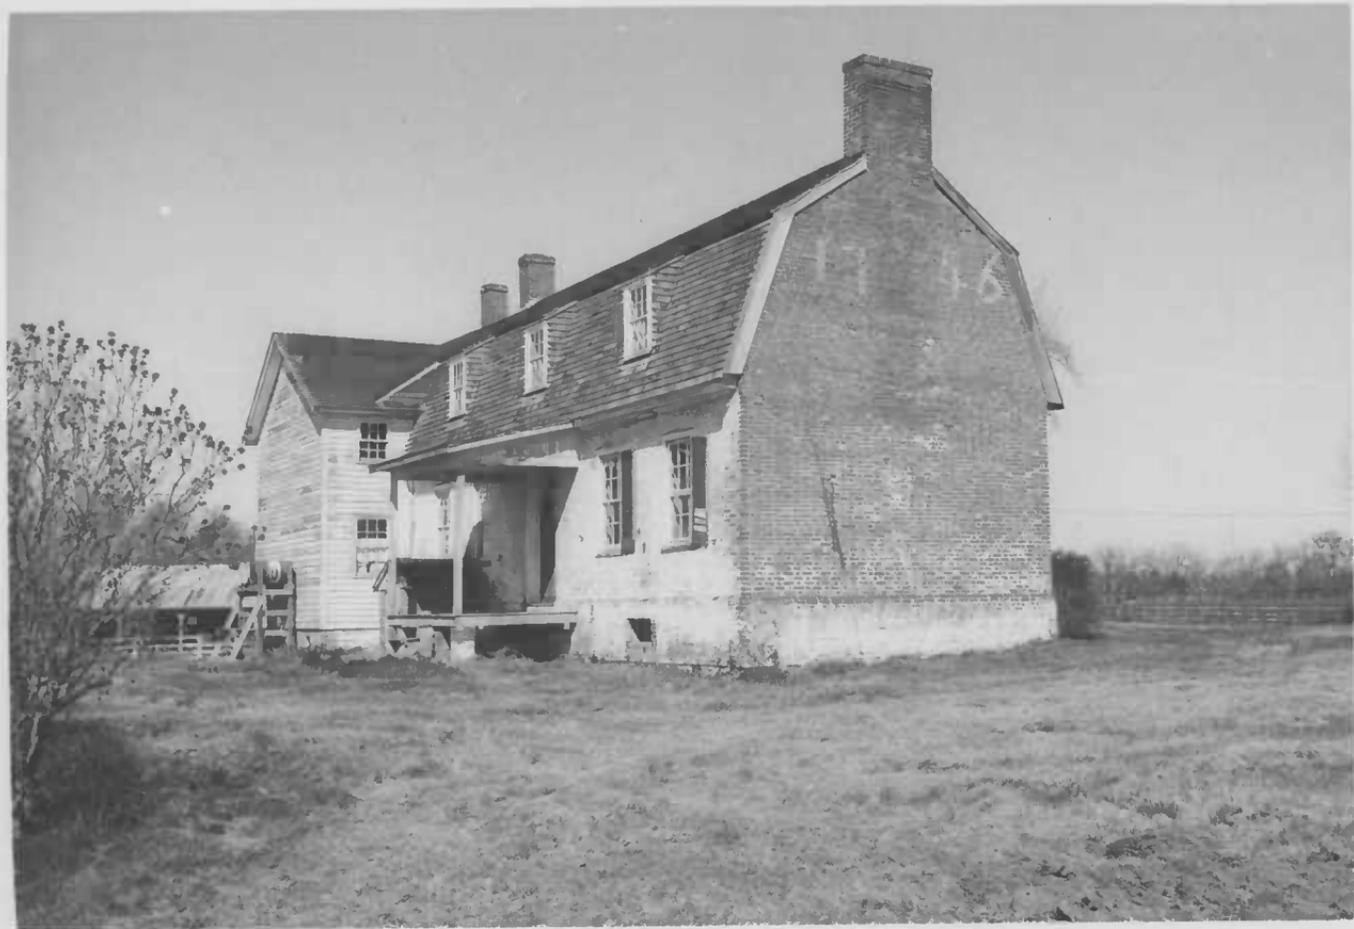
#104

There are no openings in the east gable wall. The brickwork is laid in Flemish bond in the first story and English bond in the upper gable above a molded water table and Flemish bond foundation. The date "1746" is incorporated into the upper gable wall using glazed header bricks. The gable rakeboards are replacements.

Mary Brown Farm  
Centerville vicinity  
View from SE

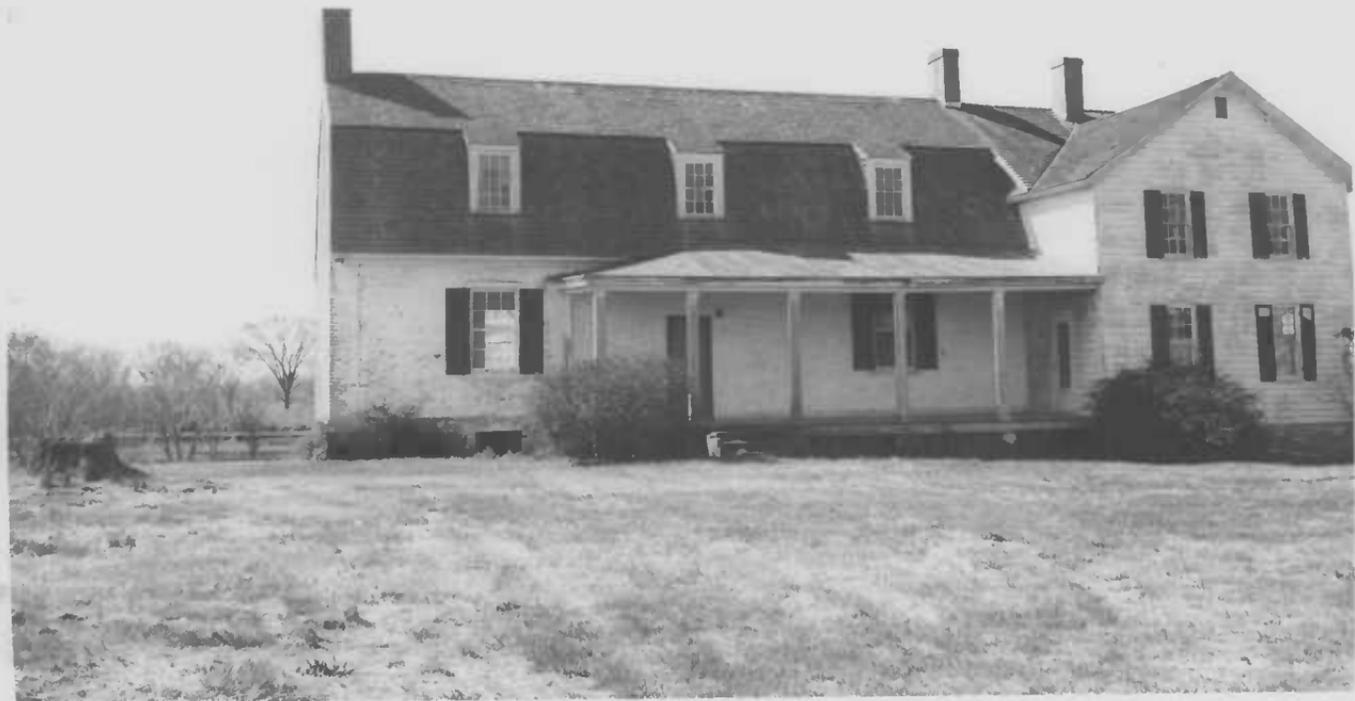
# 104

On the rear or north facade, the door is offset to left of center, flanked by a single 6/6 window on each side. Three 6/6 shed roof dormer windows are ranged across the second story. The molded water table, segmental brick window openings, molded cornice and shingle roof match the front facade.

Mary Brown Farm  
Centerville vicinity  
North facade

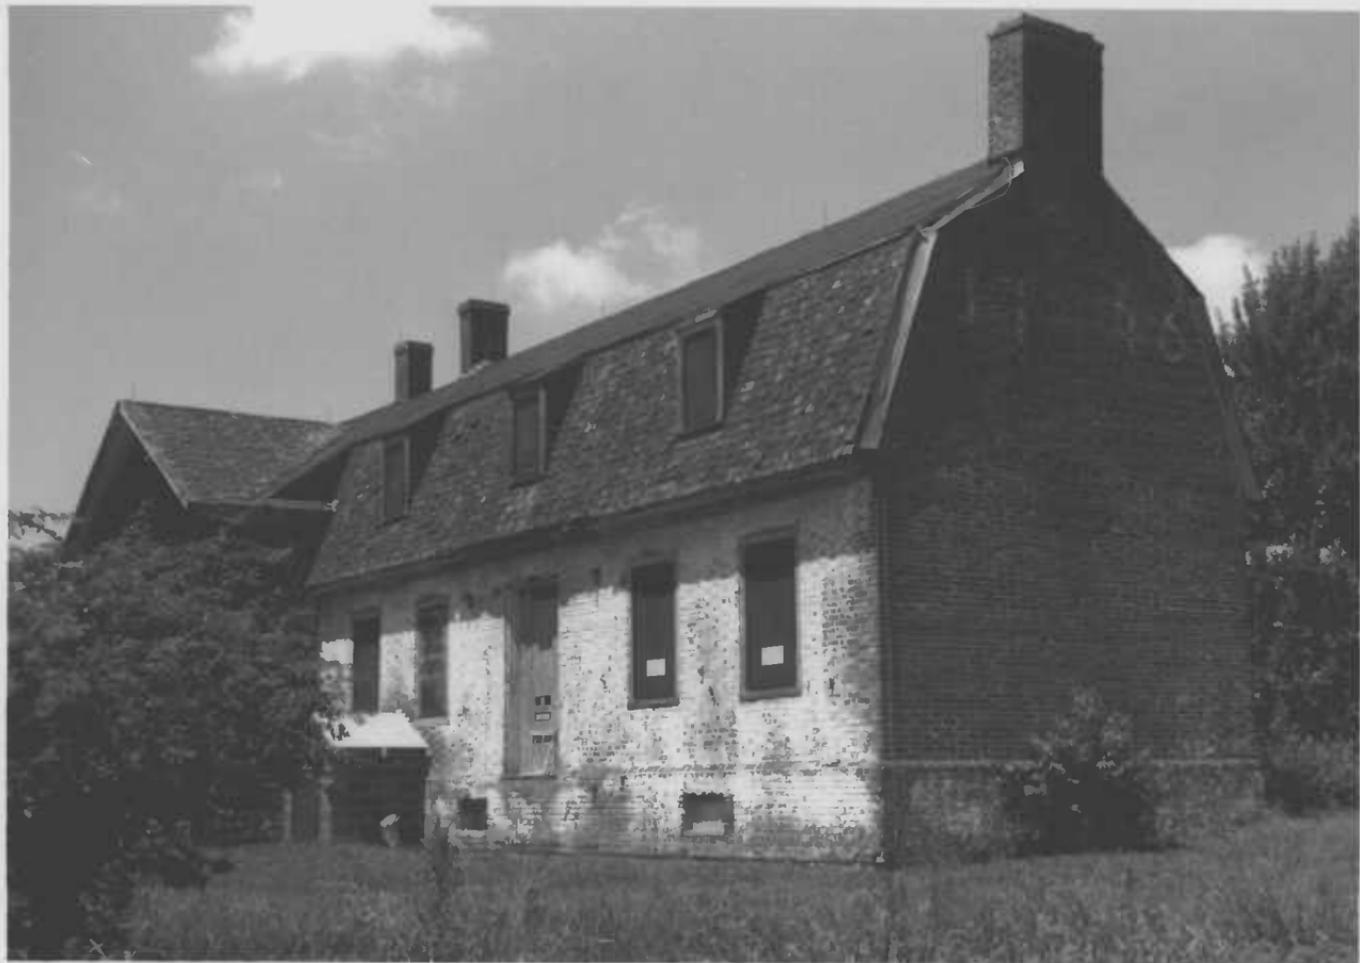
QA-104 Providence (1746)

The front facade of the house faces south, toward the Mill Stream Branch of Corsica Creek. The door is in the center bay flanked by two 6/6 windows on each side. Three 6/6 shed roof dormer windows are ranged across the second story. The brickwork is laid in Flemish bond above a

molded water table. The window openings have arched brick lintels. The center door is framed with 19th century sidelights and transom. The eaves are boxed in and trimmed with a handsome complex crown mold and bed mold; the roof is covered with wood shingles. A simple entrance porch and concrete block bulkhead cellar entrance have been added in the 20th century.

View from south
