INVENTORY FORM FOR STATE HISTORIC SITES SURVEY

Big Oak Farm

QA-250

Orlando Ridout V, Historic Sites Surveyor

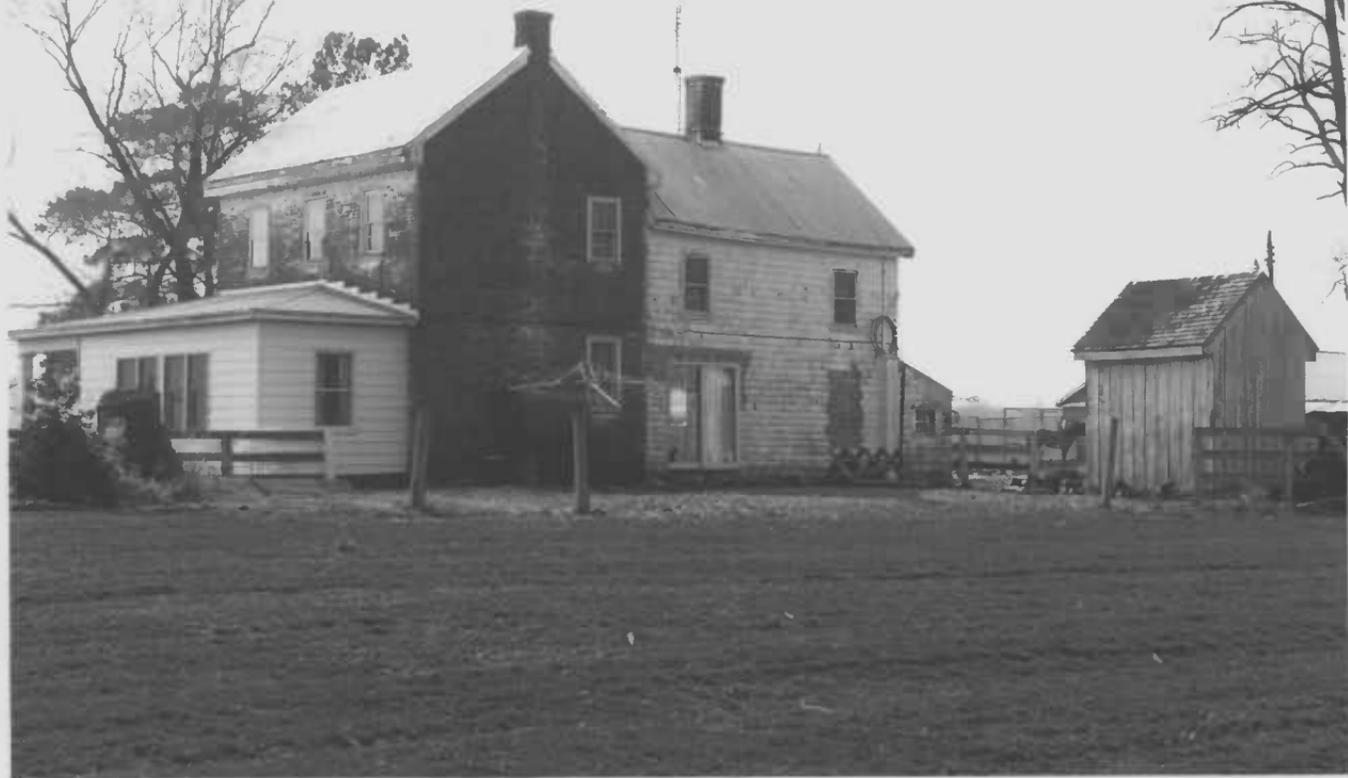
QA-250

The front facade of the main house faces east, with an entrance door with four-light transom in the south bay, two 2/2 windows to the north and three original 6/6 windows ranged across the second story. The brickwork is laid in seven-course

William Dixon, Jr. Farm
Centreville vicinity
Orlando Ridout V 1981
View from East

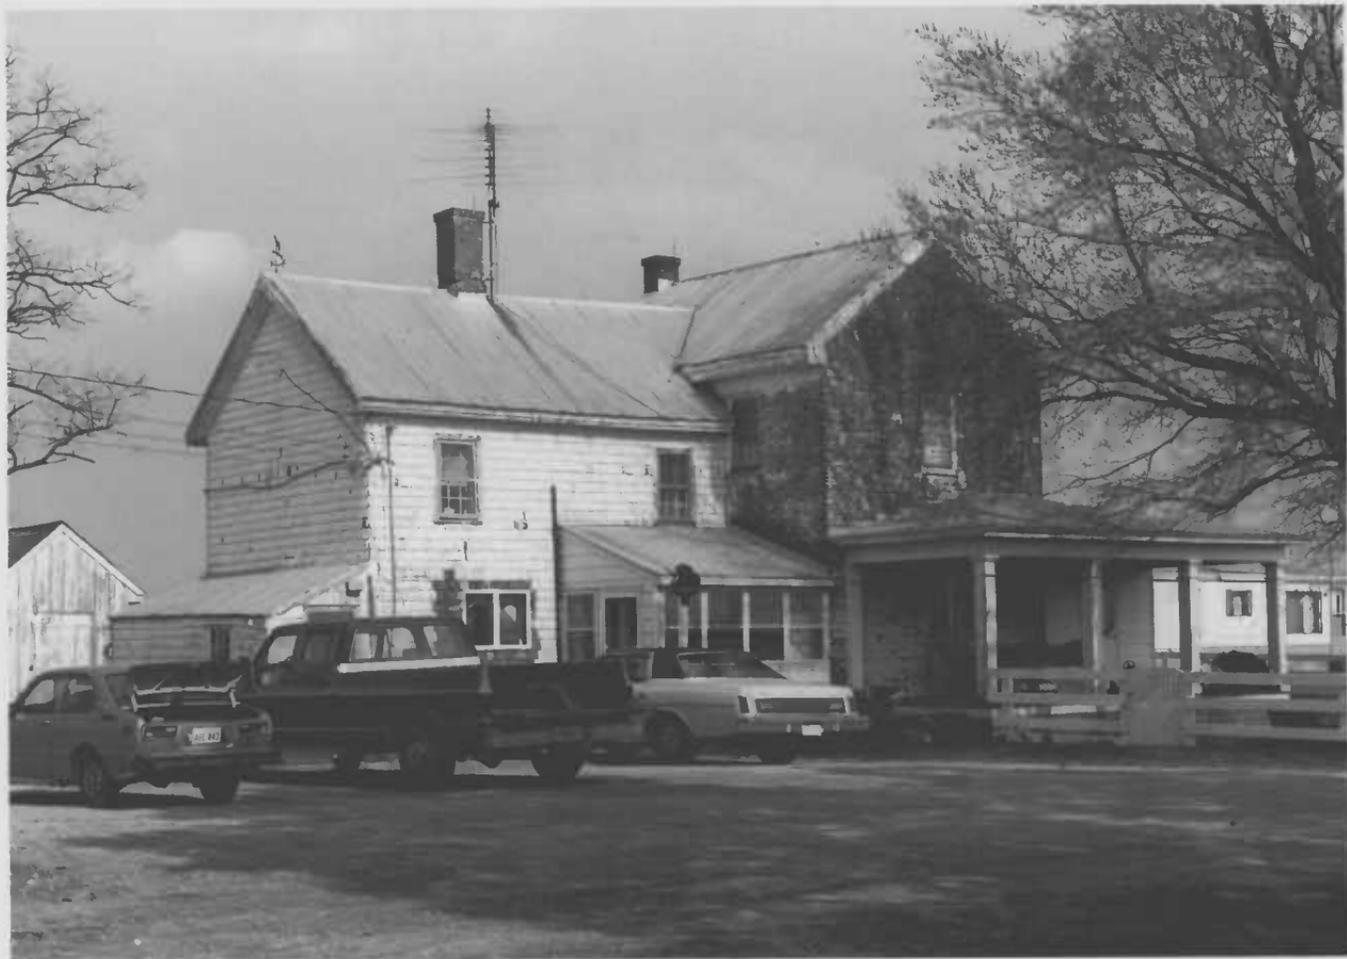
The rear facade is almost entirely covered by the two story frame wing. This wing dates to the late 19th or early 20th century but clearly incorporates or replaces an original wing. This wing is set flush with the north gable wall of the main house and is set back about 6 feet from the south gable wall, allowing an exterior door in the south bay of the rear facade of the main house on the first floor and a 6/6 window on the second floor. The north and center bays of the rear facade of the main house remain exposed in the east room of the wing. There is an original door in the center bay and no opening in the north bay. On the second floor, a door in the north bay allows access from the main house into the wing. The fenestration on the rear facade

QA-250 William Dixon, Jr. Farm
Centreville vicinity
Orlando Ridout V 1981
View from West
