QA-281
Conyer House
Grasonville vicinity
Private

INVENTORY FORM FOR STATE HISTORIC SITES SURVEY

Conyer House

CONYER HOUSE
GRASONVILLE, MARYLAND

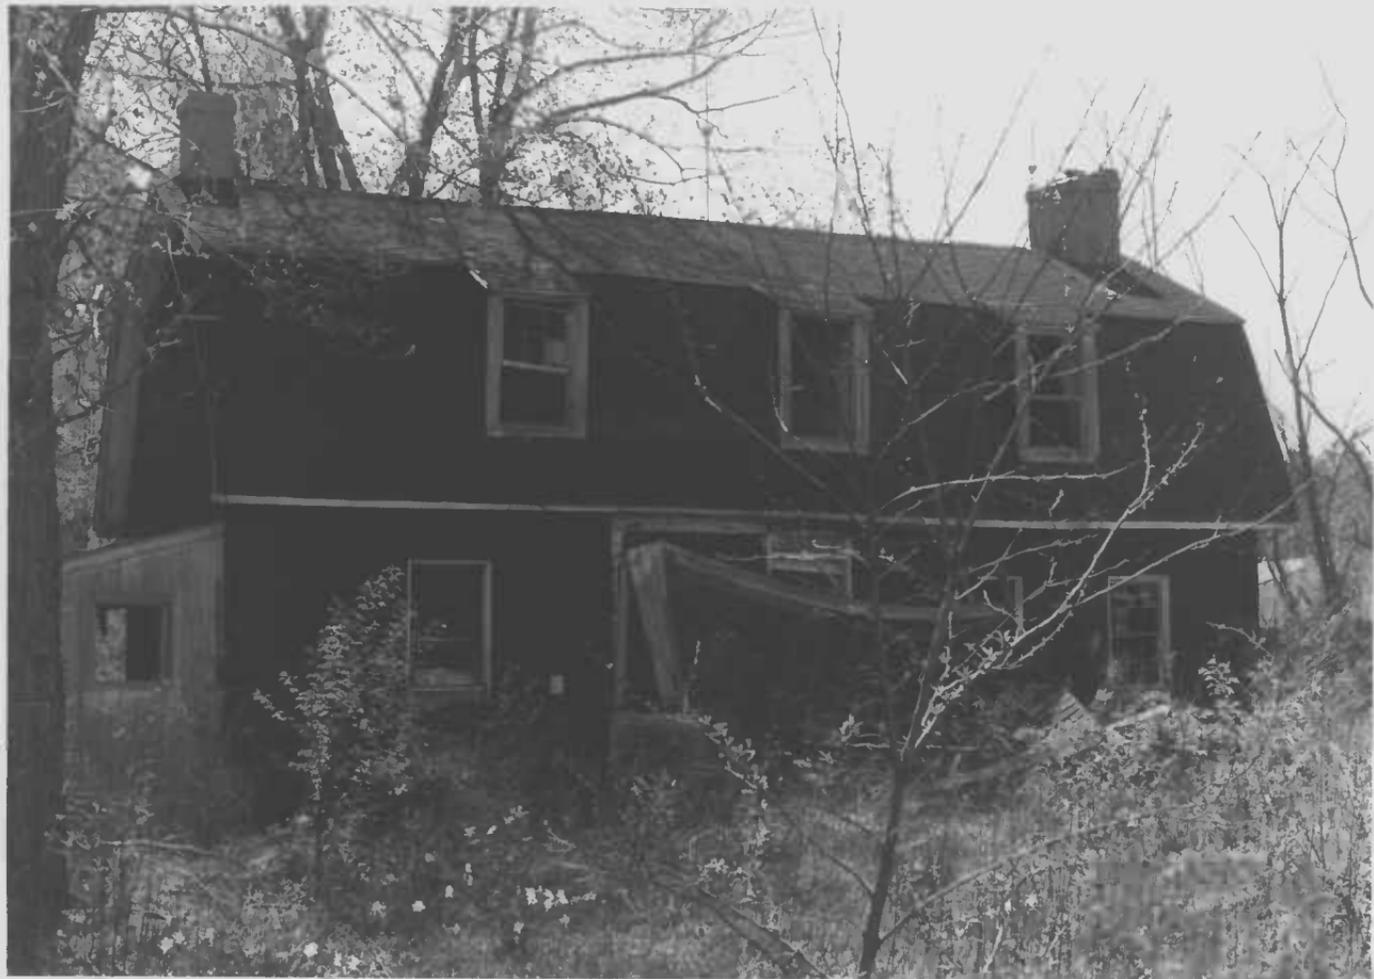
NW (front) facade

QA-281 Mabel Conyer House
Grasonville, Md.
Orlando Ricout V, 1978 (MHT)
Front Elevation, camera facing SE

The house is four bays wide and one room deep, one-and-one-half stories high with a gambrel roof. There are three shed roof dormers on each facade, a large brick chimney flush with the southwest gable and a small stove chimney flush with the northeast gable.

Fenestration of the original house consists of an exterior entrance in the northeast bay of each facade and six-over-six windows in the center and southwest bays. There are no openings in the southwest gable. The flush brick chimney is centered on that wall, laid in stretcher bond, with the brickwork exposed up to the first floor

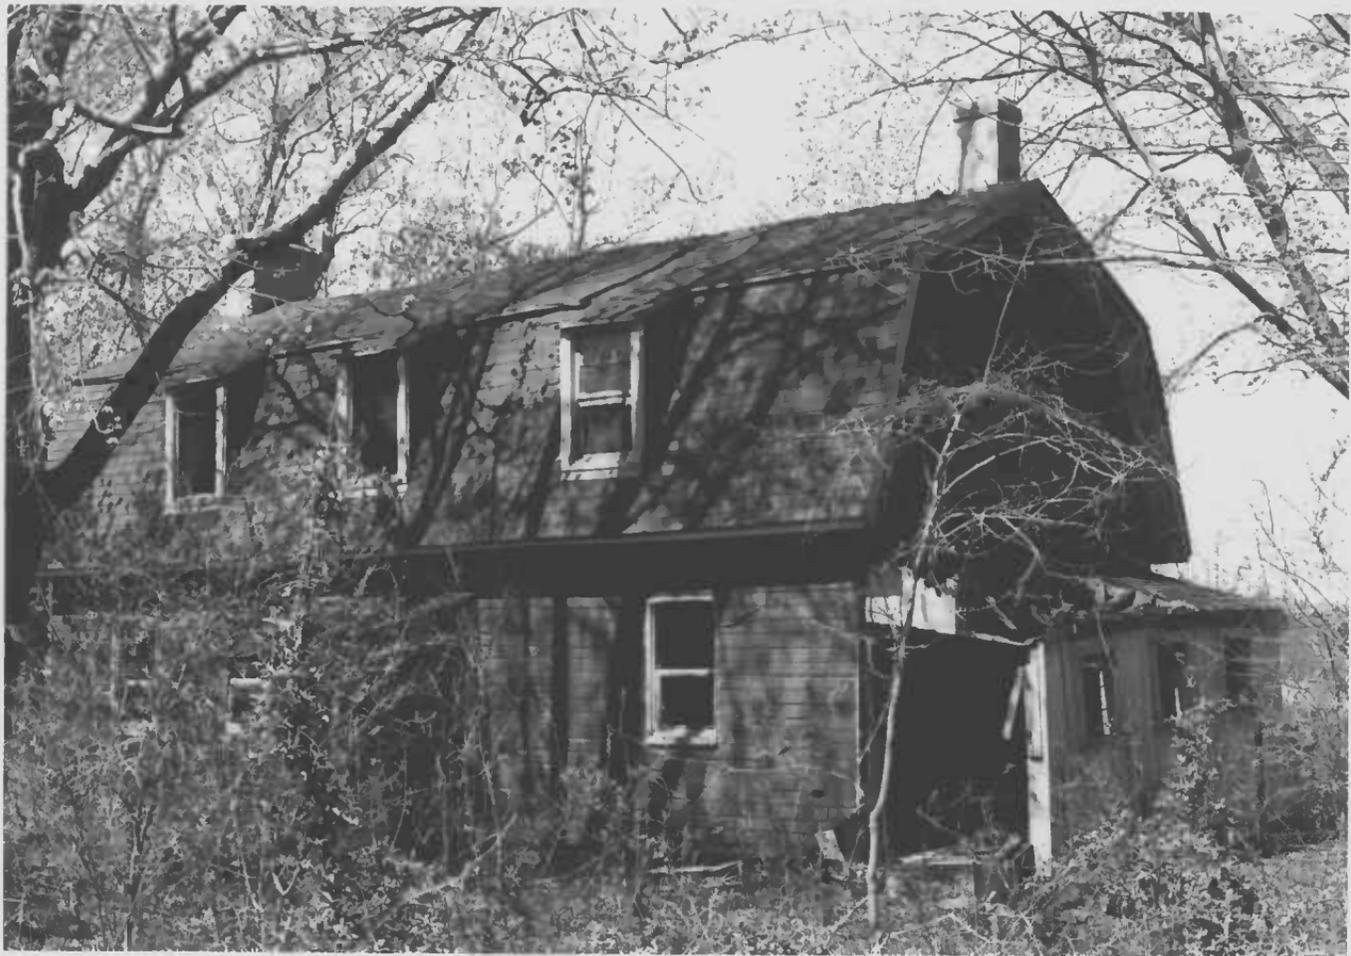
QA-281

View from East

The addition was made to the northeast gable of the original house, and consists of a single room with a six-over-six window on each facade and an exterior door in the east corner of the gable with a four-over-four window to the right of the door.

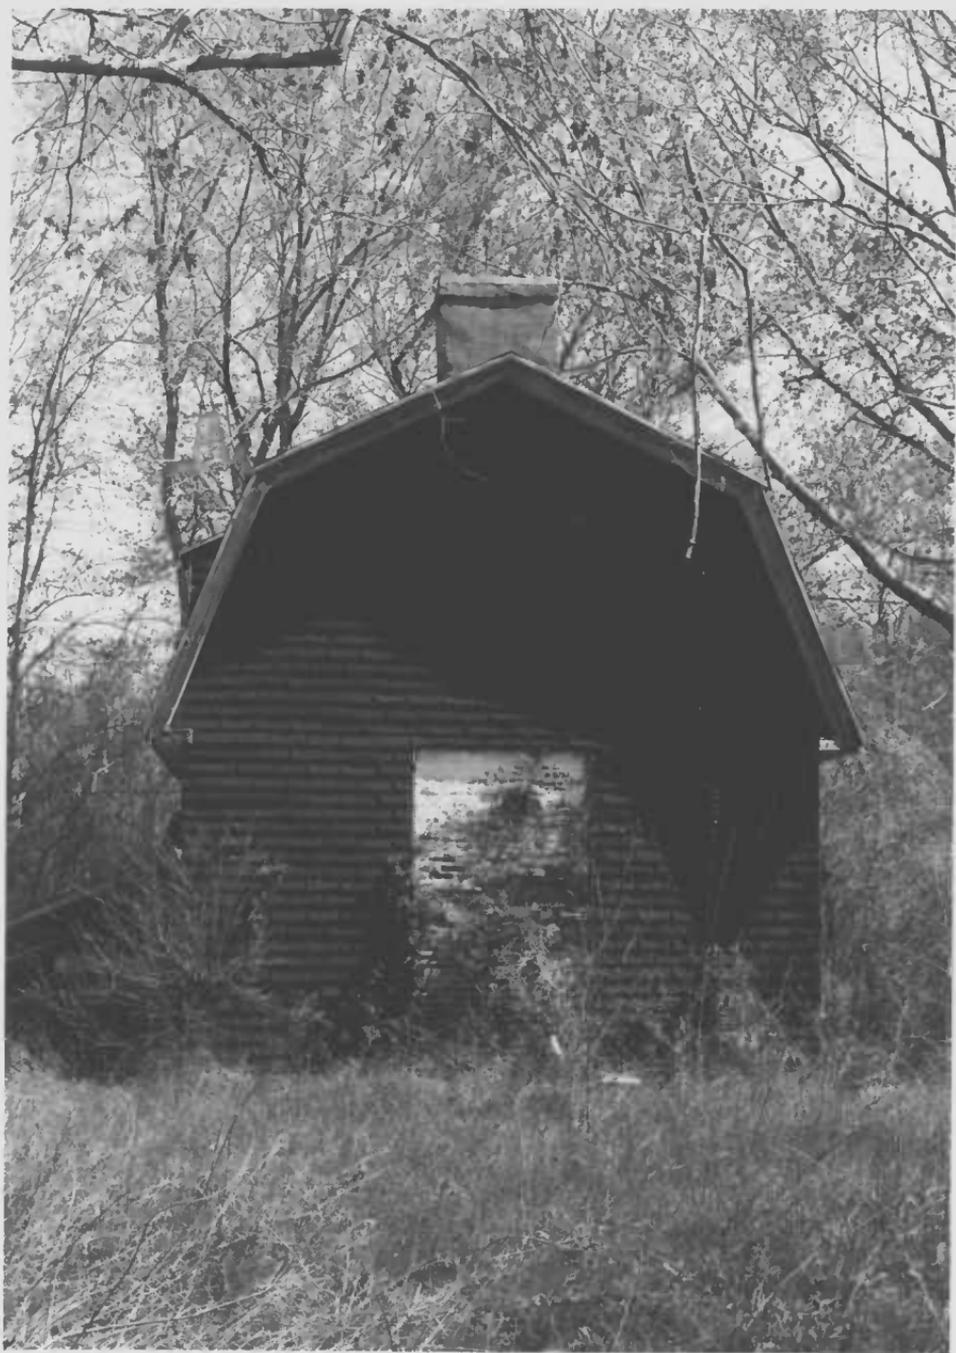
DA-281

SW gable
