QA-291
Harrison House
Crumpton
Private

circa 1883

INVENTORY FORM FOR STATE HISTORIC SITES SURVEY

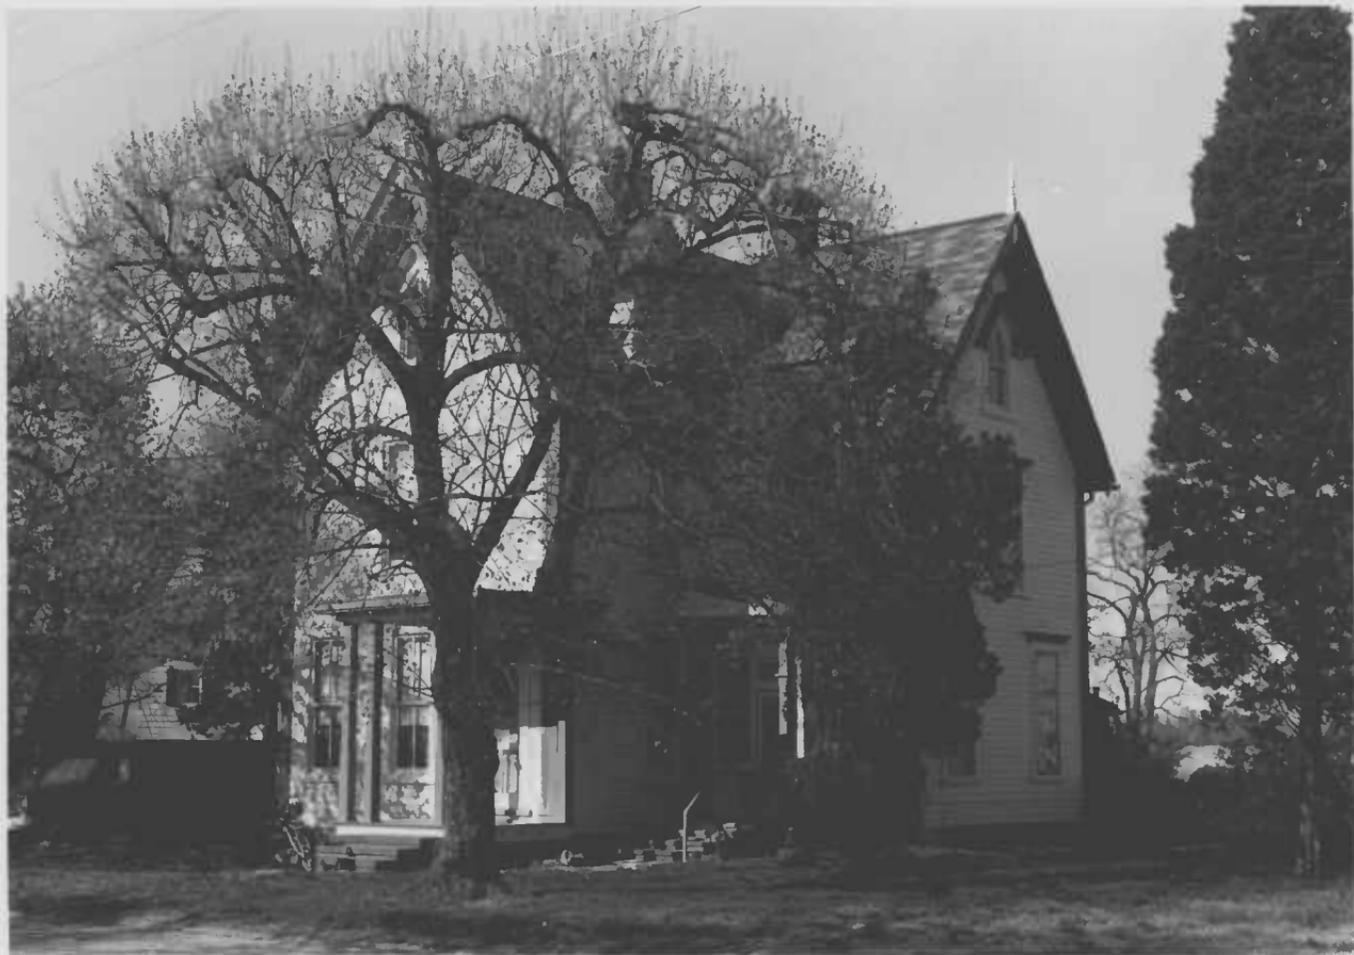
QA-291 Harrison House
Crompton, Maryland
Orlando Ridout V 1980
View from Southwest

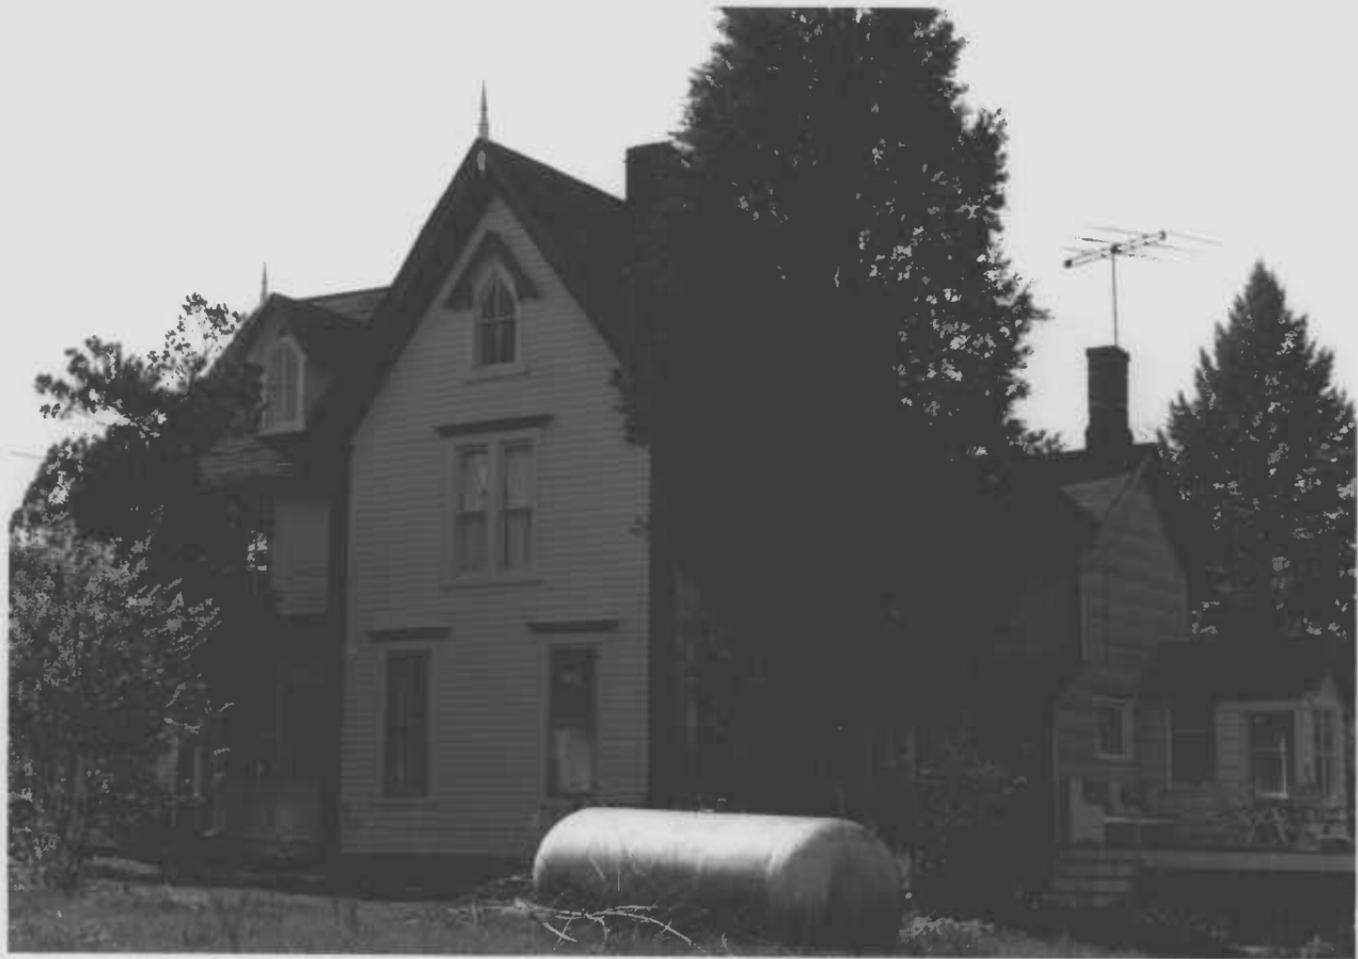
QA-291

The rear facade, facing the river, is partially concealed by an original two story kitchen wing with a one story lean-to on the south facade. One 2/2 window is located on each floor of the main house to the south of the kitchen wing, a single 1/1 window on the second floor to the north. Two 2/2 dormers are symmetrically placed on the third floor, and a brick chimney is centered on the ridge. The cornice on this facade is simply boxed in, with no decorative verge board; the paneled pilasters do not turn the corner.

Harrison House
Crumpton, Maryland
Orlando Ridout V 1980
View from East

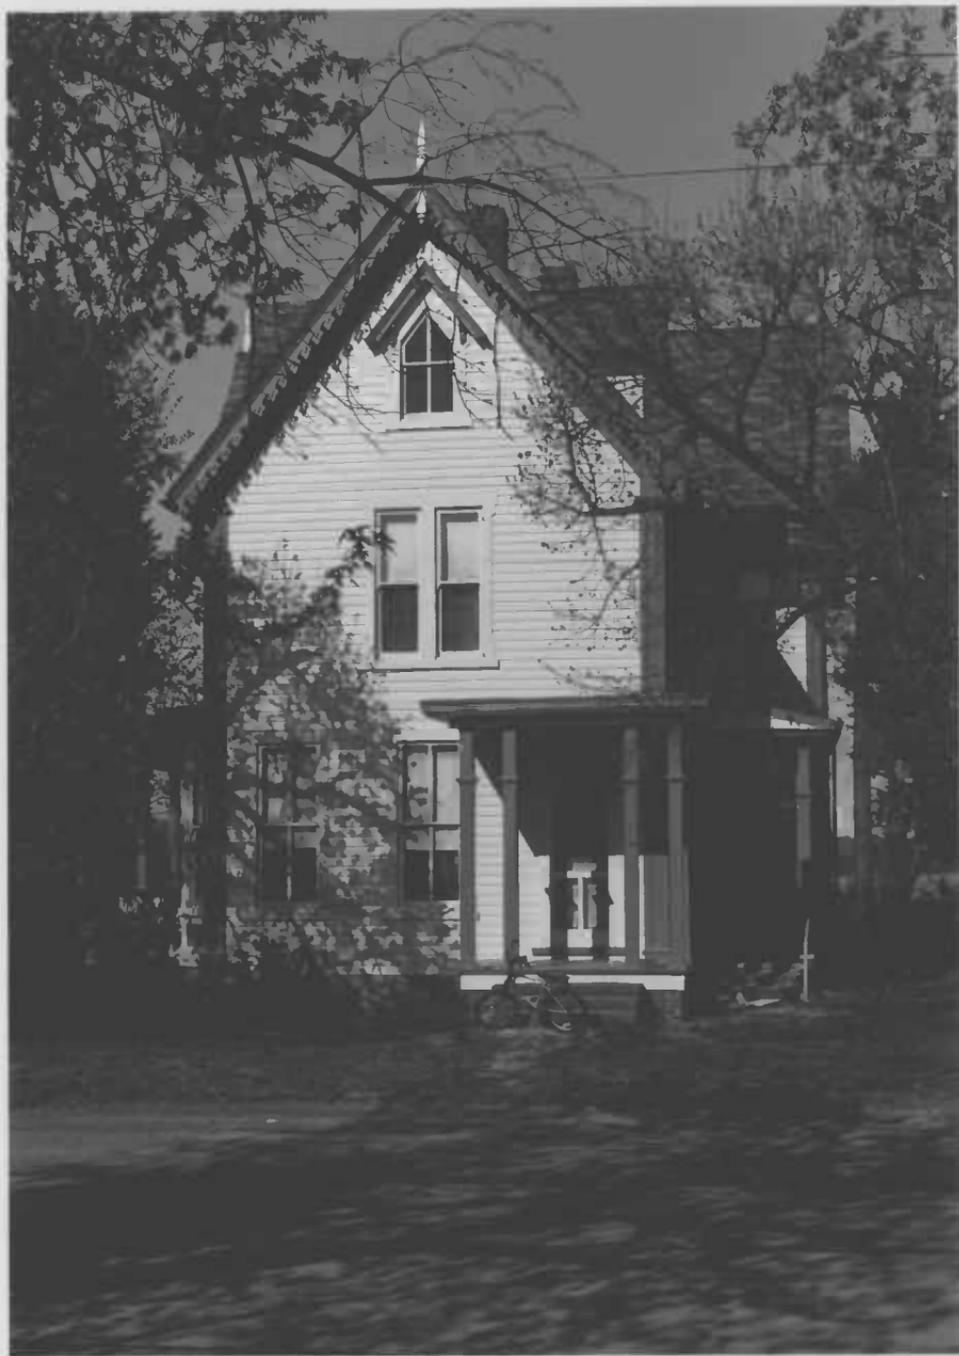
QA-291

This large frame house was constructed circa 1883, and has undergone few changes or alterations. It is 2 1/2 stories high on a continuous brick foundation, with steeply pitched gable roofs and a T-plan with original rear kitchen wing. The base of the "T" faces Broad Street in the form of a large projecting gable. The main body of the house, behind this projecting gable, is parallel to the street. The principal entrance is located in the south bay of the front gable, with two tall 2/2 windows to the left on the first floor, paired 1/1 windows in the center on the second floor, and a single 2/2 lancet window in the upper gable. The window openings are framed with wide flat architraves with flared corners; the third story window is further embellished by a molded and peaked hood supported by scrolled and drilled brackets.

The corners of this facade are accented with paneled pilasters terminated at the second story eave by a molded cap and at the bottom by a molded base. The rest of the facade is covered with horizontal German siding. The deeply overhanging eaves are boxed in with a deep soffit, plain fascia below, scrolled verge boards, and a finial at the peak of the gable. The entrance door is paneled and has a three-light transom. A one story porch with chamfered and bracketed posts originally stretched across this entire facade, but has been reduced in size to an entrance porch.

Harrison House
Crumpton, Maryland
Orlando Ridout V 1980
Front gable
