QA-326  
Harry Chambers House  
101 South Liberty Street  
Centreville  
Private

INVENTORY FORM FOR STATE HISTORIC SITES SURVEY

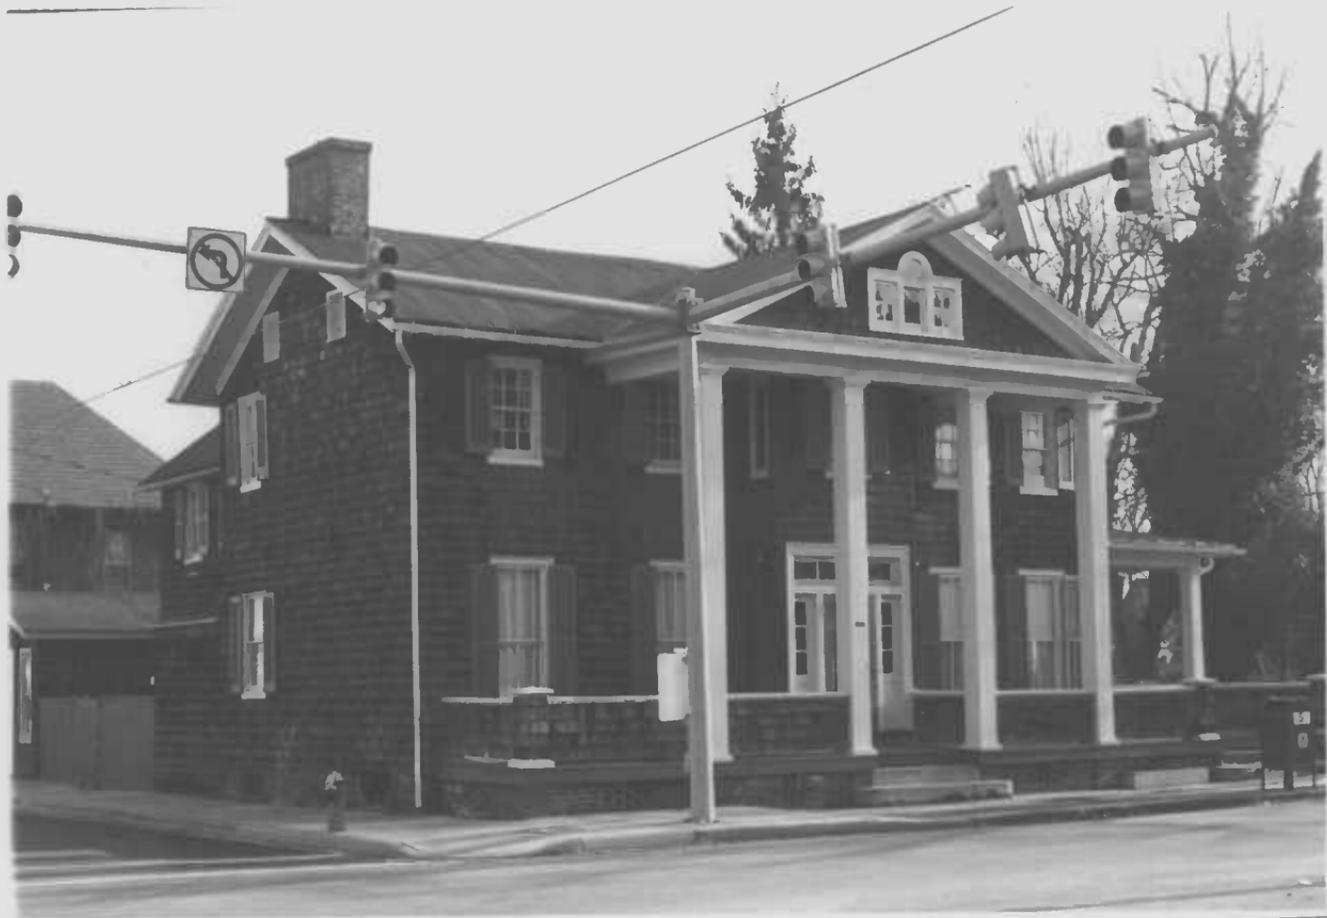
QA-326 Chambers House  
101 South Liberty Street  
Centreville, Maryland  
Orlando Ridout V 1981  
Front facade from Northwest

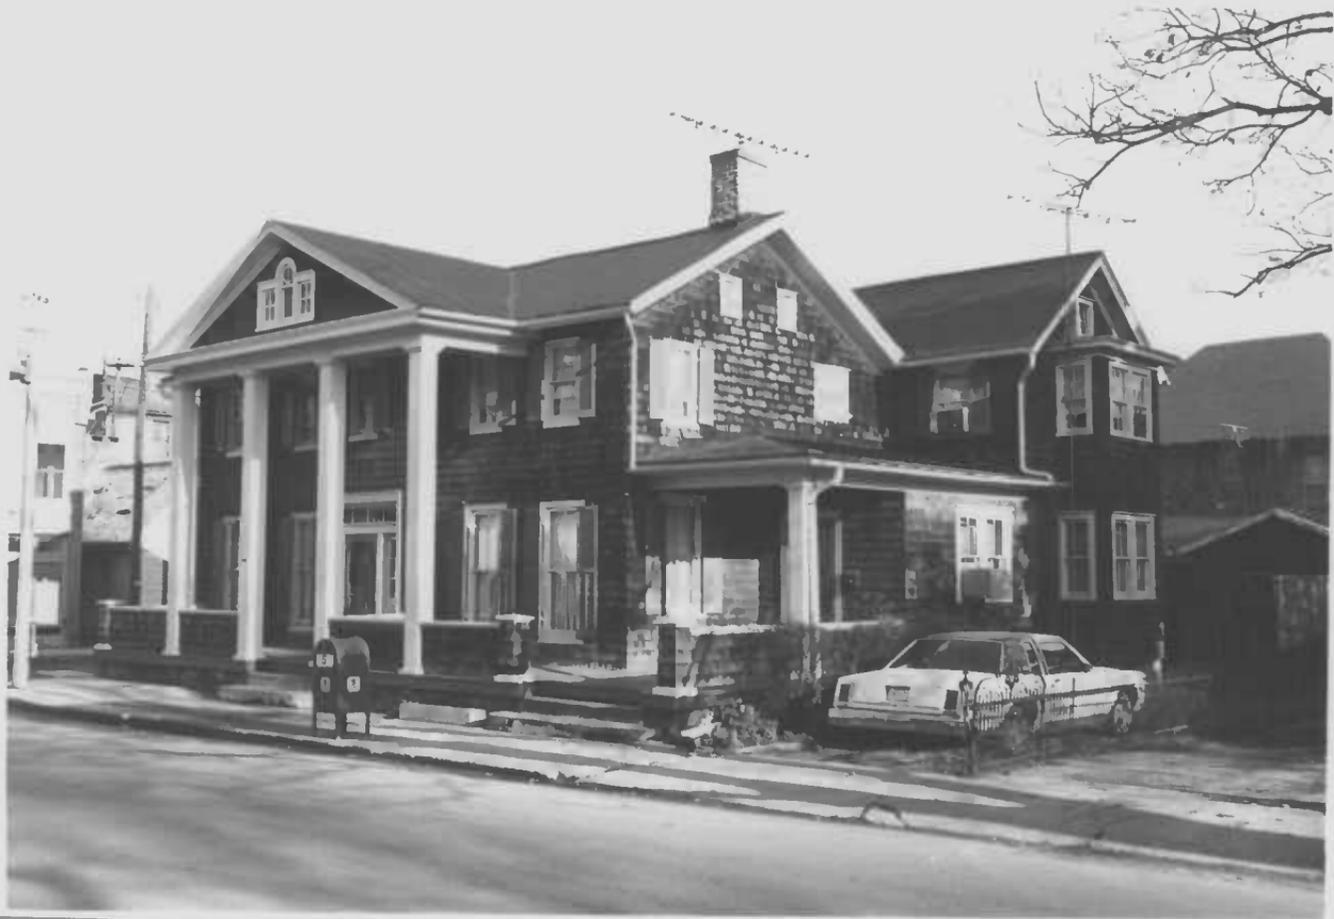
QA-326 Chambers House  
101 South Liberty St.  
Centreville, Maryland  
Orlando Ridout V  
Front facade from Southwest
