INVENTORY FORM FOR STATE HISTORIC SITES SURVEY

Captain Clash's Warehouse

QA-433

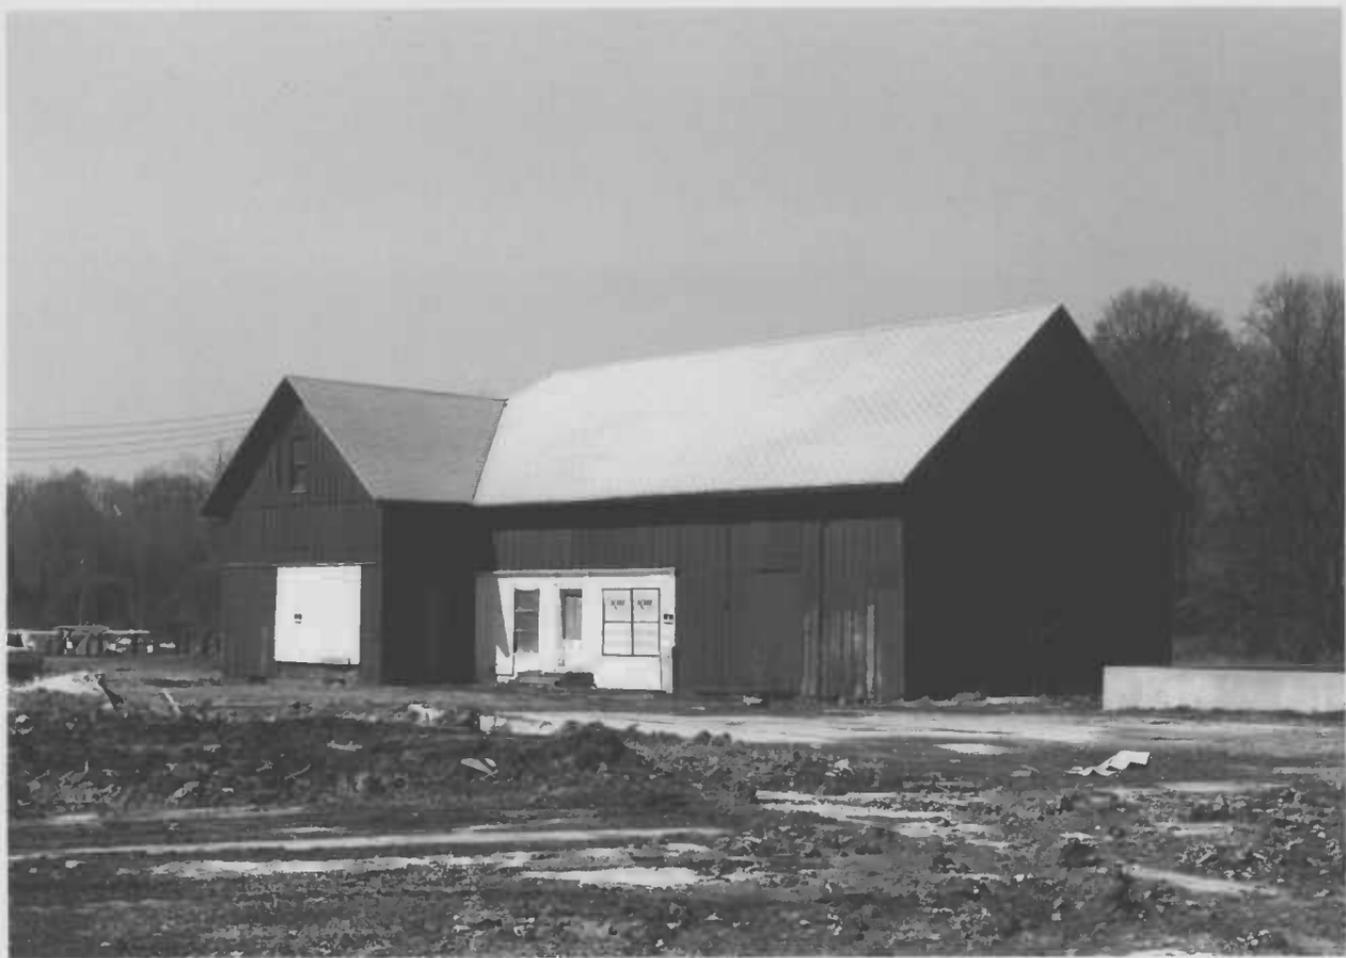
QA-433

The east facade of the original building, facing away from the creek, is covered with vertical board-and-batten siding. There is a 20th century glass-and-panel door to the left flanked by simple pilasters and a pair of large

multi-pane store windows. At the north end of this facade there is a 20th century batten door on the first floor and an early batten door with wrought strap hinges on the second floor. The eaves oversail and are left exposed; the roof is covered with asphalt shingles.

Clash Warehouse  
Centreville Wharf  
Orlando Ridout V 1981  
View from East
