Maryland Inventory of Historic Properties number: QA-492

Name: 17021/MD 2130182 Old Mill Stream Branch

MARYLAND INVENTORY OF HISTORIC BRIDGES  
HISTORIC BRIDGE INVENTORY  
MARYLAND STATE HIGHWAY ADMINISTRATION/  
MARYLAND HISTORICAL TRUST

SHA Bridge No. 17021 Bridge name MD 213 over Old Mill Stream Branch

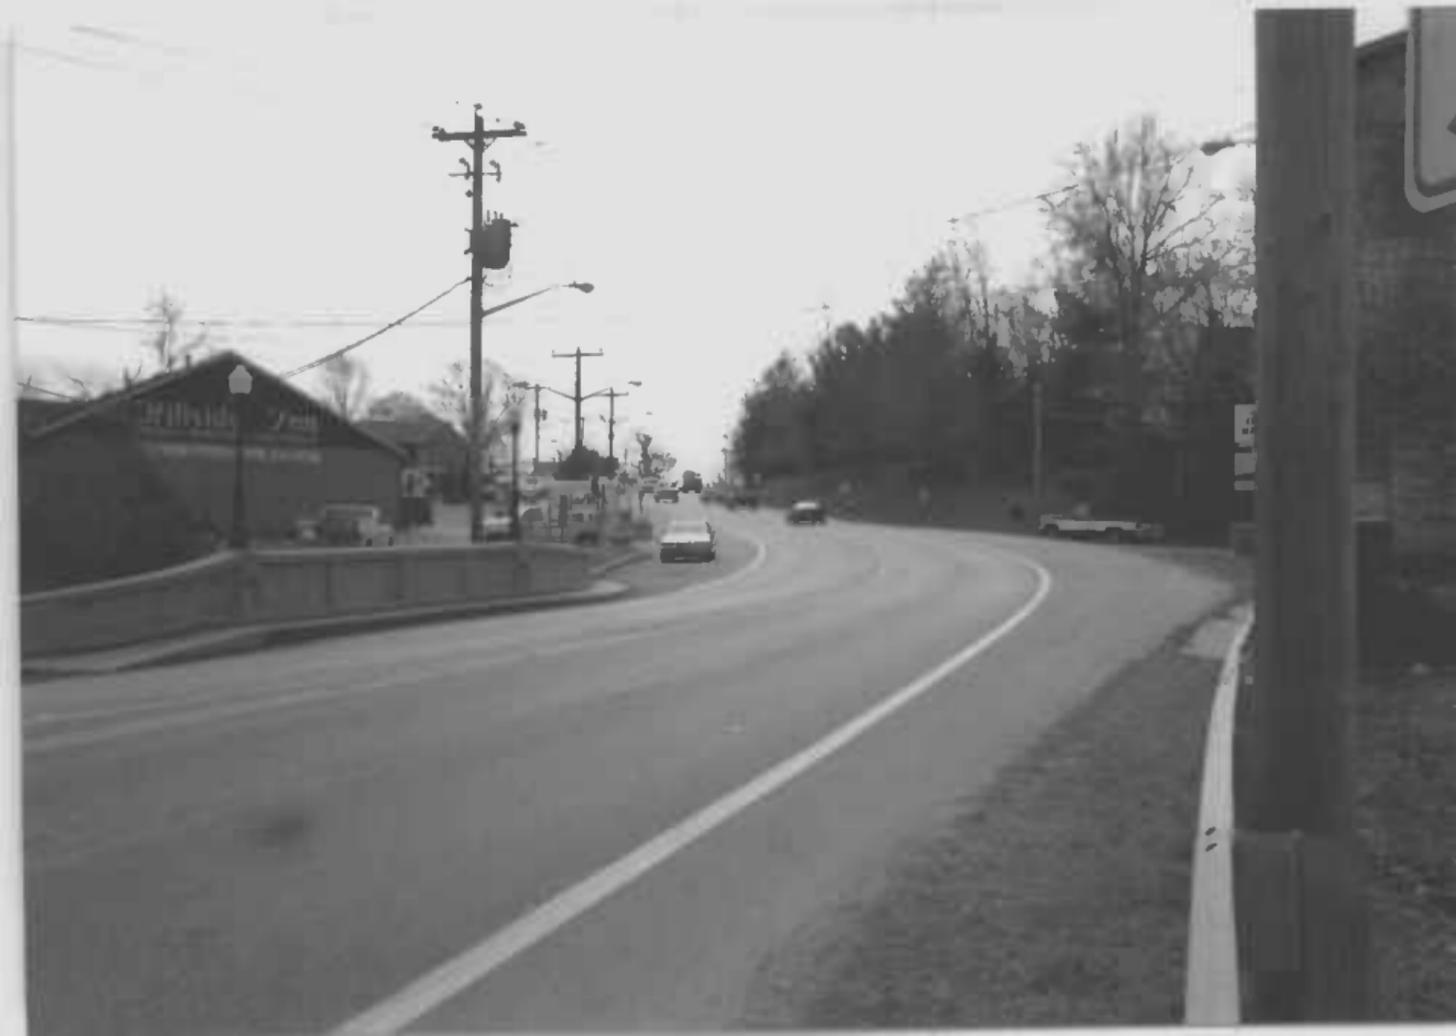
8. 4 of 6

7. roadway approach

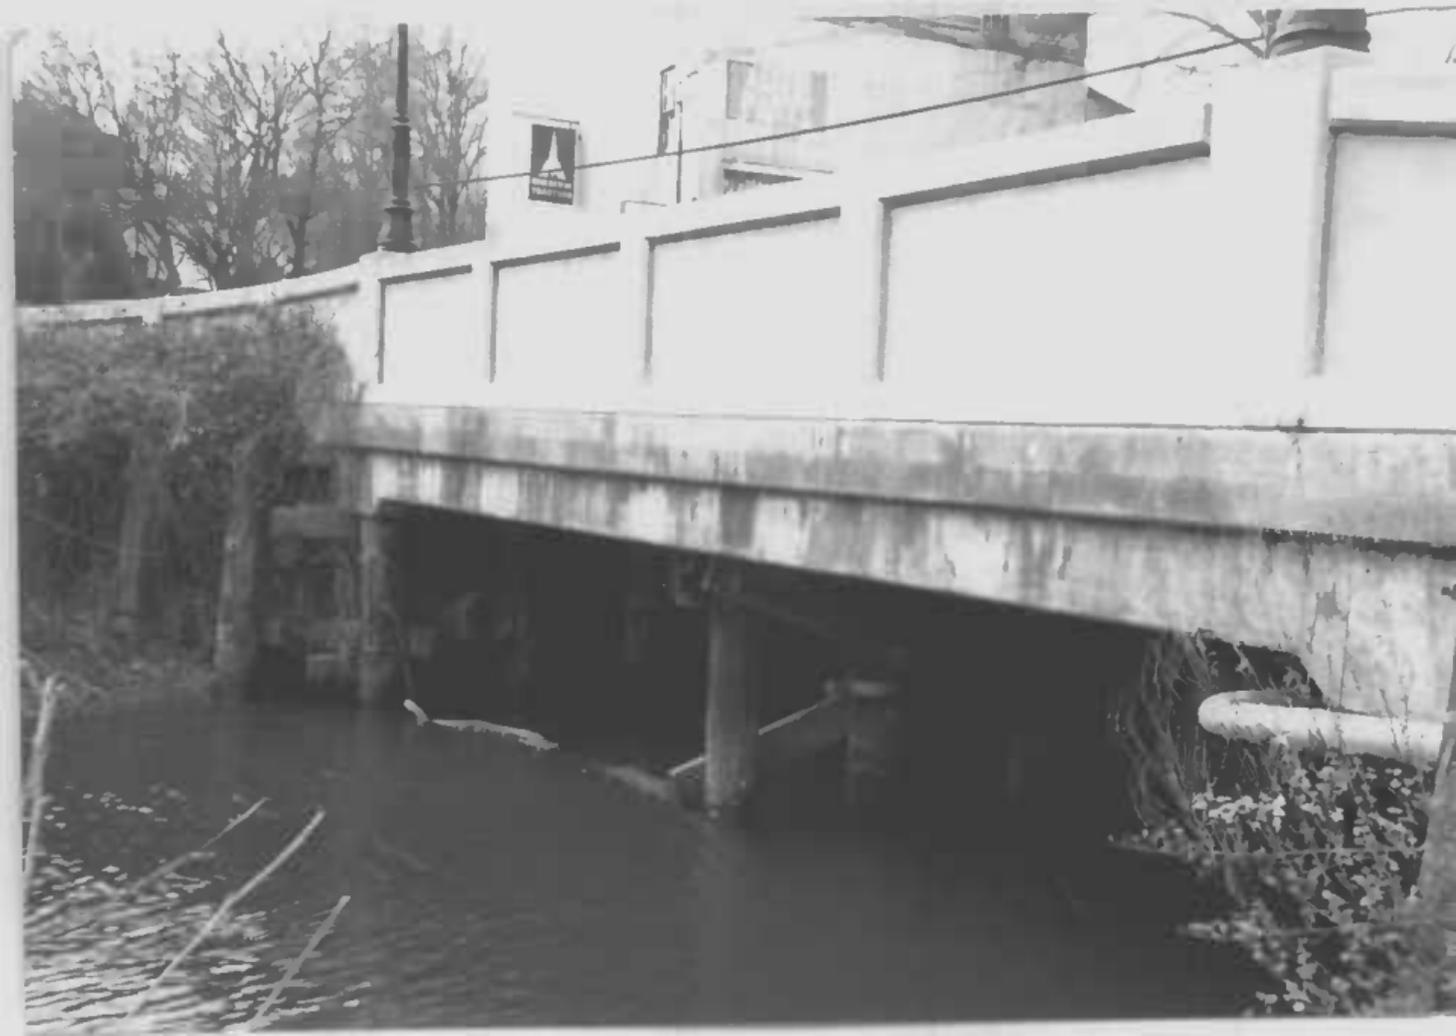
8. 5 of 6

According to the 1995 inspection report, this structure was in fair condition. The timber piles had checks, cracks and delamination and the timber cross-bracing was in good condition. The timber abutments had some rotted areas with delamination and section loss. The timber wing walls had areas of rot and checks, splits and delamination. The concrete culvert had concrete erosion and cracking and the concrete slab was in good condition with no defects. The parapets were in good condition, as were the lights on the bridge.

7. detail of substructure

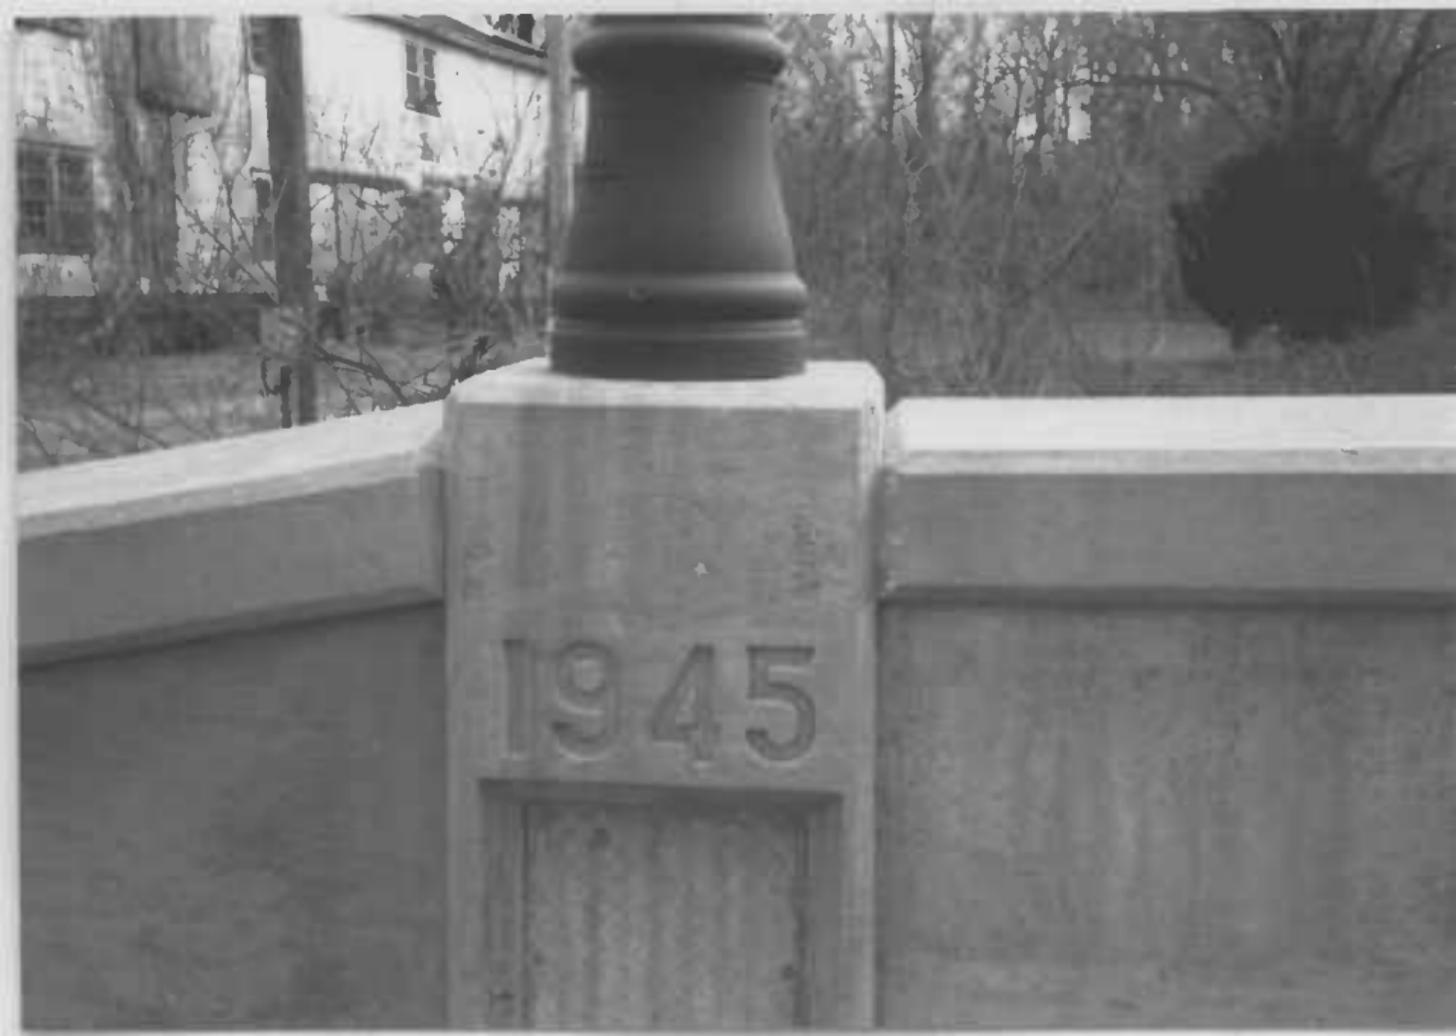
1. QA-492
2. MD 213 over Old Mill Stream Branch
3. Queen Anne Co, Md (17021)
4. Caroline Hall
5. 3/97
6. MDSHPO
7. detail of date stamp
8. leaf 6

**WHEN was the bridge built:** \_\_\_\_\_ 1945 \_\_\_\_\_  
**This date is:** Actual X \_\_\_\_\_ Estimated \_\_\_\_\_  
**Source of date:** Plaque X Design plans \_\_\_\_\_ County bridge files/inspection form \_\_\_\_\_  
**Other (specify):** State Highway Administration bridge files/inspection form

A black and white photograph of a stone pillar, likely a gatepost, with the year "1945" engraved on its face. The pillar is topped with a dark, cylindrical finial. The pillar is part of a stone wall or fence. In the background, there are bare trees and a building with windows.
