Maryland Inventory of Historic Properties number: QA-494

Name: #17039 / MD 662 OVER BRANCH OF WYE RIVER

MARYLAND INVENTORY OF HISTORIC BRIDGES  
HISTORIC BRIDGE INVENTORY  
MARYLAND STATE HIGHWAY ADMINISTRATION/  
MARYLAND HISTORICAL TRUST

SHA Bridge No. 17039 Bridge name MD 662 over Branch of Wye River

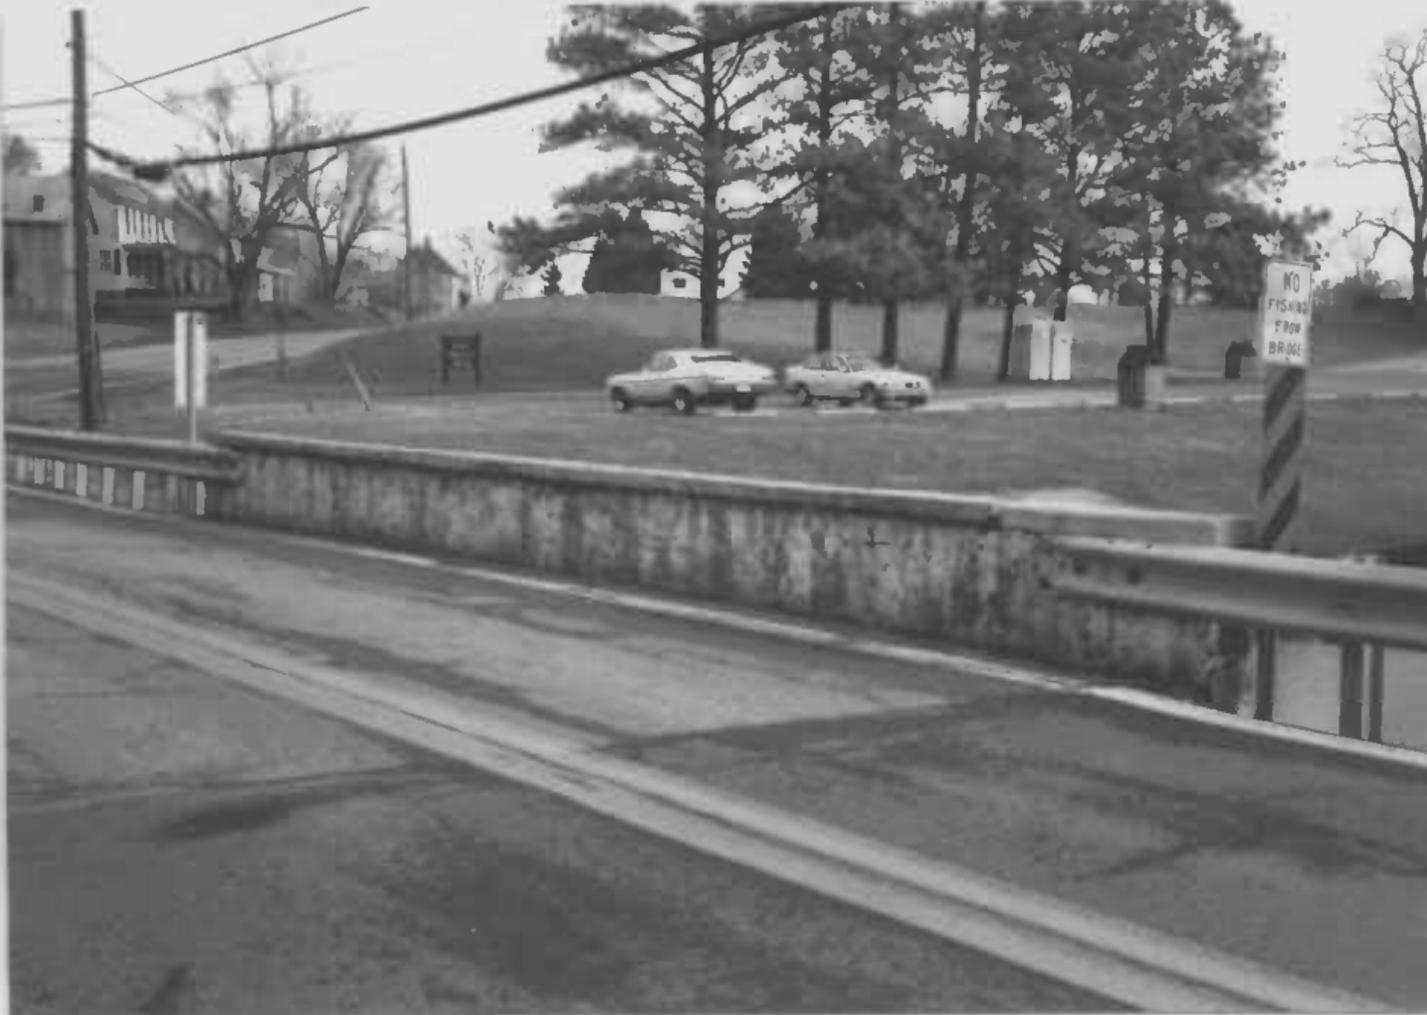
1. QA-494
2. MD662 over branch of Wye River (17039)
3. Queen Anne Co, Md.
4. Caroline Hall
5. 3/97
6. MDSHPO
7. east parapet wall
8. 5 of 6

According to the inspection reports, scour repairs were conducted in 1991. These repairs included patching areas of the concrete beams, wing walls, abutments, and parapets. In addition, the face of the parapet walls along the roadway were parged, eliminating the panelled profile and creating a smooth concrete surface.
