QA-156
Robinett House
Centreville
Private

INVENTORY FORM FOR STATE HISTORIC SITES SURVEY

Robinett House

110 South Liberty Street

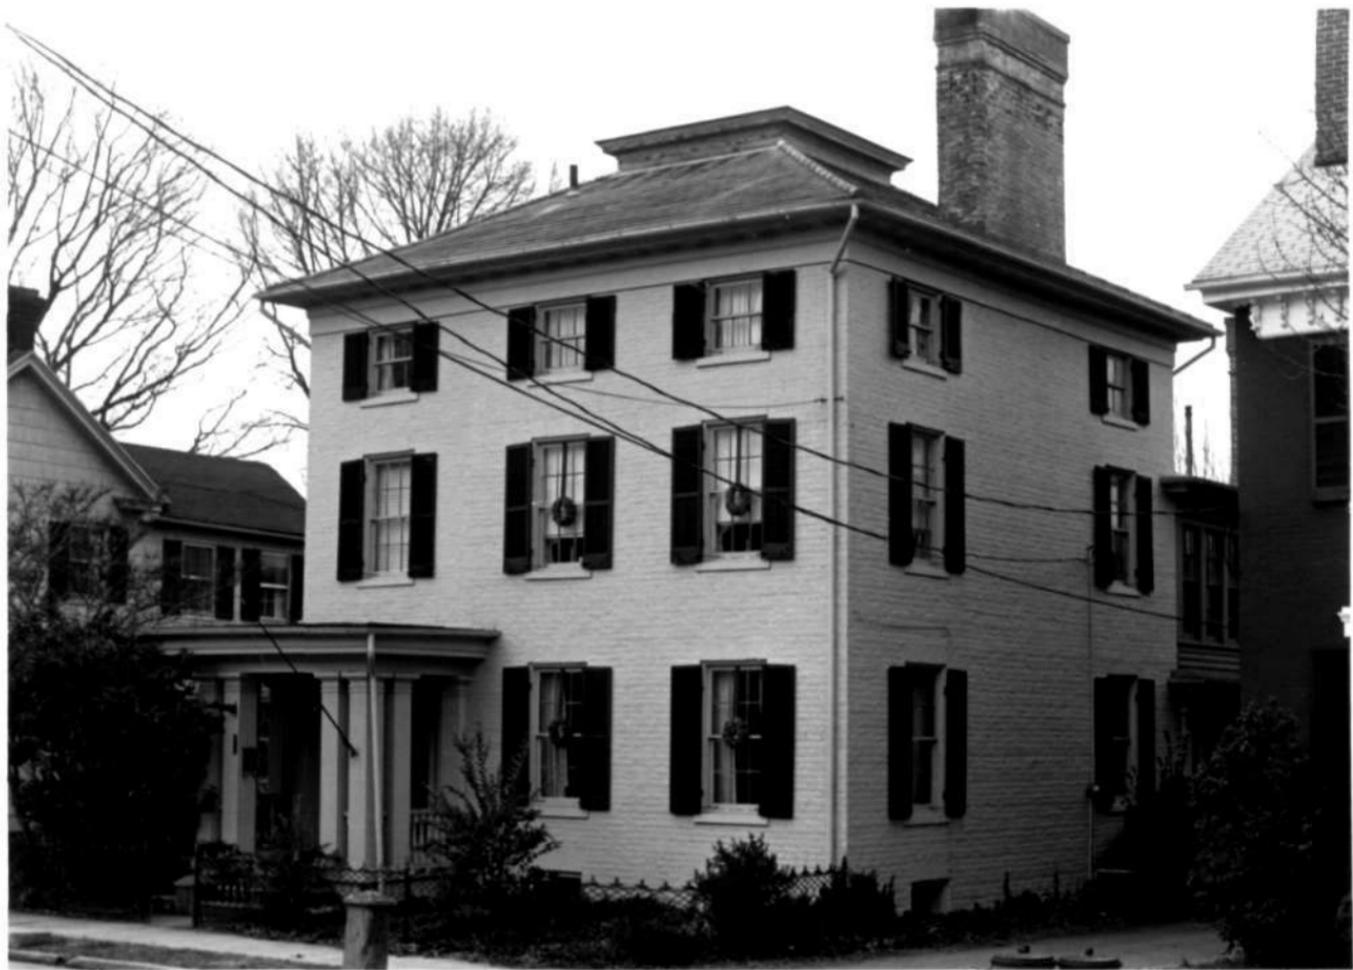
QA-156 Robinette House
110 South Liberty Street
Centreville, Maryland
Orlando Ridout V 1980
View from Northeast

The principal facade, facing Liberty Street, is now three bays wide. The entrance door with sidelights but no transom is in the left or south bay on the first floor. There are two 6/6 windows to the right of the door, three 6/6 windows on the second floor, and three 3/3 windows on the third floor. A pair of three-light cellar windows pierce the foundation below the first floor windows. The brickwork of the original house is laid in Flemish bond with no watertable. The added bay to the south and the third story are laid in seven-course common bond. Both first floor window openings have been reworked. The jambs and splayed lintels date to the second period of construction and were presumably part of the renovation which included converting the original door to a window. The eaves are finished with a broad, overhanging cornice with guttae below the soffit and wide frieze broken into two fields by a small horizontal ogee band of molding. An ogee crown mold is applied to the fascia of the cornice. In 1910-12 a one story open porch was added, covering the entrance door on the front facade

In contrast, the north gable is laid in three-course bond up to and outlining the pitched roof of the original 2 1/2 story house. Above this point the brick is laid in seven-course bond. The lower part of the chimney shaft is original, the upper part was added in the mid-19th century. There are two 6/6 windows on the first and second floor and two 3/3 windows on the third. A bulkhead cellar entrance in the west bay offsets a three-light cellar window in the east bay.

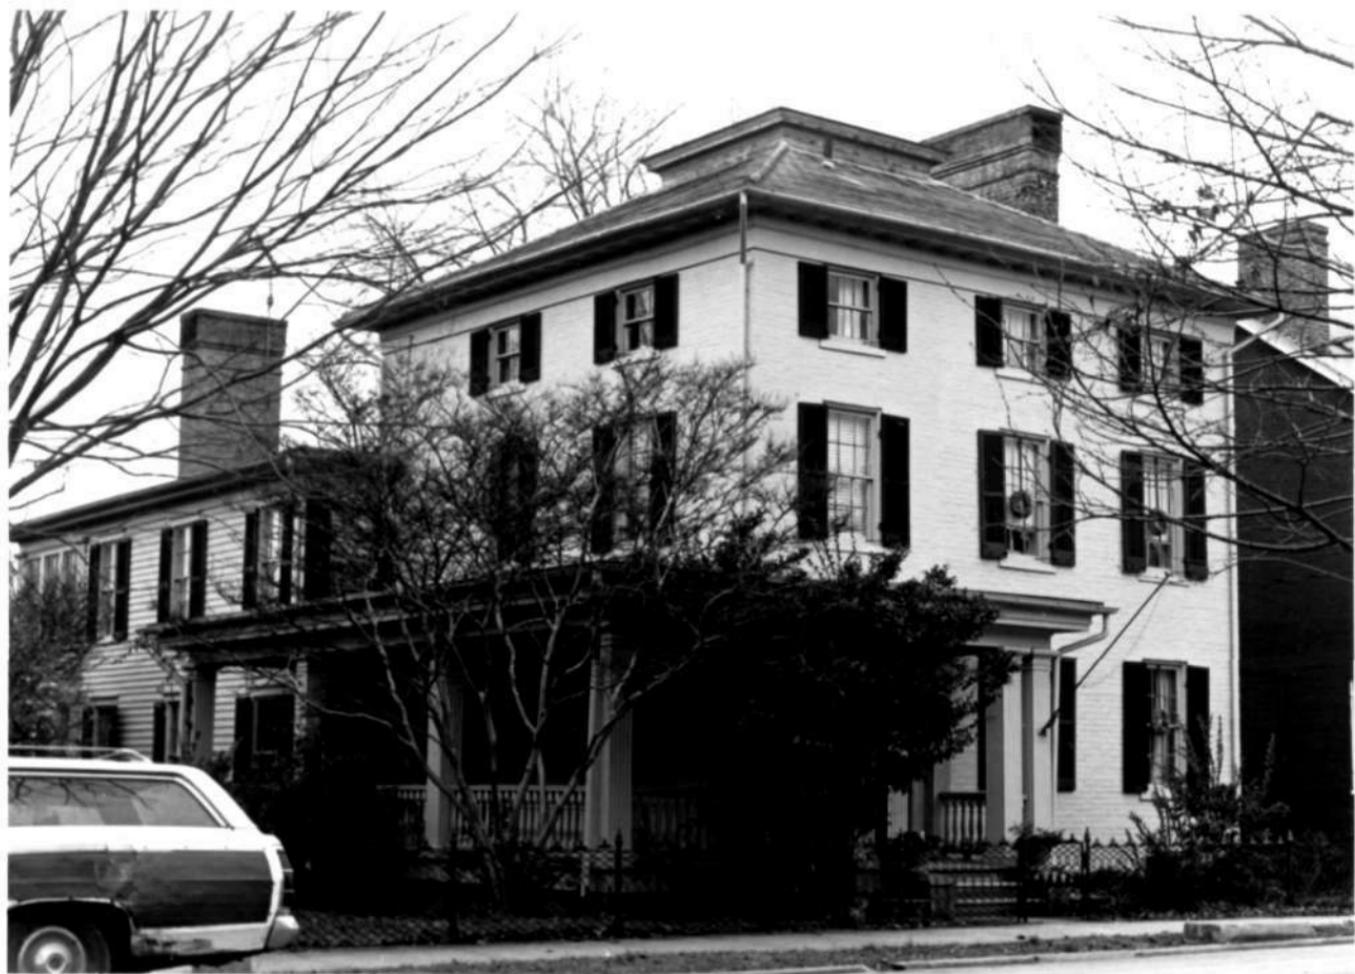
Robinette House
110 South Liberty Street
Centreville, Maryland
Orlando Ridout V 1980
View from Southeast

The entire south gable is laid in seven-course bond, dating to the second period of construction in the mid-19th century. There are two 6/6 windows on the first and second floor, and three 3/3 windows on the third floor.

wall. Aside from the considerable increase in vegetation, few changes have occurred. The most significant alteration has been the removal of the ballustrade from the widow's walk, the roof of the side porch, and the roof of the wing. This ballustrade consisted of two horizontal rails with diamond latticework between the widely spaced vertical balusters.
