WI-355
Riverton United Methodist Church
Riverton
Public worship

RESOURCE NAME: Riverton United Methodist Church

MHT INVENTORY NUMBER: WI-355

Maryland Historical Trust State Historic Sites Inventory Form

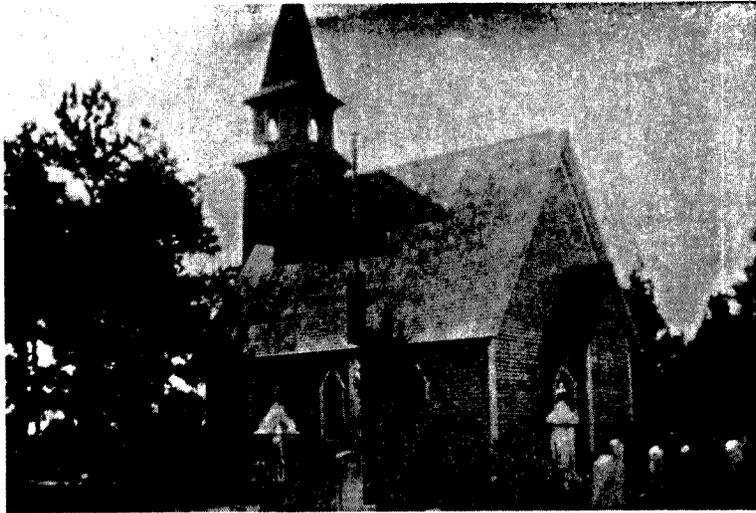
Riverton Methodist Church, burned Jan., 1936. Furnishings which were saved were used in the new church, dedicated March 1937 and still in use. Below, interior of original church.
