**NATIONAL REGISTER OF HISTORIC PLACES
 INVENTORY -- NOMINATION FORM**

St. Martins Church, Worcester Parish

Old St. Martins Church

2 LOCATION
 West side of intersection of U.S. 113 and Maryland 589,
 STREET & NUMBER one mile south of Showell

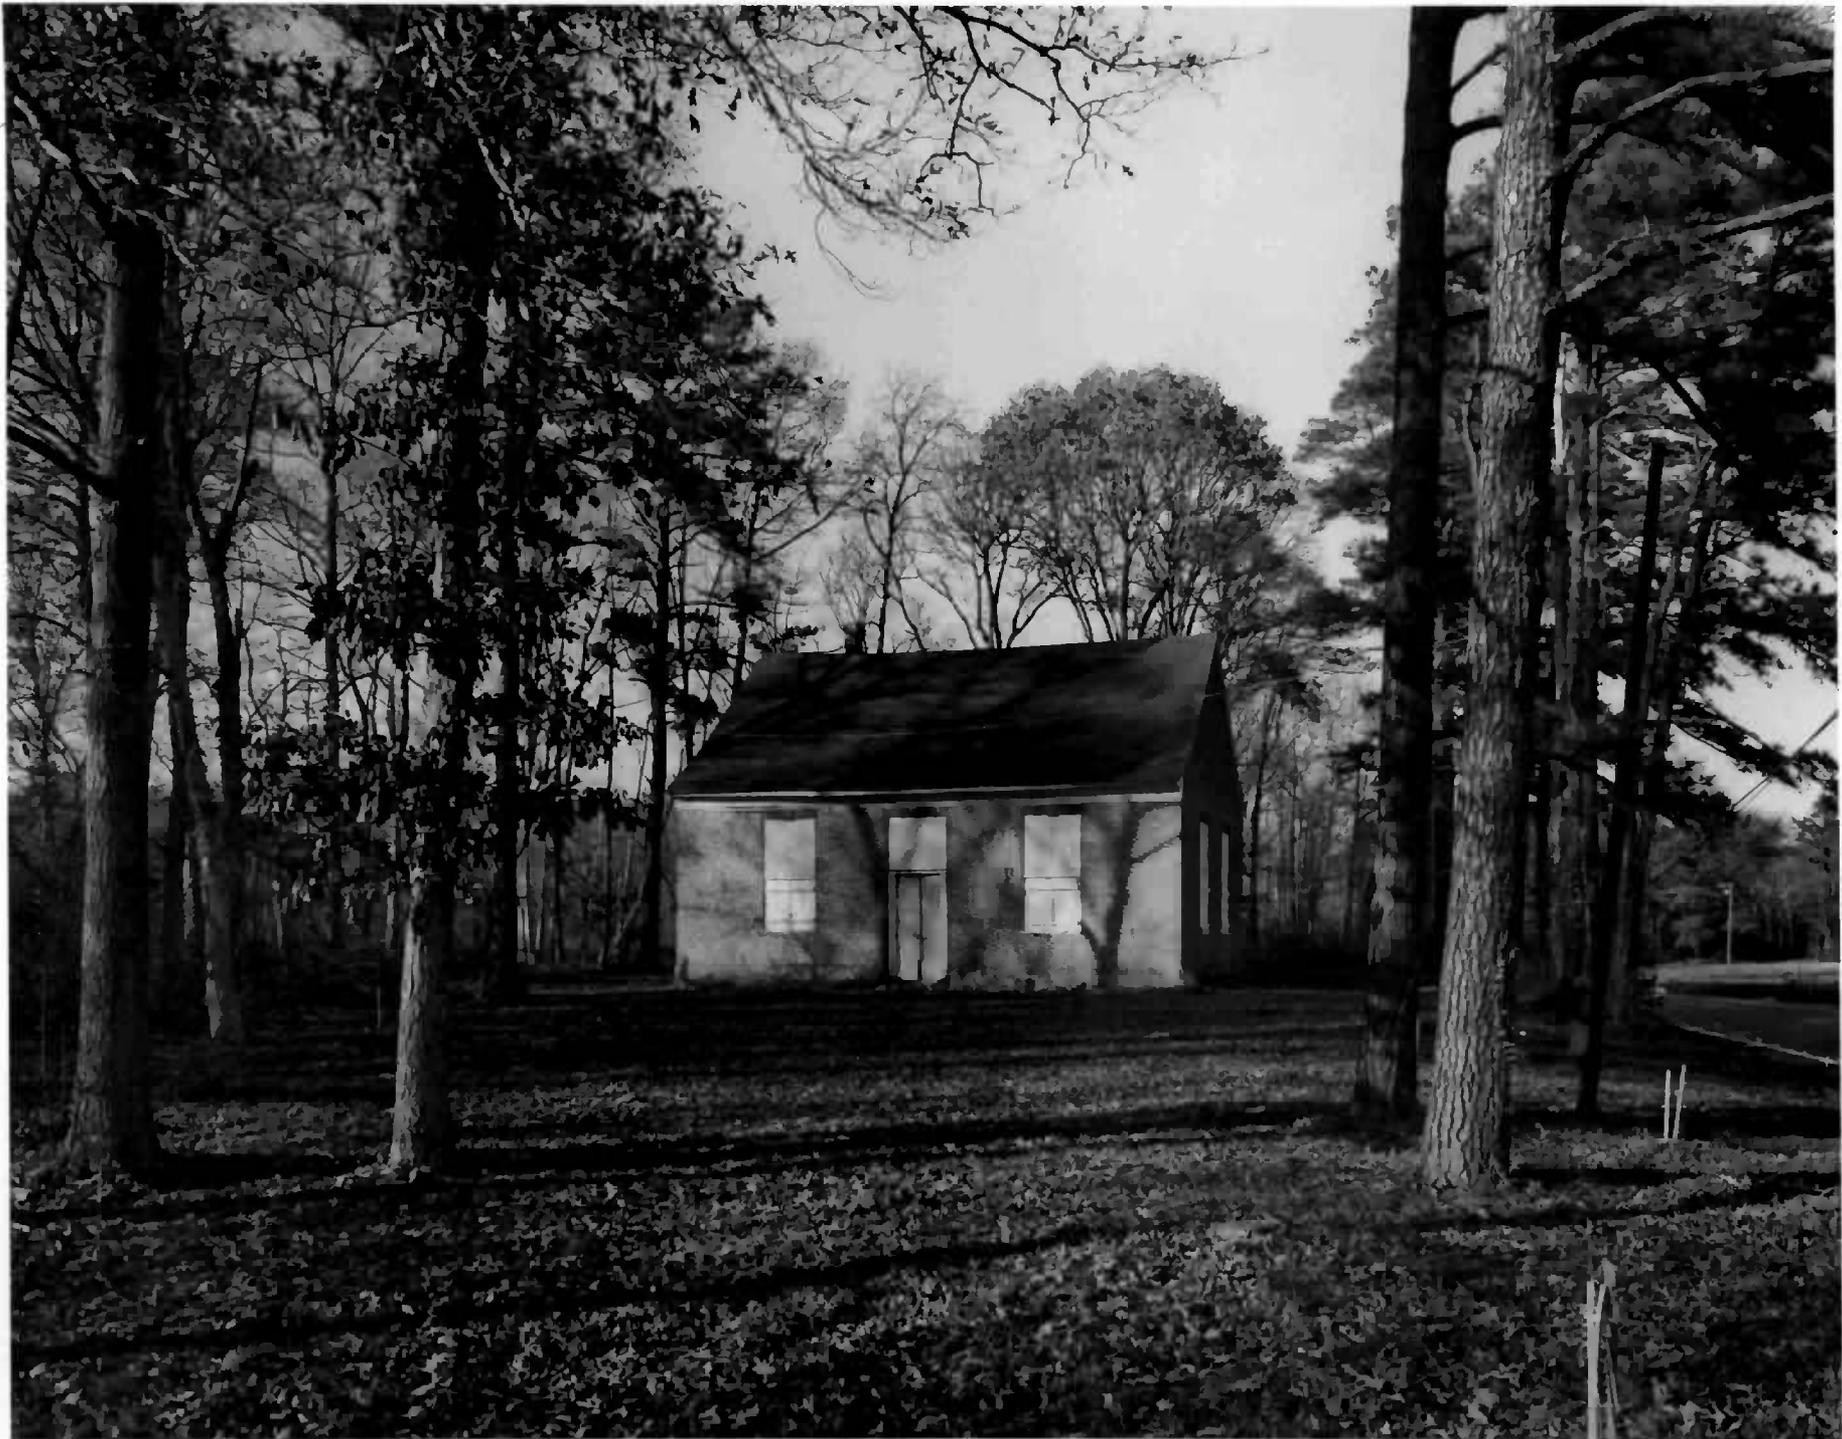
SOUTH ELEVATION

The south facade is three bays long with a double batten door and transom (now boarded up) in the center bay. The two flanking windows are now closed on the lower half by batten shutters with strap hinges and are completely boarded over^m the upper half. The lintels above the windows and doors are of gauged brick, and those above the windows have a gauged brick keystone. The west facade also contains an entrance with double batten doors. At gallery level is another boarded window. One of the unusual features of the building is the flat arches above the entrances which have an ogee ground into the bottom of the arch similar to those at Holly Hill, Anne Arundel County, Maryland.

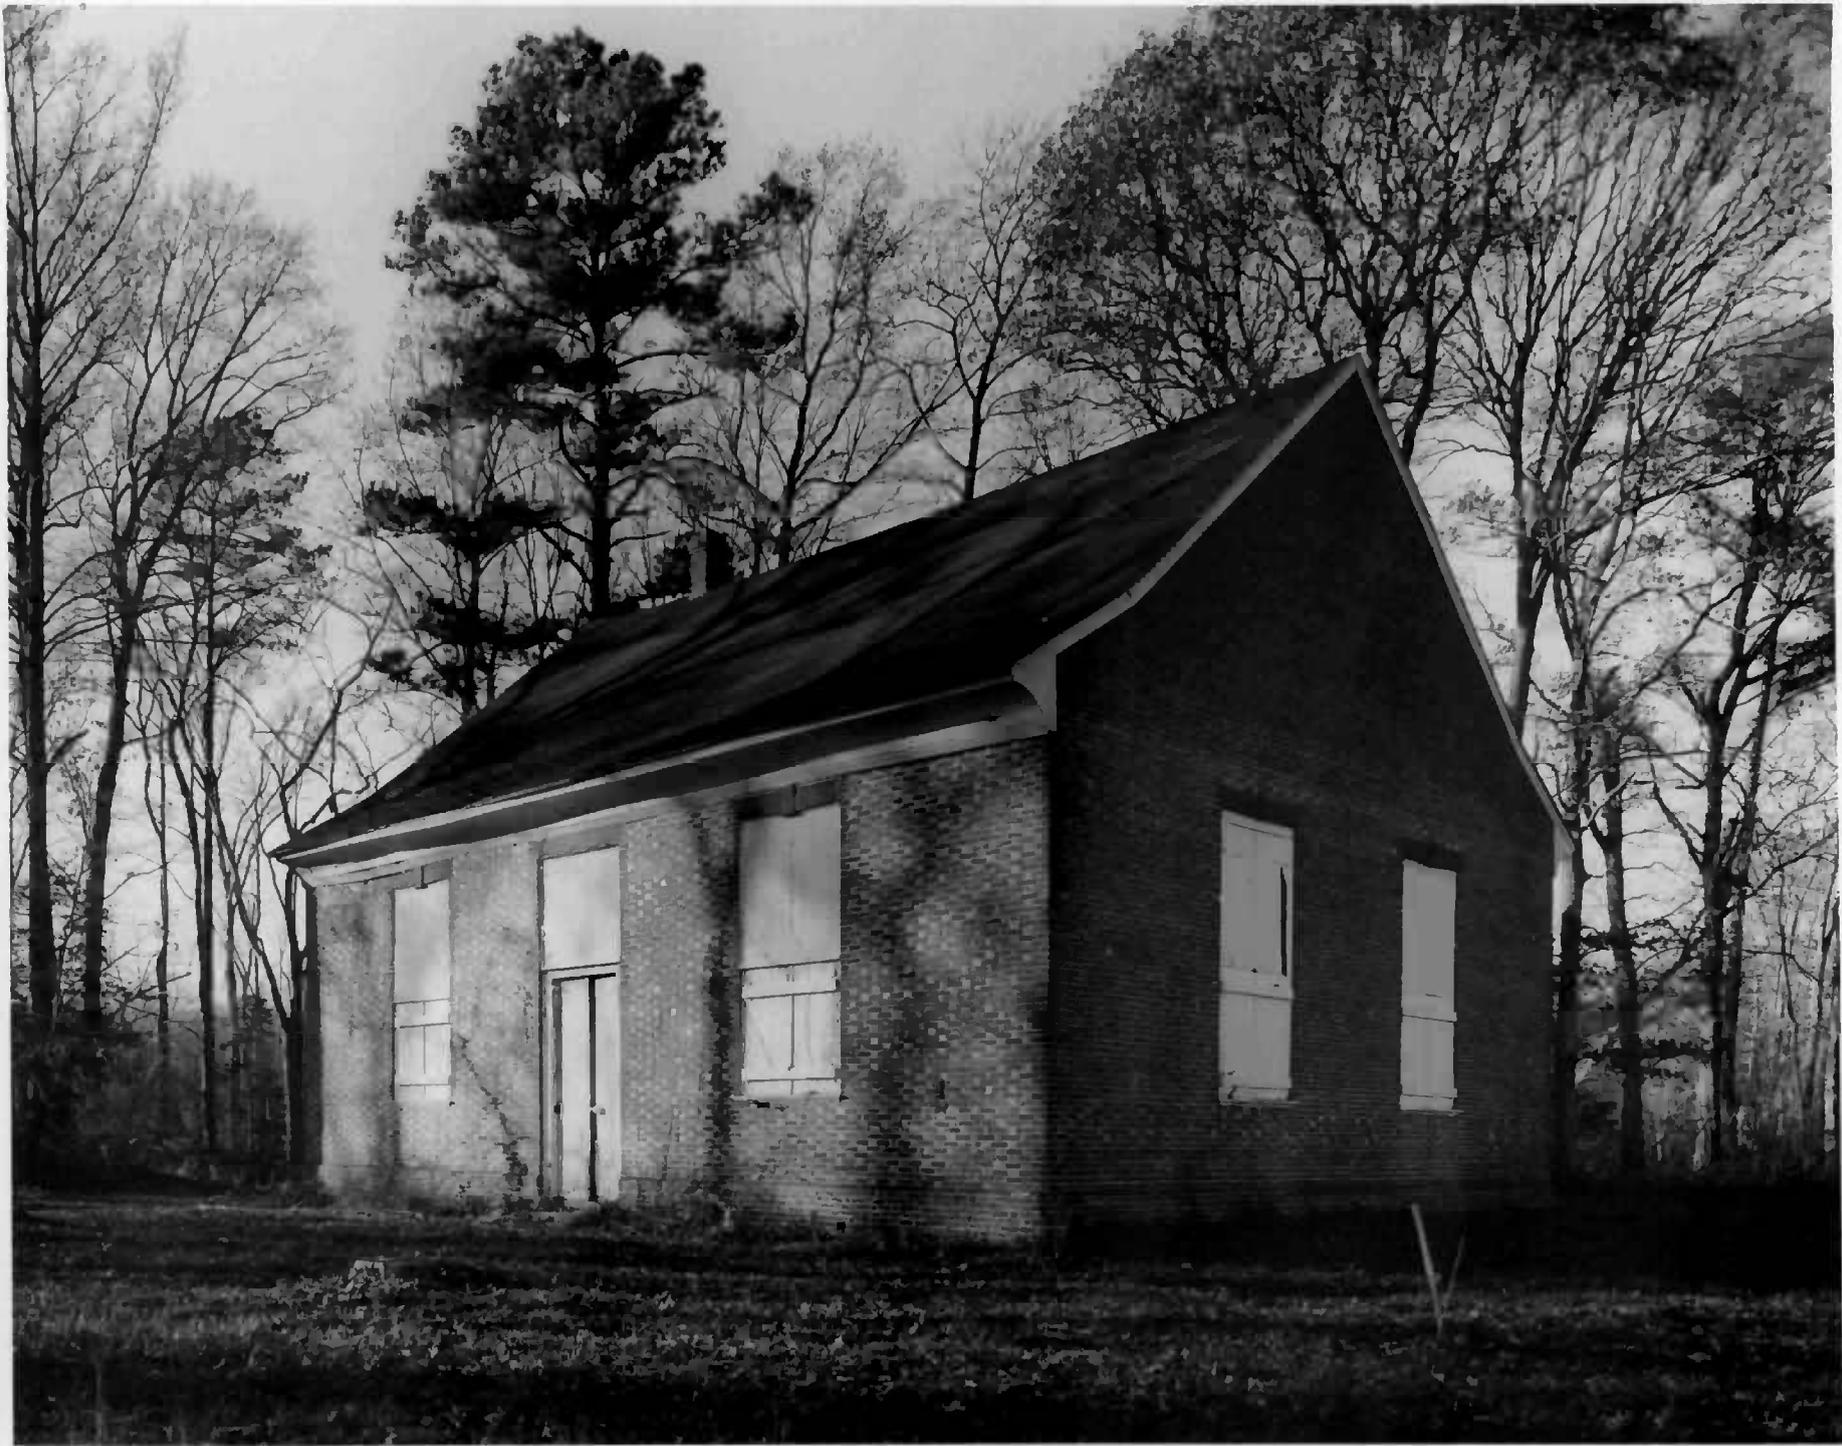
SOUTHEAST ELEVATION

The north and east sides have two windows each exhibiting the same treatment as the south facade, with keystones in the gauged flat arches and shuttered and boarded windows. The east gable appears to have been rebuilt with brick of a more modern date.
