**MARYLAND HISTORICAL TRUST
DETERMINATION OF ELIGIBILITY FORM**

Property Name: Sparrows Point Shipyard District Inventory Number: BA-3208
 Address: 600 Shipyard Road City: Baltimore Zip Code: 21219-1023
 County: Baltimore County USGS Topographic Map: Sparrows Point
 Owner: SPS Limited Partnership LLLP and SPS 35 LLC Is the property being evaluated a district? yes
 Tax Parcel Number: 464 Tax Map Number: 10 Tax Account ID Number: 1502024100
 Project: Sparrows Point LNG Facility Agency: FERC
 Site visit by MHT Staff: no yes Name: _____ Date: _____
 Is the property located within a historic district? yes no

The Sparrows Point Shipyard is a significant industrial landscape associated with the greater Baltimore area. It is significant as a subsidiary of the giant Bethlehem Steel Corporation, which was a virtual monopoly on steel production in the Mid-Atlantic States from its purchase of the shipyard in 1916. The Shipyard itself is significant in local labor and social history for its employment, at its height of production in World War II, was between 26,000-30,000 people. On an international level, the Shipyard is significant as it produced many ships as part of the Lend Lease agreeme

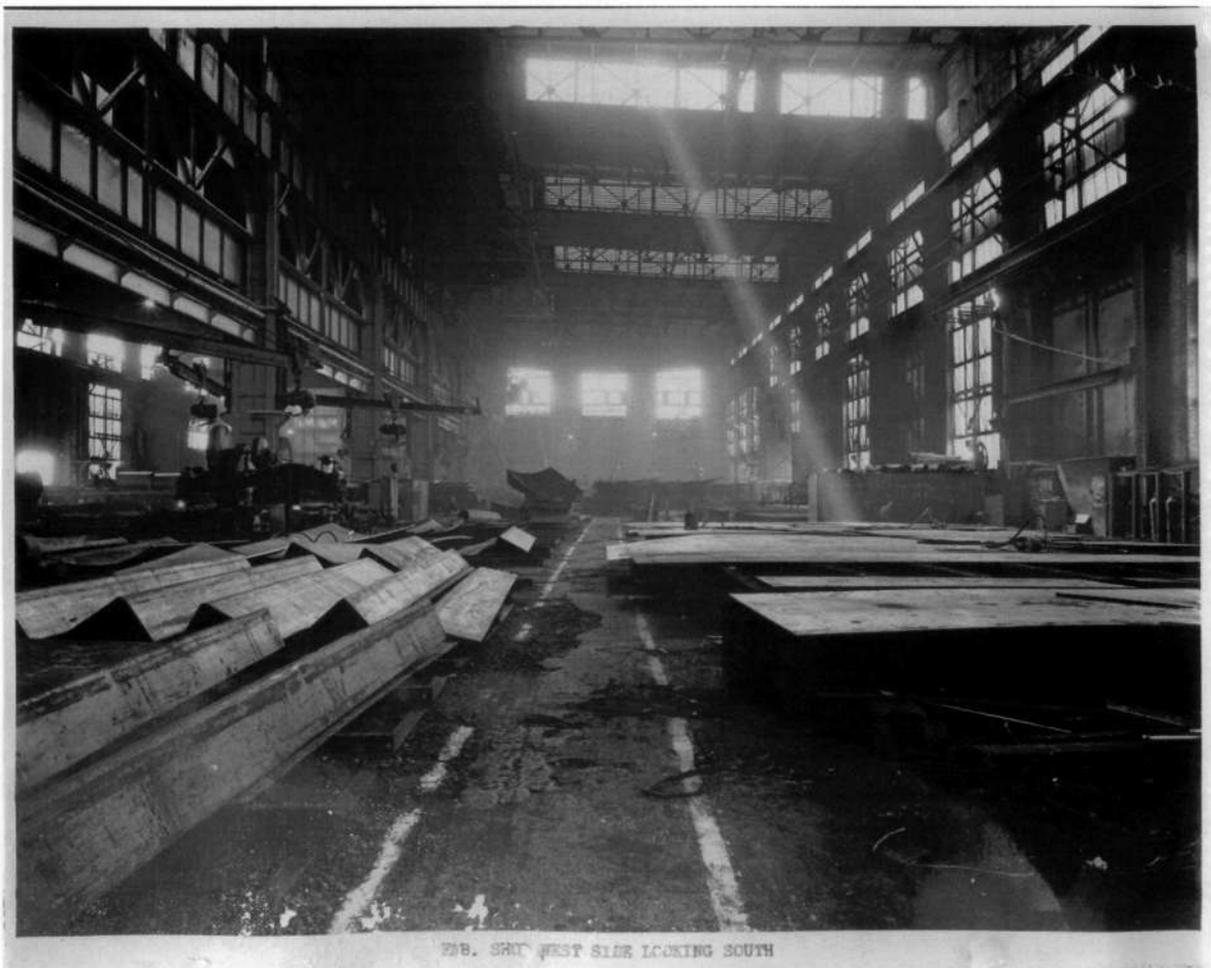
288. SHIP WEST SIDE LOOKING SOUTH

Fabricating Shop, Center West side looking South. Bethlehem-Sparrows Point Shipyard, Inc., Sparrows Point, Maryland. March 26, 1945. Photo by A. Leigh Sanders, 105 E. Franklin St., Baltimore-2, Md. Original in Shipyard Archives.

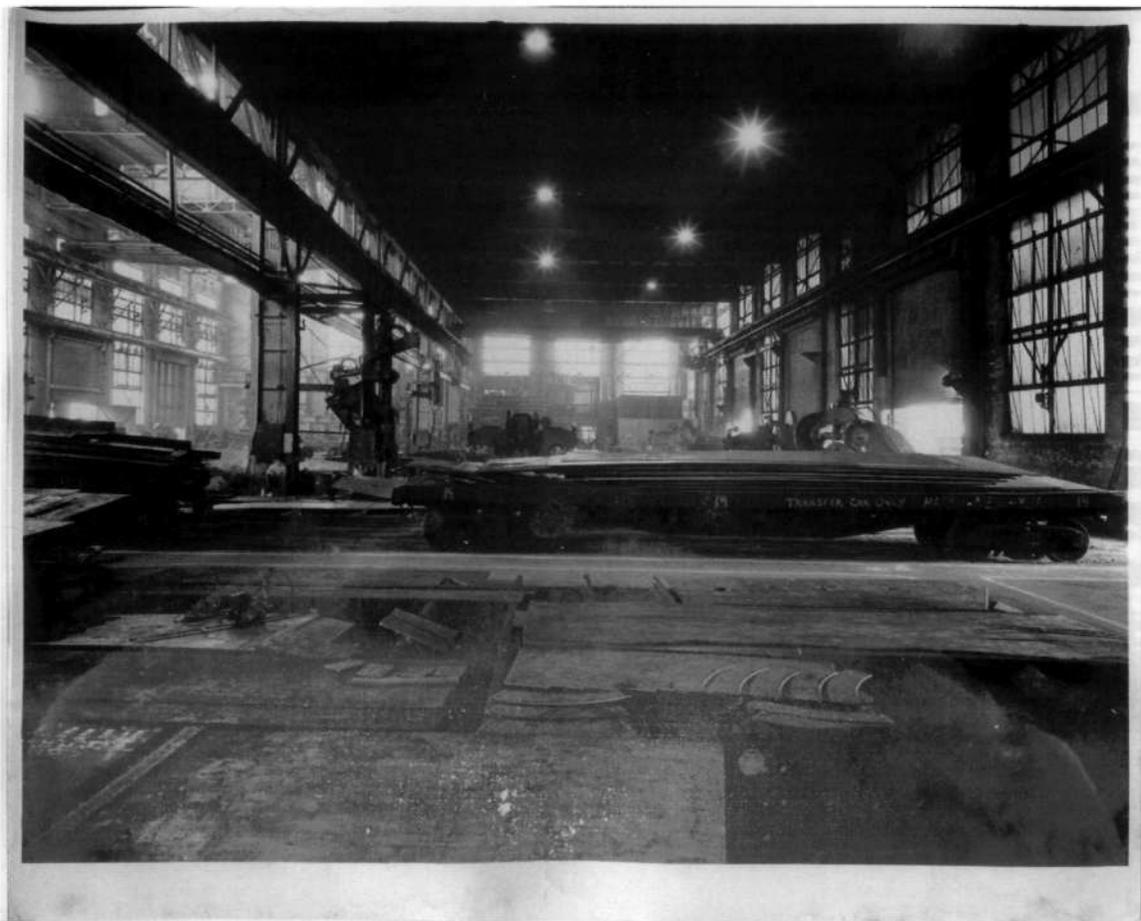
Fabricating Shop, Center West Side looking North. Bethlehem-Sparrows Point Shipyard, Inc., Sparrows Point, Maryland. March 26, 1945. Photo by A. Leigh Sanders, 105 E. Franklin St., Baltimore-2, Md. Original in Shipyard Archives.

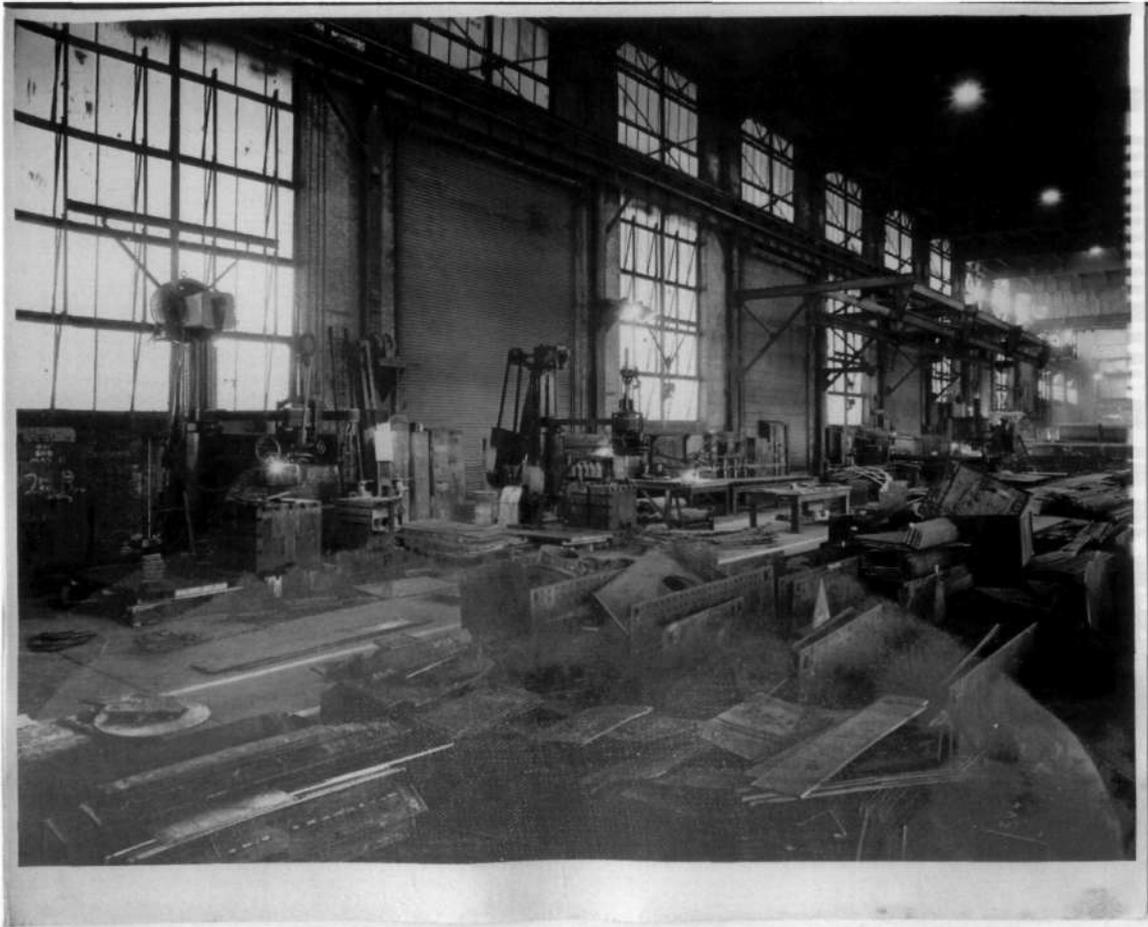
Fabricating Shop, Center East side looking Southeast. Bethlehem-Sparrows Point Shipyard, Inc., Sparrows Point, Maryland. March 26, 1945. Photo by A. Leigh Sanders, 105 E. Franklin St., Baltimore-2, Md. Original in Shipyard Archives.

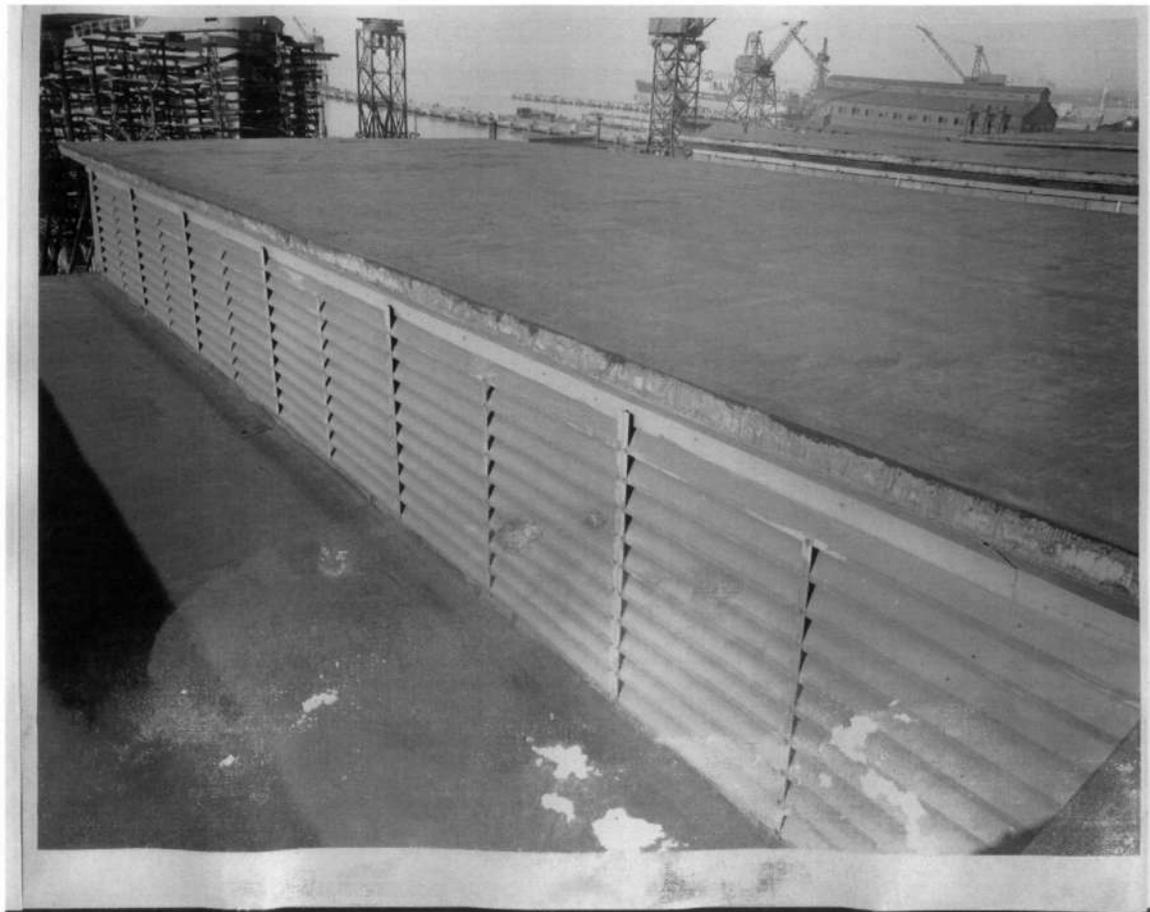
Mold Loft on top of Fabricating Shop. Bethlehem-Sparrows Point Shipyard, Inc., Sparrows Point, Maryland. December 14, 1948. Photo by A. Leigh Sanders, 105 E. Franklin St., Baltimore-2, Md. Original in Shipyard Archives.

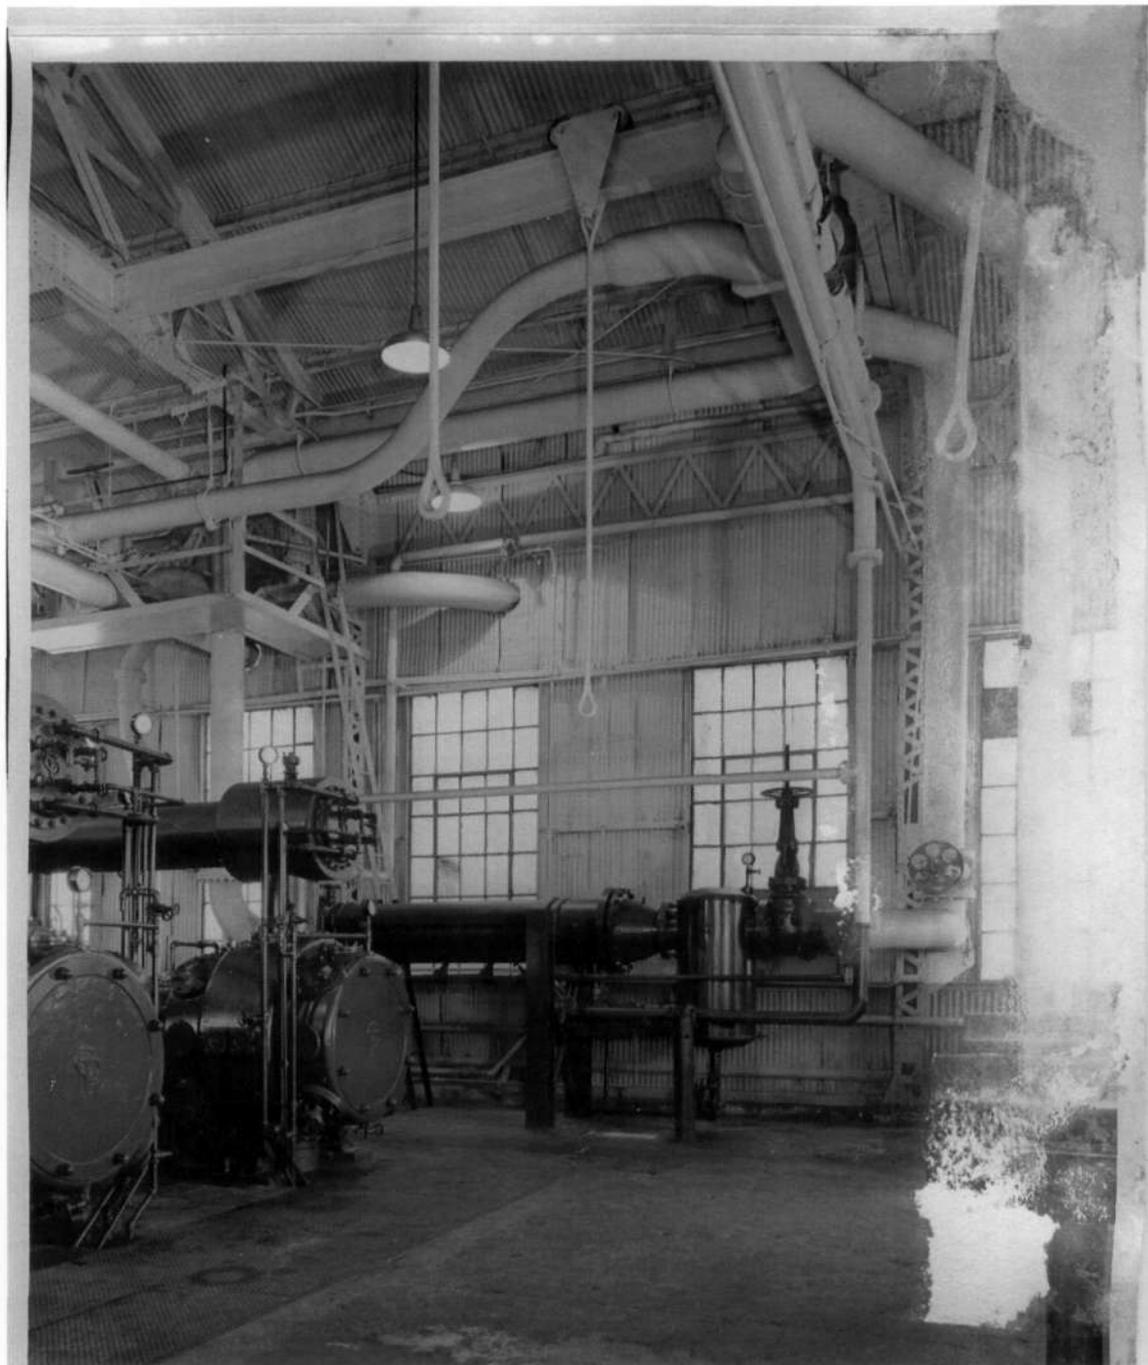
Air Compressor Room. Bethlehem-Sparrows Point Shipyard, Inc., Sparrows Point, Maryland. March 23, 1951. Photo by A. Leigh Sanders, 105 E. Franklin St., Baltimore-2, Md. Original in Shipyard Archives.

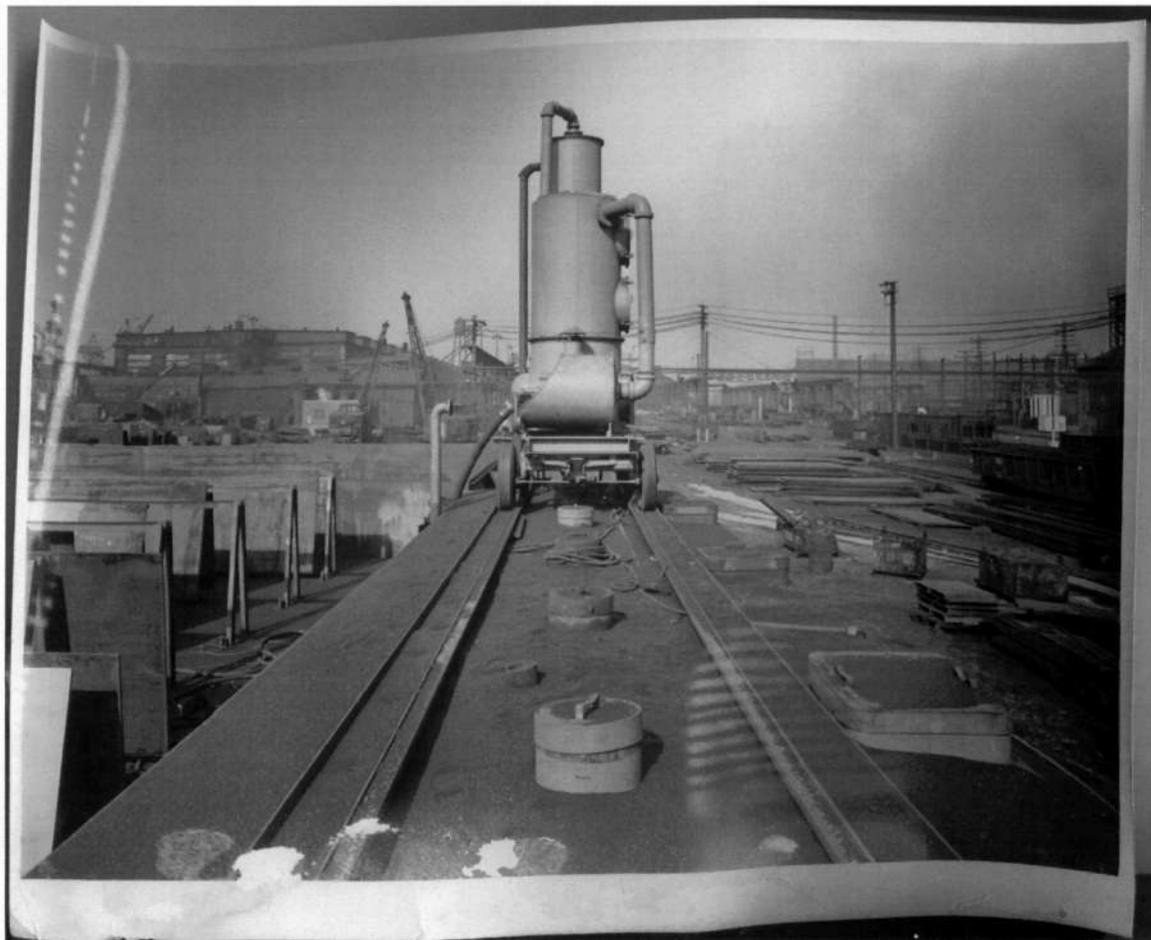
Sandblasting Dept. Bethlehem-Sparrows Point Shipyard, Inc., Sparrows Point, Maryland. February 8, 1952. Photo by A. Leigh Sanders, 105 E. Franklin St., Baltimore-2, Md. Original in Shipyard Archives.

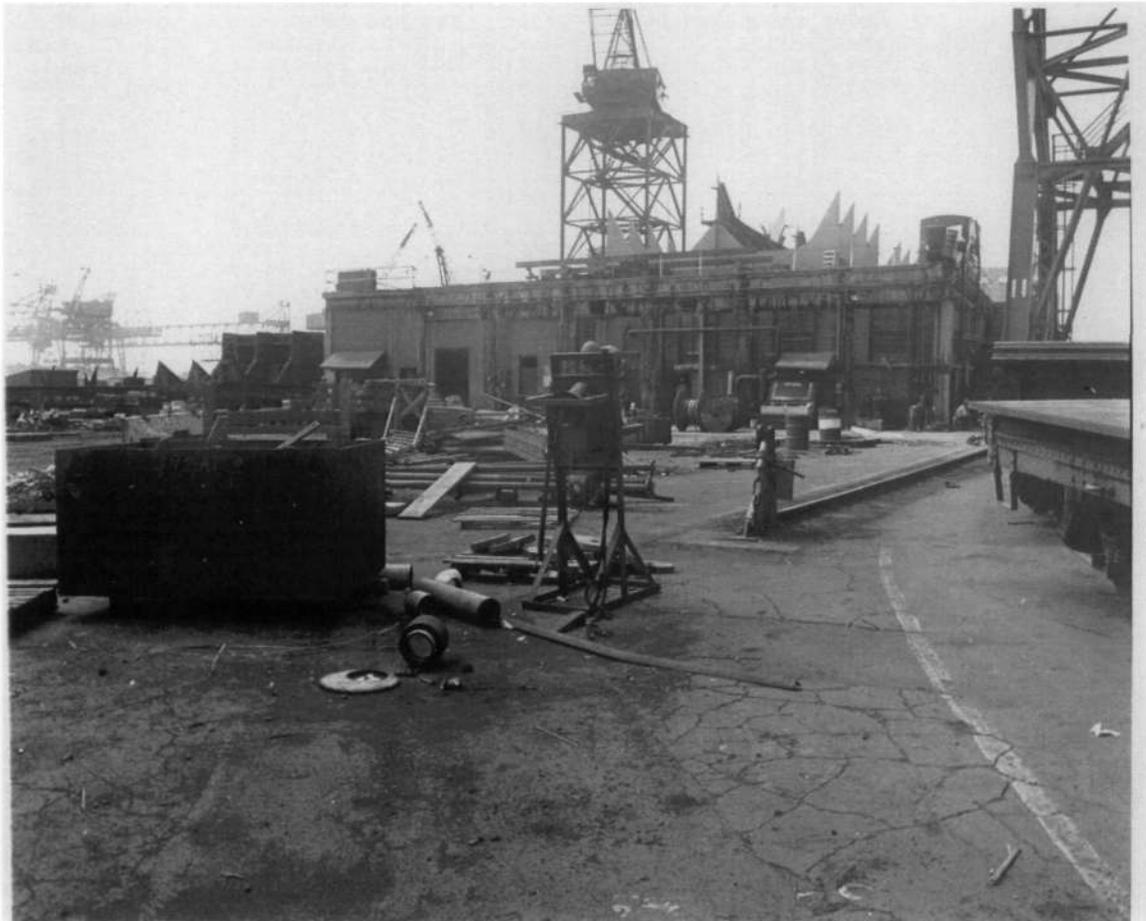
Graving Dock. Bethlehem-Sparrows Point Shipyard. August 31, 1970. Photo By:
Francis DiGennaro, 5805 Chinquapin Parkway, Balto. 12, MD. Original in Shipyard
Archives.
