MARYLAND HISTORICAL TRUST
NR-ELIGIBILITY REVIEW FORM

Property Name: Knox Farm/Morris Farm Inventory Number: T-1137

Project: Harrison Tower Agency: FCC

Maryland Historical Trust Maryland Inventory of Historic Properties Form

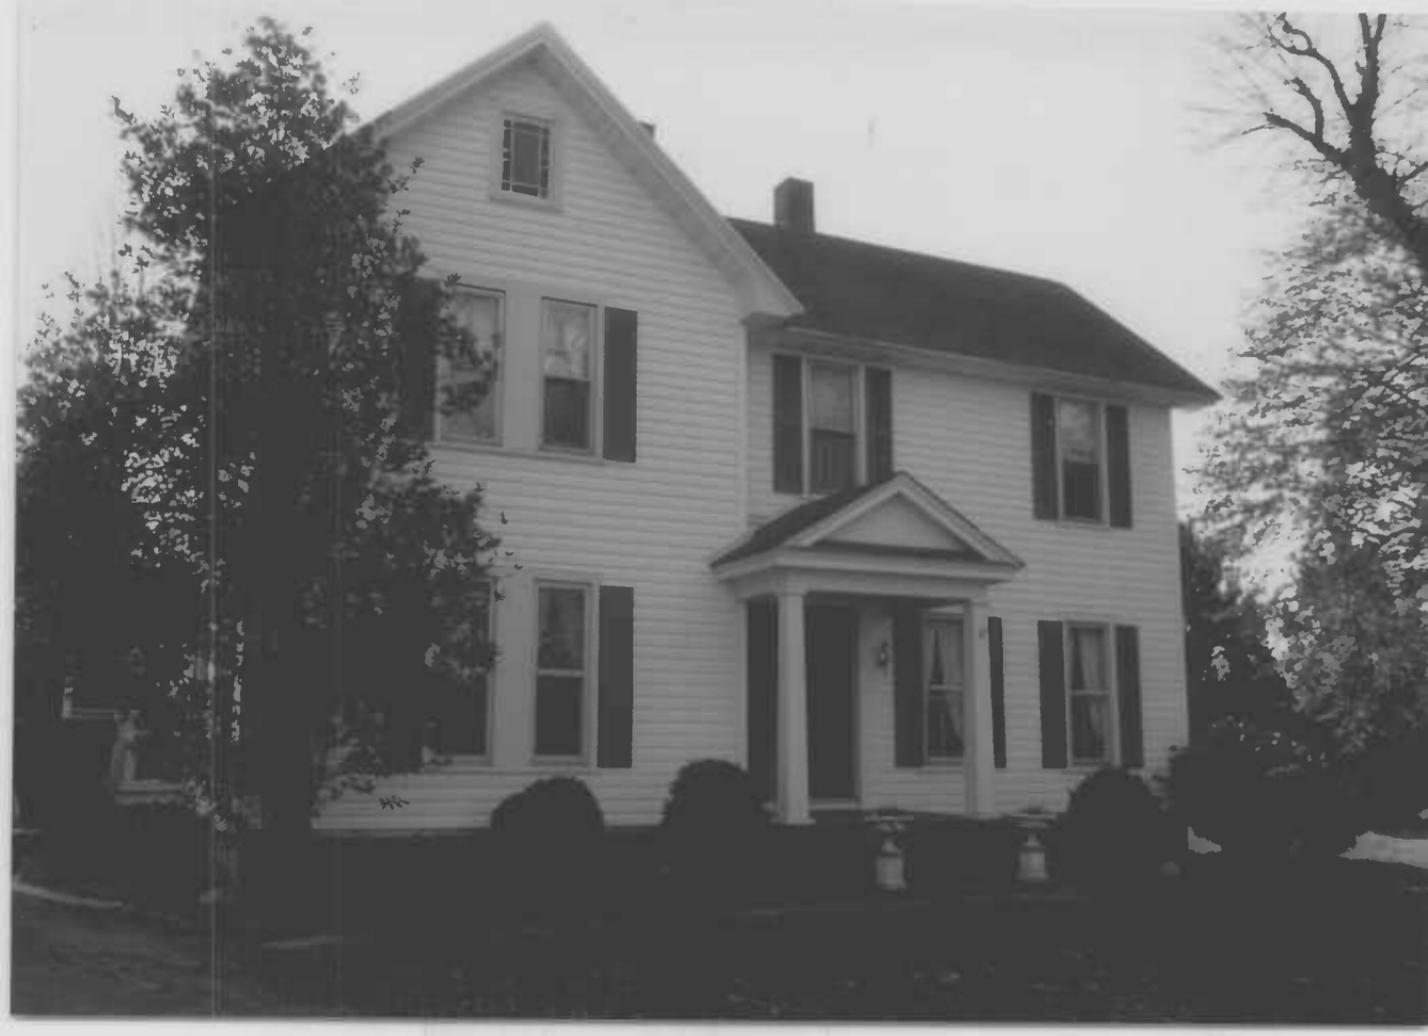
15

The house at this property is a 2½-story wood frame vernacular building constructed on brick foundation. The house has an irregular plan, the result of multiple additions. Measuring five bays by four bays, there is a front portico situated on the north side of the house and a screened shed-roof side entry porch. The front (north) portico has squared square wood columns and a pedimented gable roof. The cross-gabled house has metal double-hung sash (2/2 lights) windows, and the cross gable block has paired ribbon windows in the north elevation. There also is a gable peak window in the cross gable with a single colorless pane surrounded by smaller stained glass panes.

House, North elevation

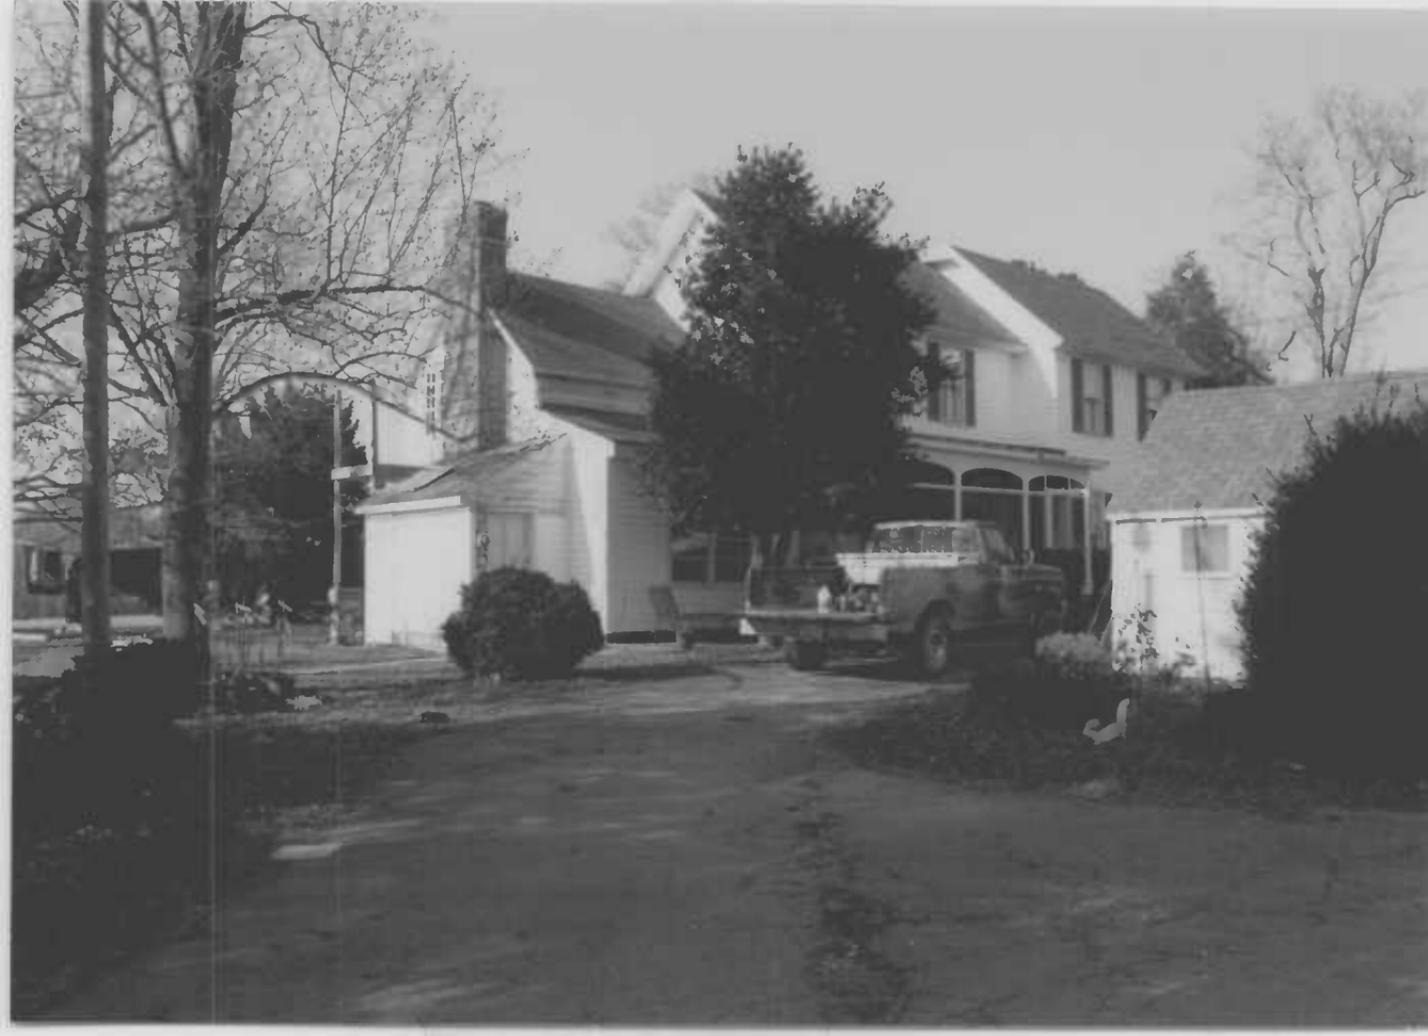
2/5

The house extends to the south (rear) by two gable-roof additions and a shed roof addition. There are two interior brick chimneys. The house is clad by vinyl siding and the roof is clad by composition shingles.

House, east (side) and
South (rear) elevations

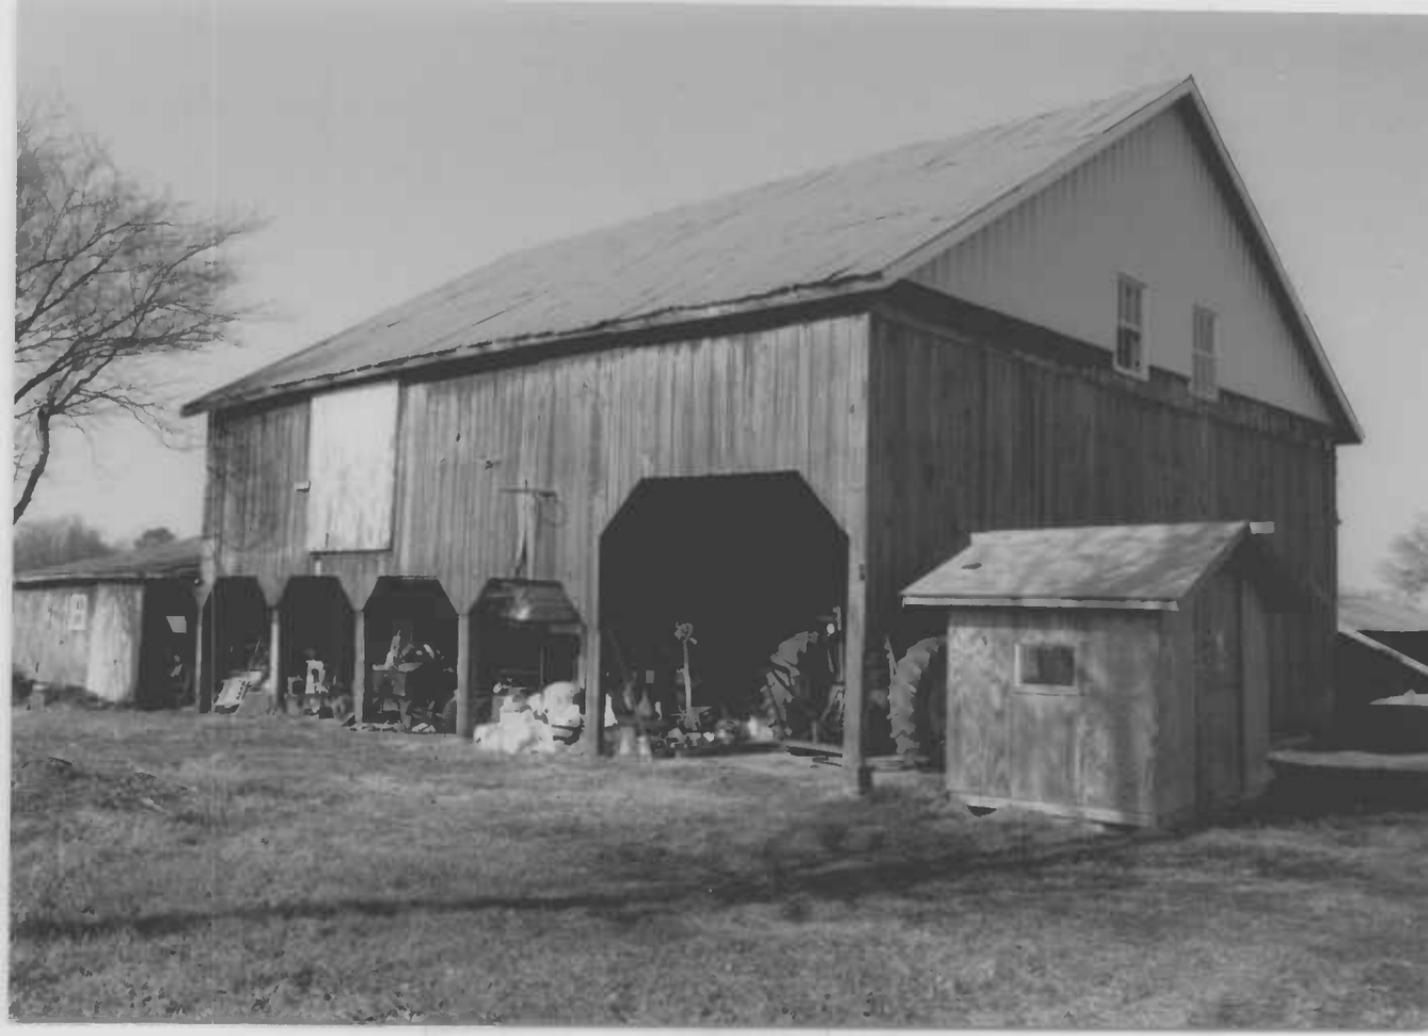
3/5

The barn is a side-gabled wood frame building constructed on a post and pier (brick) foundation. The barn rises two stories and there is a one-story shed roof addition to its west side. The barn is clad by vertical planks and vinyl siding (gable end), the roof is clad by corrugated metal. According to the landowner, the barn was built in 1907.

Barn, view to
the NW

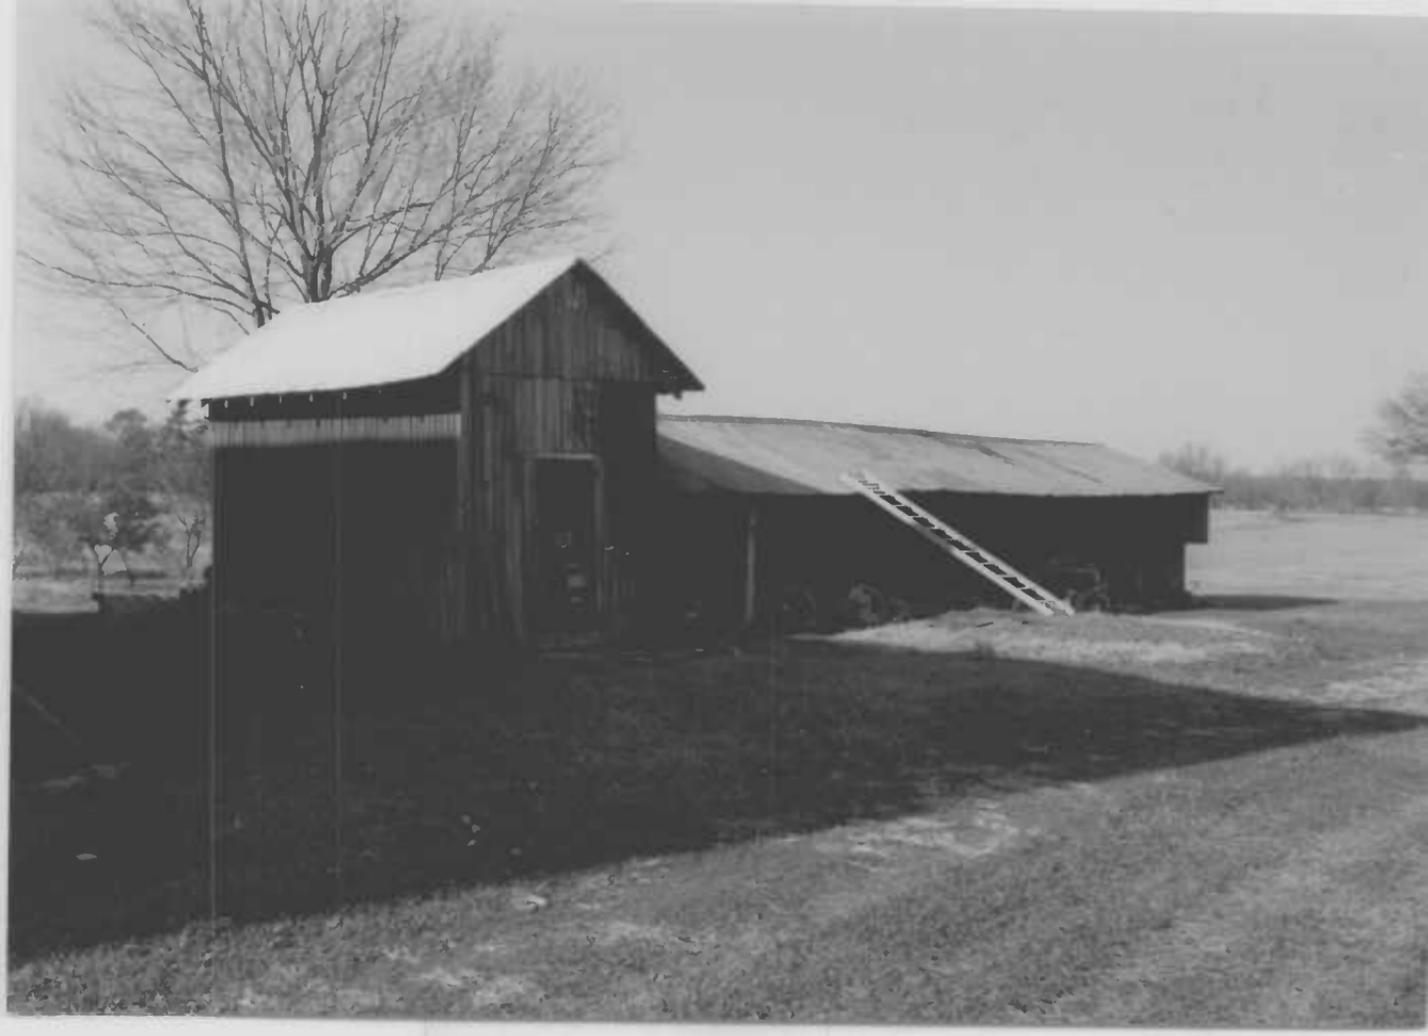
4/5

To the north of the barn, there is a gable-roofed wood frame corn crib clad by vertical plank siding and a corrugated metal roof. Adjacent (north) to the corn crib is a wood frame gable roof equipment shed (Figure 4?11). There also is a recently constructed plywood storage building located near the southeastern corner of the barn.

Corn crib (left) and shed
(right), view to NW

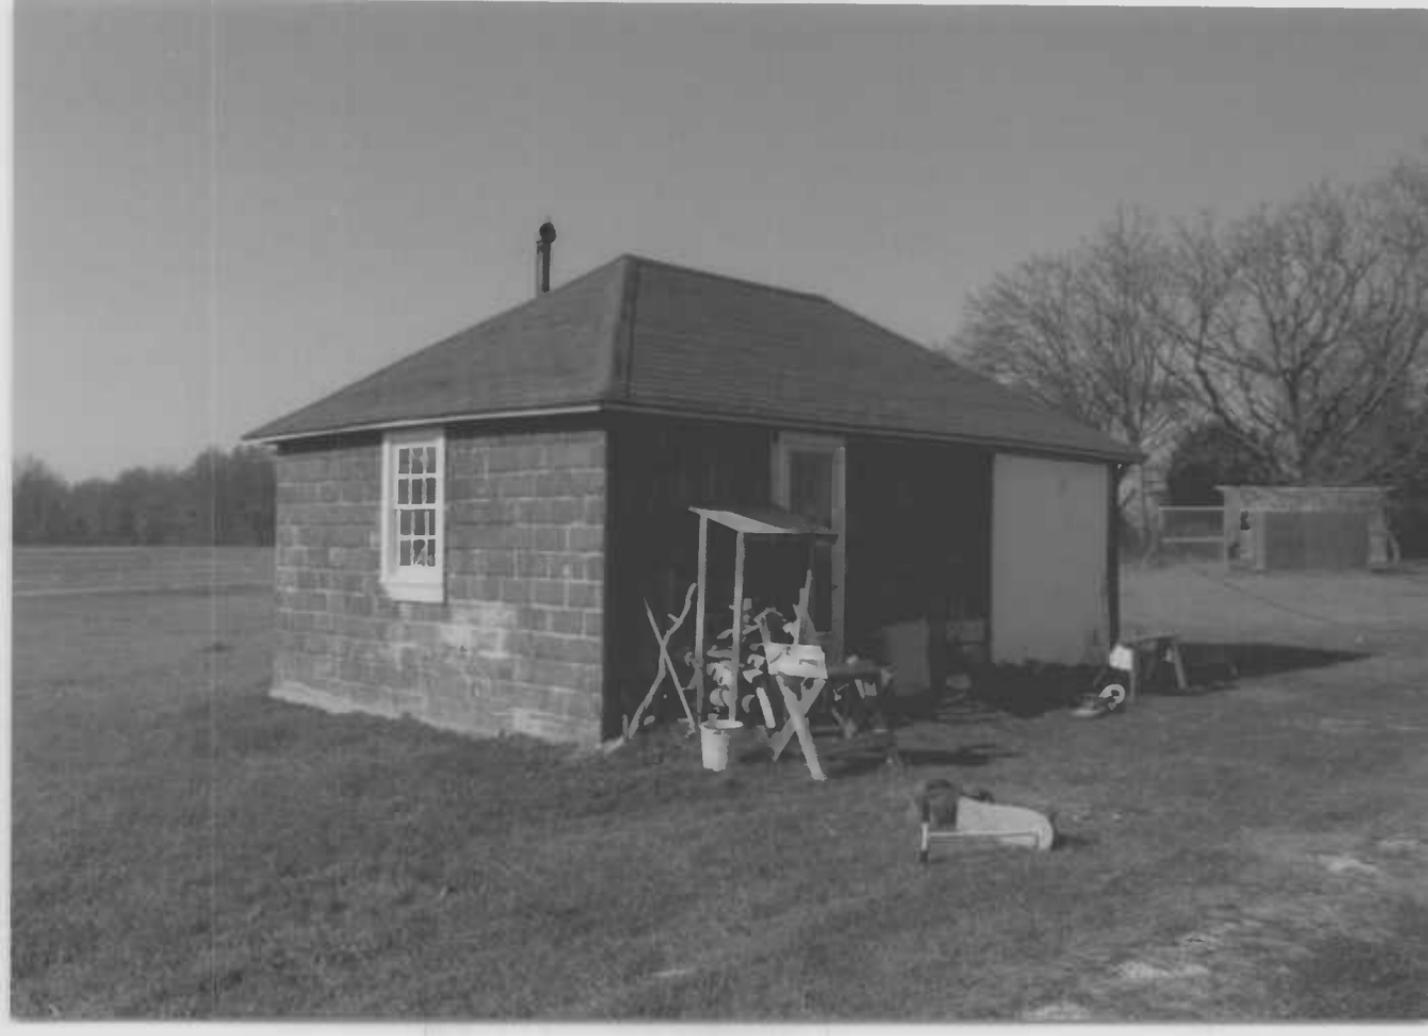
5/5

Between the cluster of agricultural buildings (barn, crib, shed) and the house, there is a square concrete block storage building with a hip roof and a wood double-hung sash (6/6 lights) window. The roof is pierced by a metal stove flue.

Concrete block
building, view to
NW
