**MARYLAND HISTORICAL TRUST
NR-ELIGIBILITY REVIEW FORM**

Property Name: Home Farm/Beaverdam Farm Inventory Number: T-1144

Project: Matthews Tower Agency: FCC

Maryland Historical Trust Maryland Inventory of Historic Properties Form

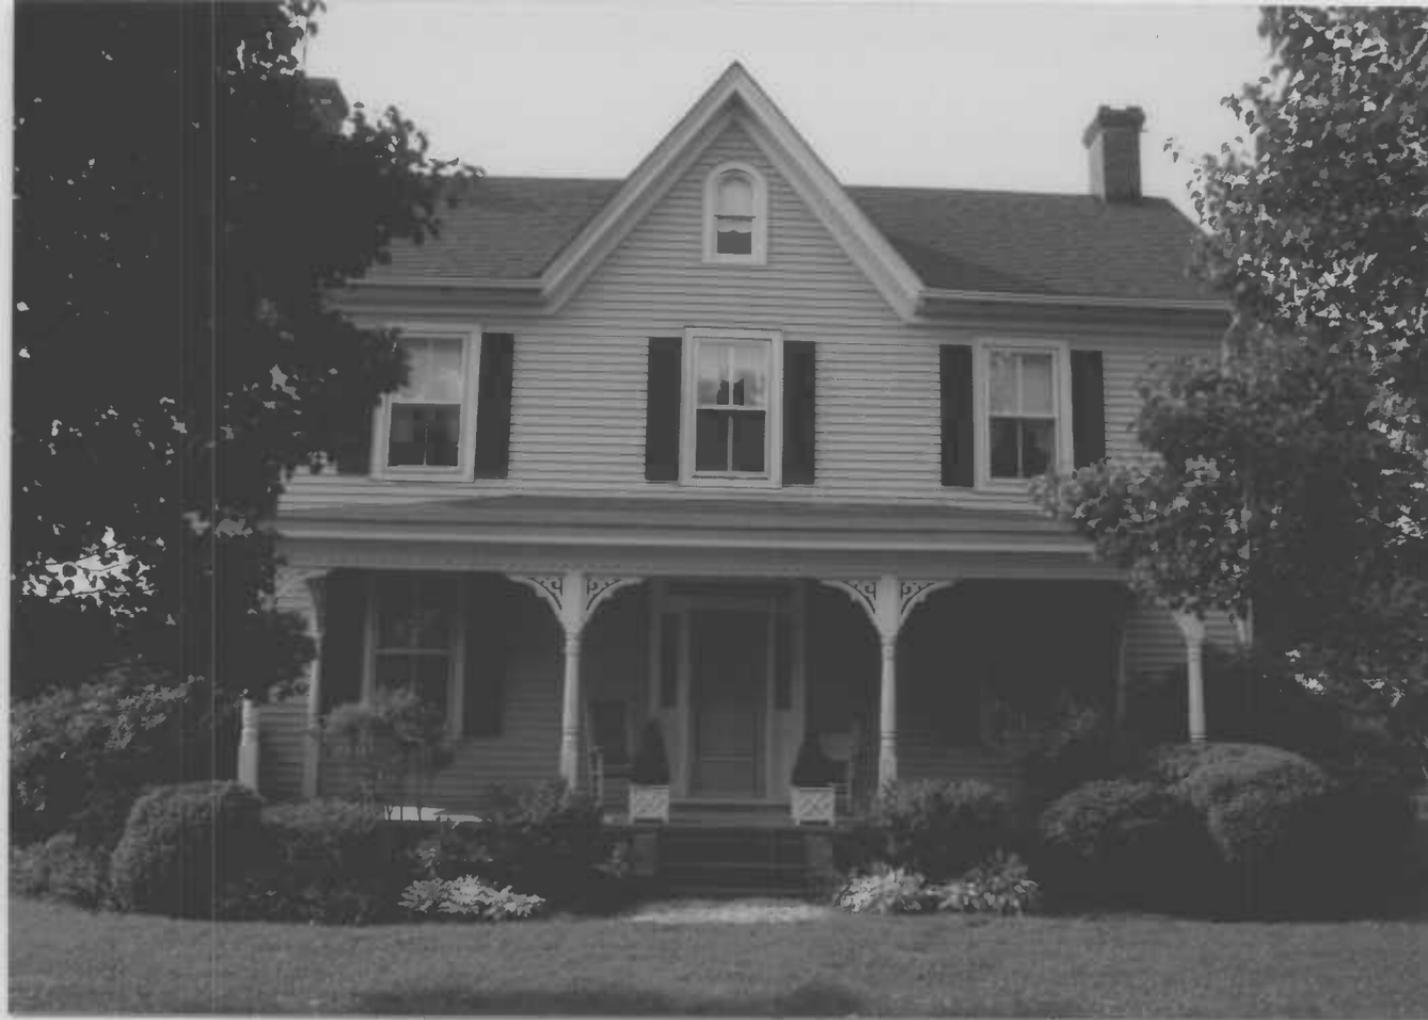
1/5

The farmhouse is a 2.5-story T-plan frame building constructed on a continuous brick foundation. The house measures 3 bays by 3 bays and has a symmetrical main façade (north). There is a three bay hip roof, bracketed porch on this façade with turned wood posts. The main entry (in this elevation) has a four-light transom and three-light sidelights. There is a central cross gable in the roof with a rounded gable peak window. The roof has cornice returns and is clad by composition shingles; there are three internal brick chimneys.

The farmhouse is a 2.5-story T-plan frame building constructed on a continuous brick foundation. The house measures 3 bays by 3 bays and has a symmetrical main façade (north). There is a three bay hip-roof, bracketed porch on this façade with turned wood posts. The main entry (in this elevation) has a four-light transom and three-light sidelights. There is a central cross gable in the roof with a rounded gable peak window. The roof has cornice returns and is clad by composition shingles; there are three internal brick chimneys.

House: N. Elevation

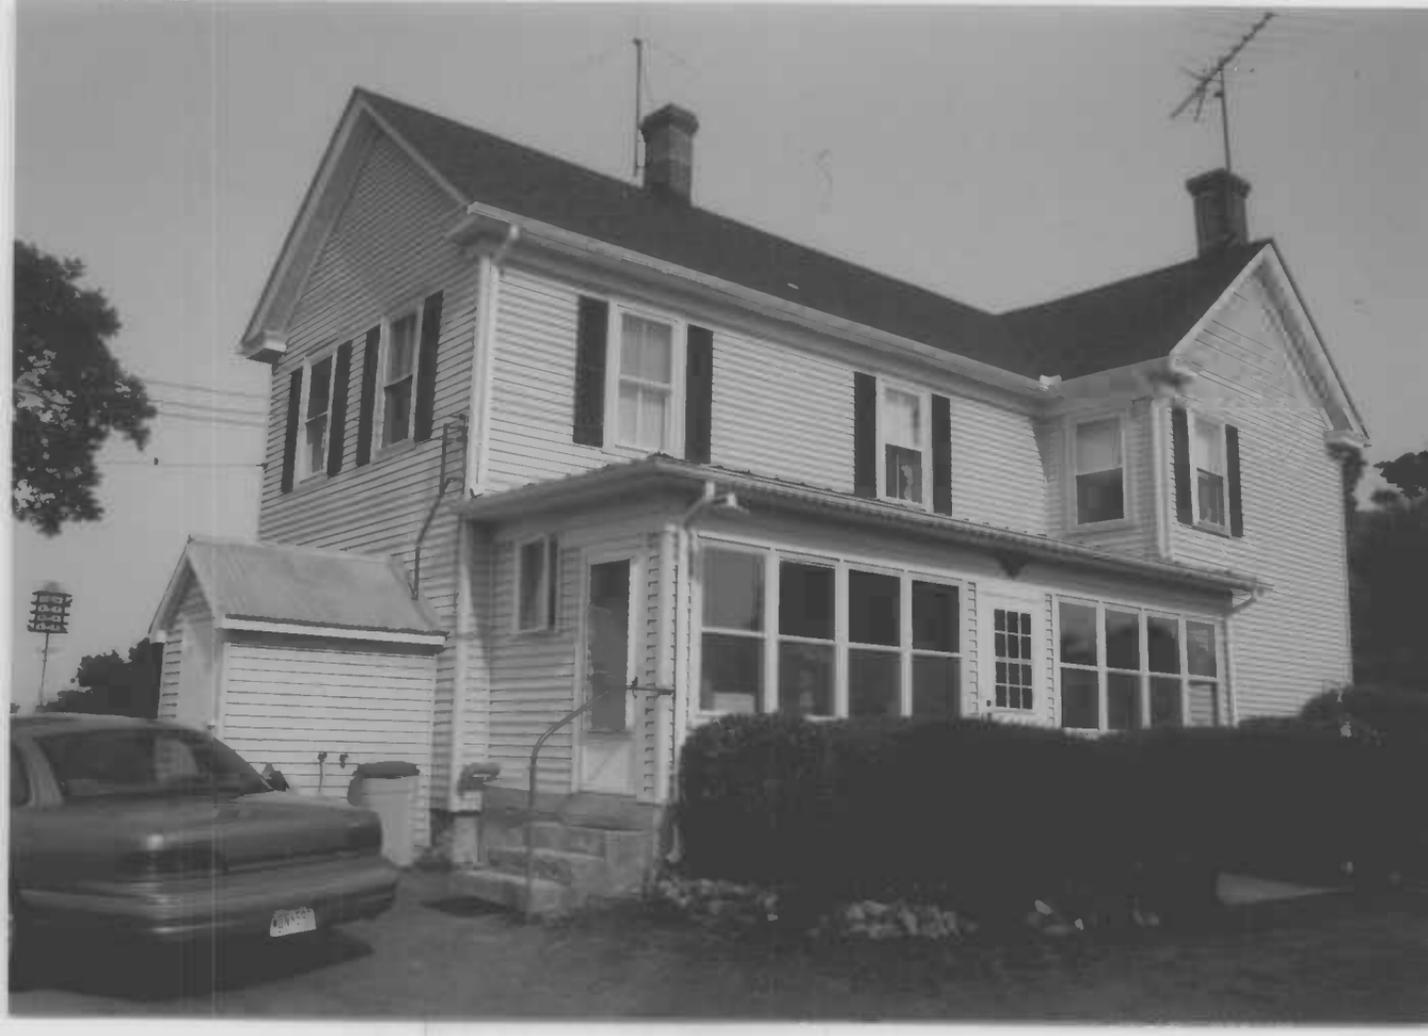
2/5-

The rear ell addition has an enclosed side entry shed roof porch (east) and there is an enclosed gable roof porch extension in the rear elevation. The house has 2/2 wood DHS and 1/1 vinyl DHS windows and is clad by vinyl siding. Alterations to the original building fabric, in addition to the siding, include a television antenna mounted on a chimney in the side gabled block. The agricultural outbuildings are modern concrete block and metal-clad buildings. They are non-contributing elements to this property.

The rear ell addition has an enclosed side entry shed roof porch (east) and there is an enclosed gable roof porch extension in the rear elevation. The house has 2/2 wood DHS and 1/1 vinyl DHS windows and is clad by vinyl siding. Alterations to the original building fabric, in addition to the siding, include a television antenna mounted on a chimney in the side gabled block.

House: E. Elevation

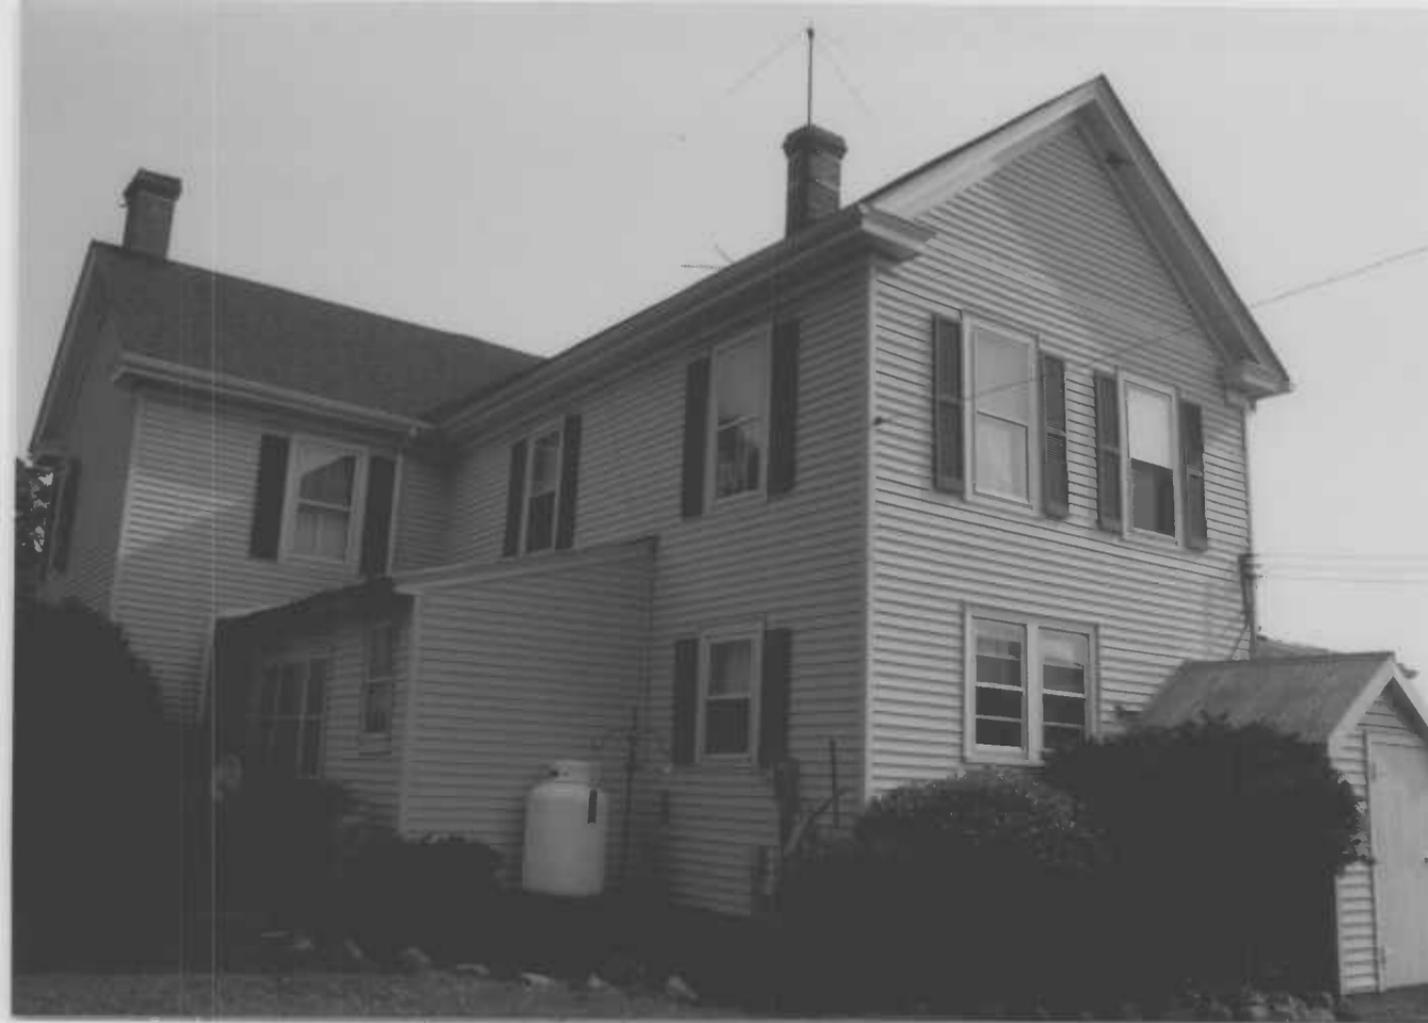
315

7-1144
Home Farm / Beavertown Farm
Talbot Co., MD
David Rotenstein
June 2001
MDSHPO
House: S. Elevation
(Rear)

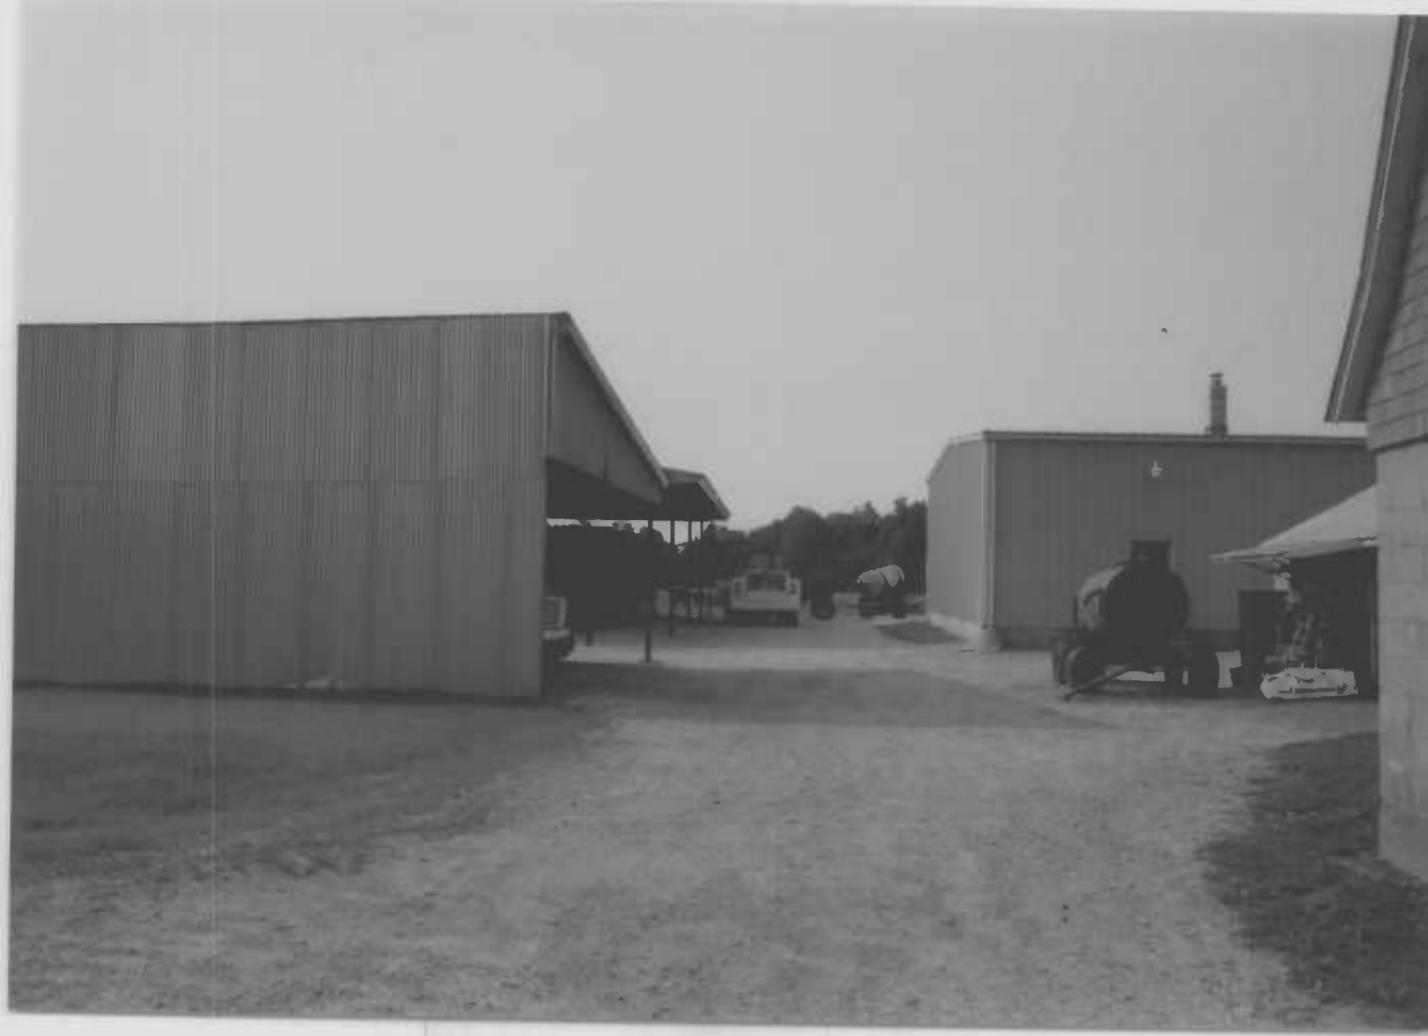
4/5

The agricultural outbuildings are modern concrete block and metal-clad buildings. They are non-contributing elements to this property.

The property does not appear to retain its historical integrity (materials, workmanship, design). The farmhouse has been altered by the addition of siding and replacement windows and the existing agricultural outbuildings are modern; no historical agricultural outbuildings exist or survive at this property.

Agricultural outbuildings
view to South

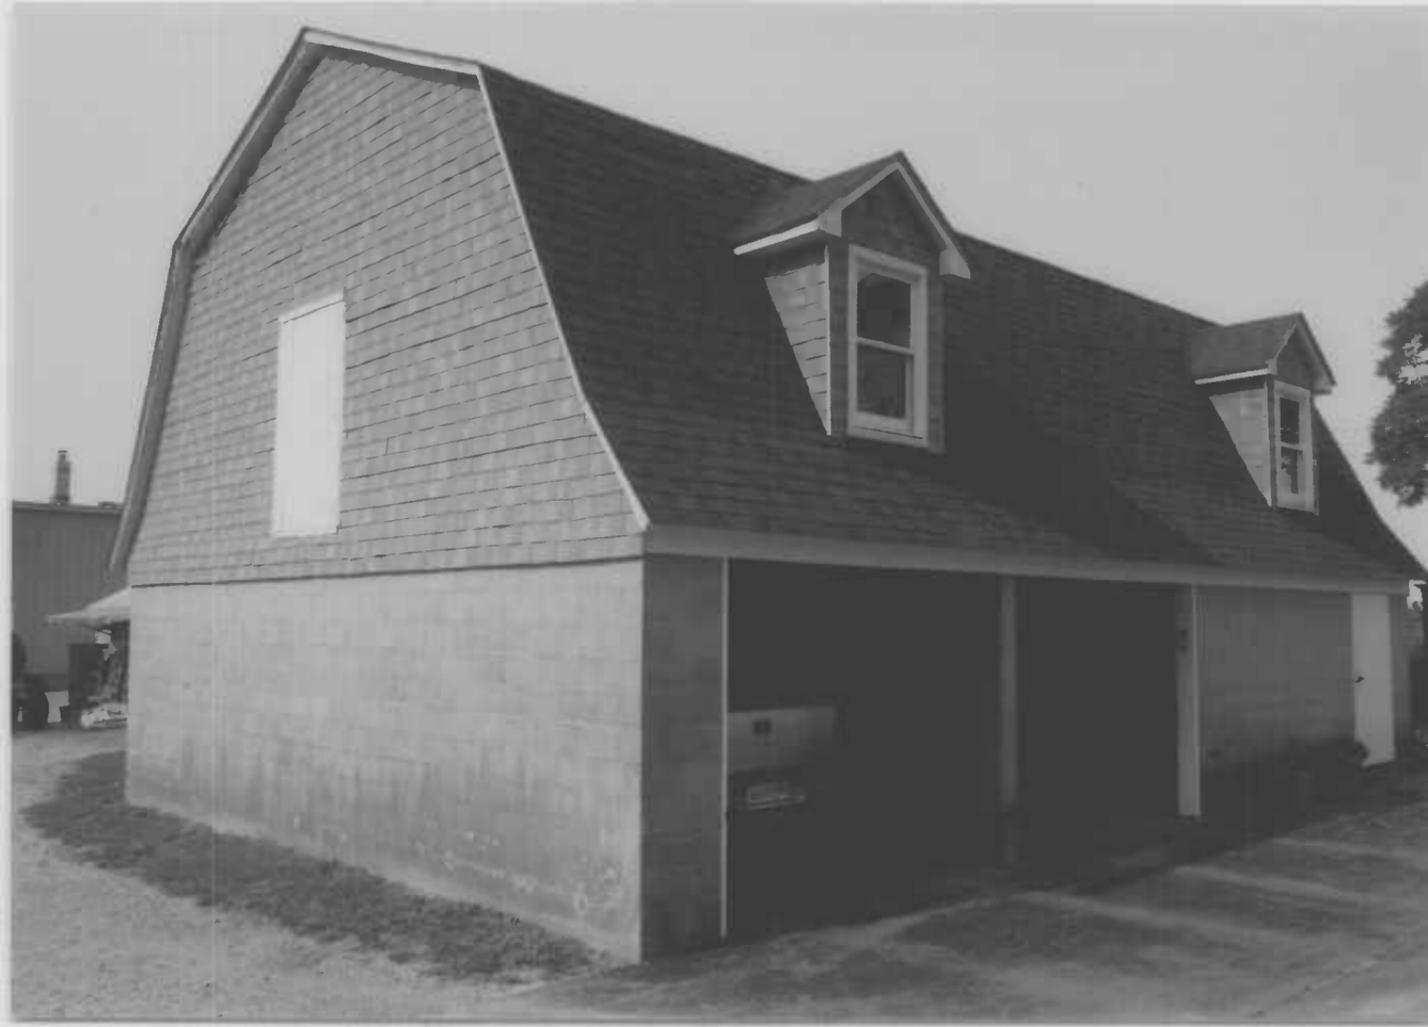
5/5

7-1144
Home Farm/Beaverdam Farm
Talbot Co., MD
David Rotenstein
June 2001
MD SHPD
Garage. View to SW
