CARR-1581

4550 Baptist Road, Harney Vicinity

National Register of Historic Places Registration Form

historic name John Sheets Farm
other names/site number CARR-1581

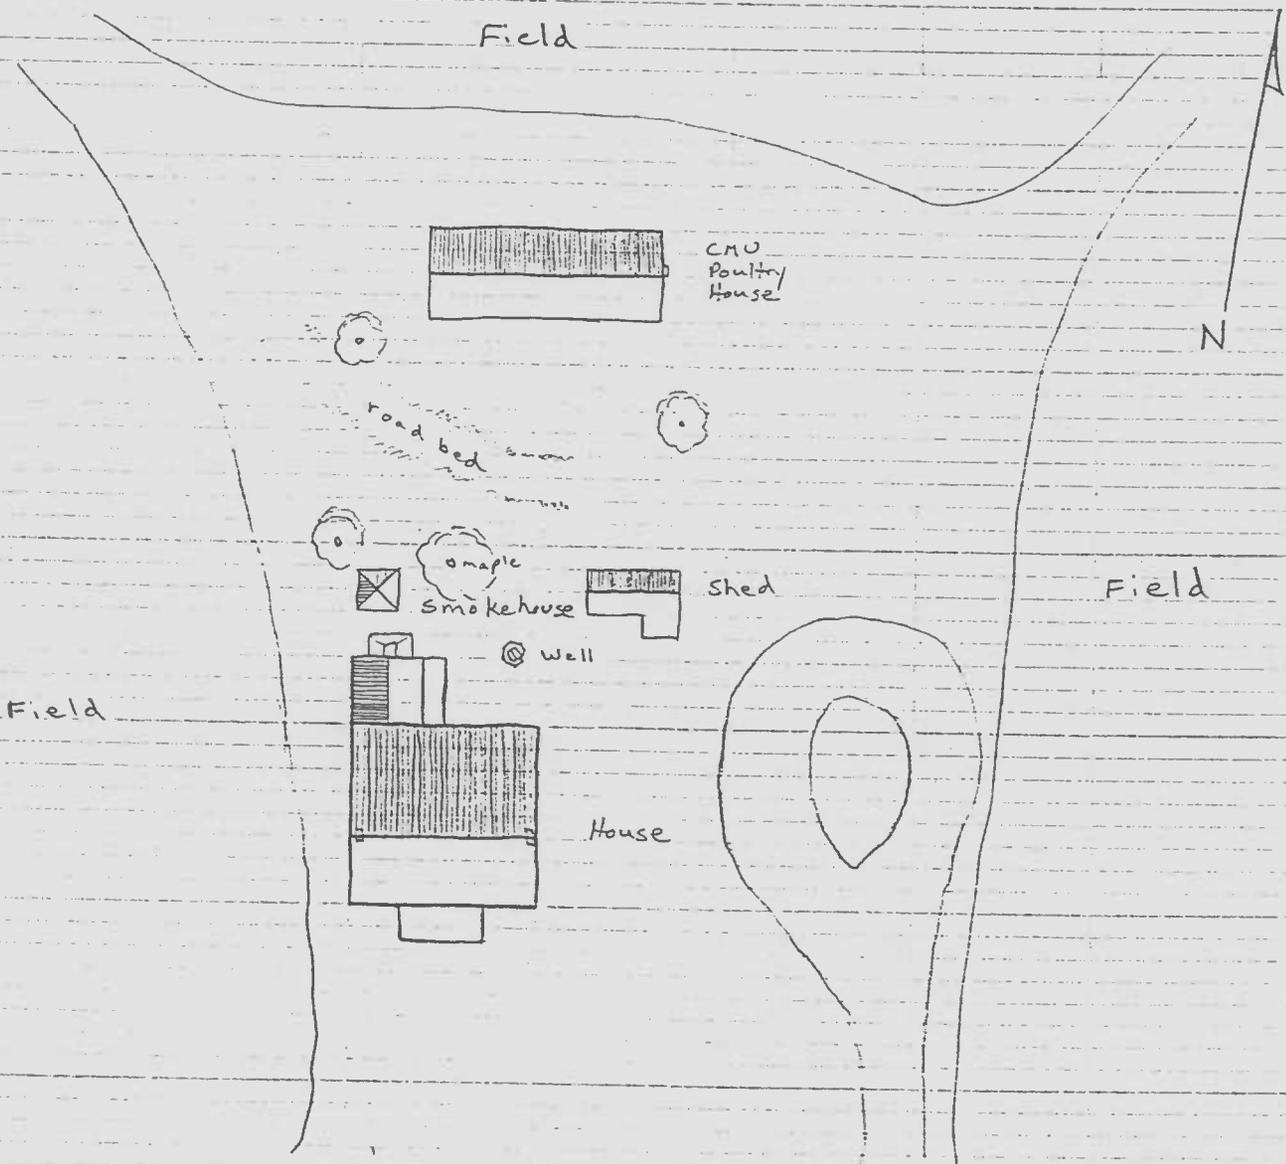
4550 Baptist Rd - CARR-1581
Site Plan

The John Sheets Farm is located at 4550 Baptist Road approximately one mile southwest of Harney in northwestern Carroll County, Maryland. The complex consists of a stone house; stone summer kitchen; stone smokehouse; frame shed and CMU poultry house. The complex is set on a very flat site approximately 200 yards east of the Monocacy River.

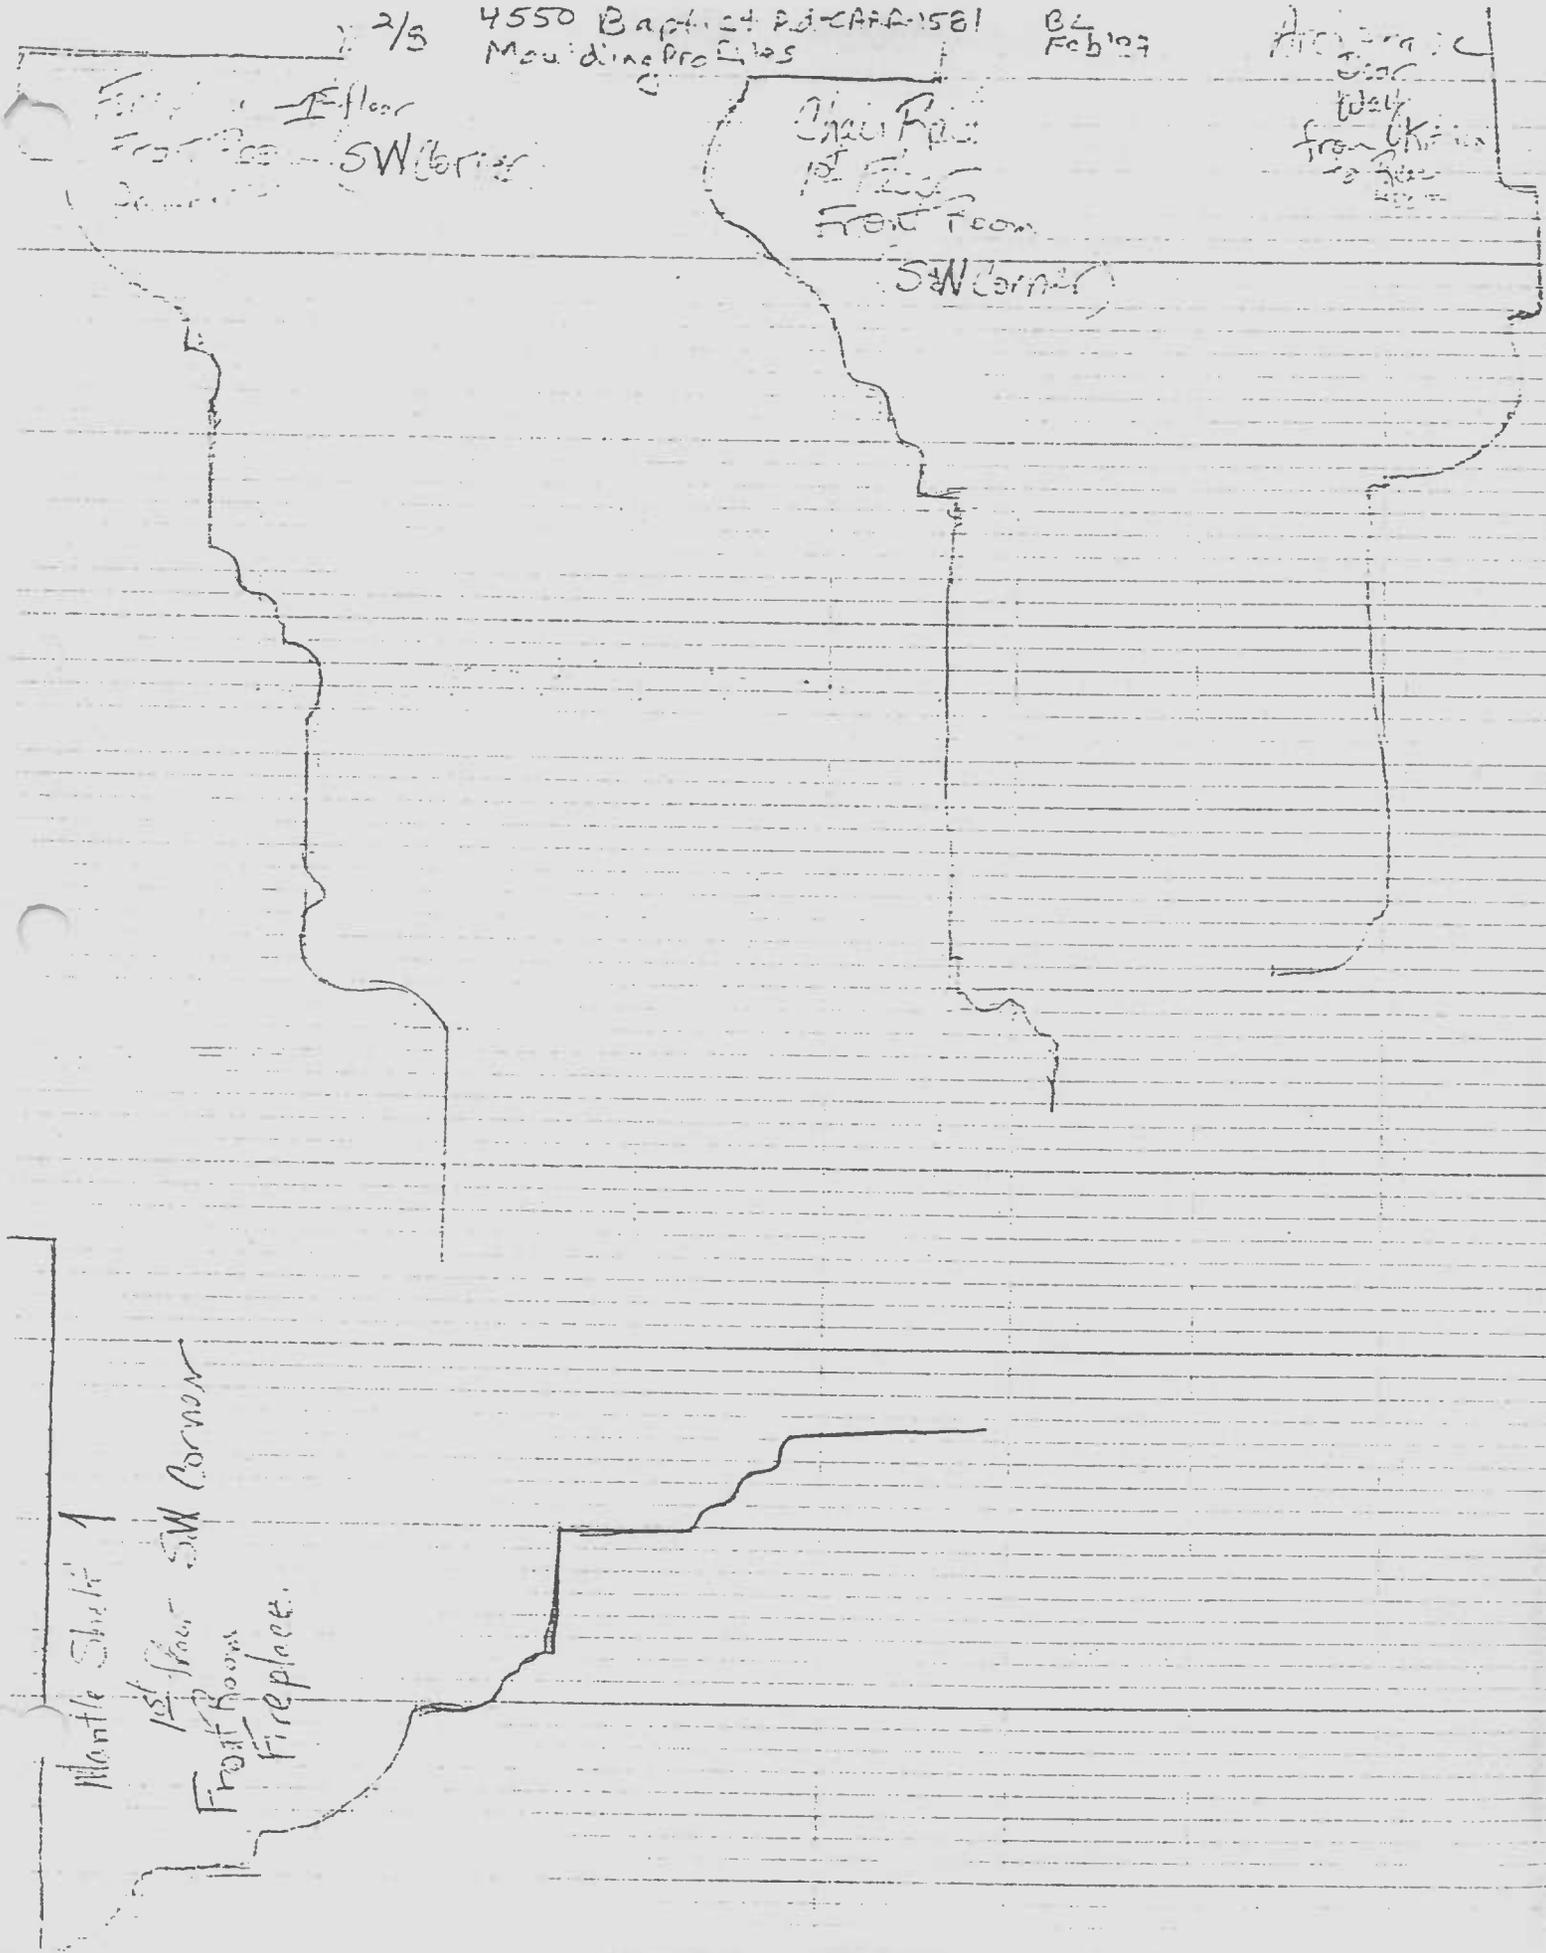
4550 Baptist Rd - CARR-1581
Moulding Profiles

1st floor SW Corner

1st Floor Front Room
SW Corner

Mantle Shelf 1

1st floor SW Corner
Front Room
Fireplace.

The southwest room has random width flooring that runs east/west. There is chair rail on the south and west walls only and it matches that in the southeast room. The thin partition walls on the east and north suggests that they are board walls and that the boards were originally exposed but were later plastered over. The southeast room on the other hand appears to have been plastered on all four walls from the beginning. There is a fireplace in the northwest corner it has straight parged jambs with a reveal in each front corner. The wood mantle is similar to that in the northeast room and has three panels in the frieze. It has a plastered over mantle with rails and stiles of wood. The over mantle has a cornice.

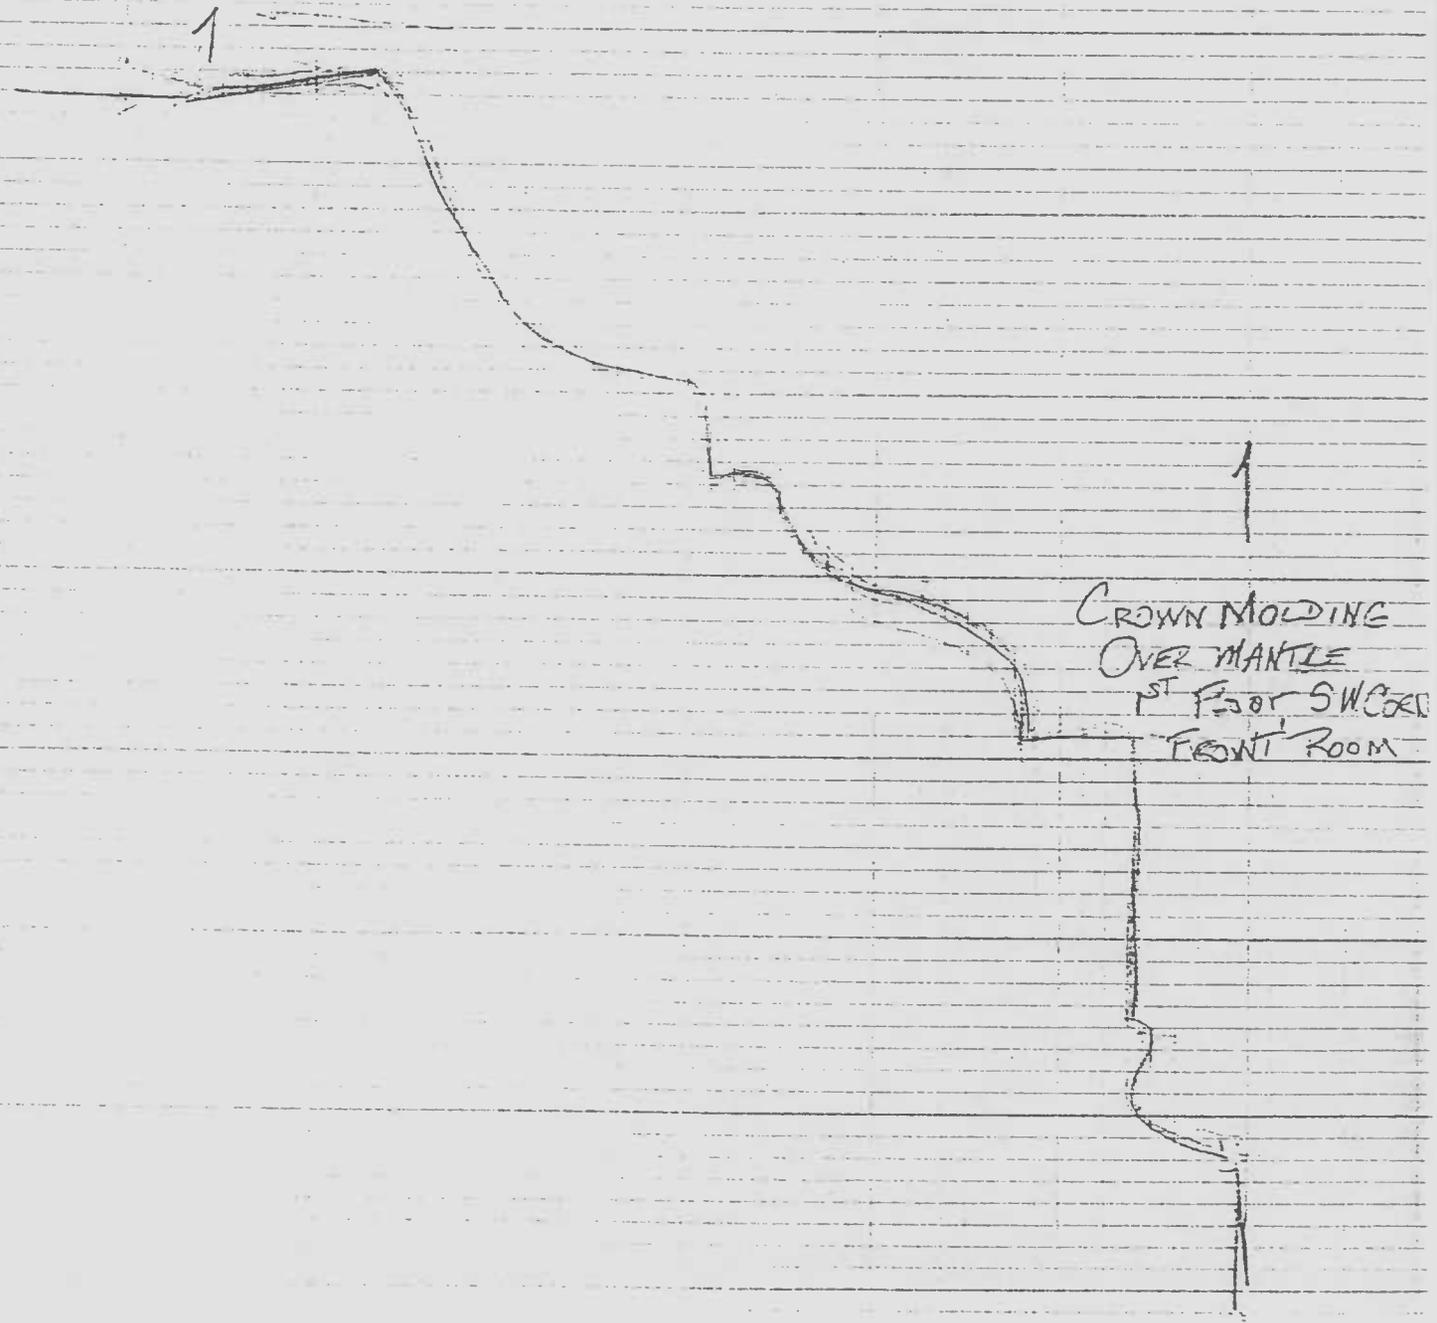
4550 Baptist Rd - CARR-1581
Moulding Profiles

Crown
molded over
Overmantle

1st Floor SE Corner
Front Room

In the southeast room the flooring is about 5 1/4 wide and runs east/west. The north wall of this room appears to be rebuilt, this room has chair rail with a Torres at the top and ogee in the center and a flattened bead beneath it. There is also a bead at the bottom edge. The windows have two panels on each jamb and two panels on the soffit. The frames have an ovolo run on the edge of the board. This is the only room without a fireplace, although it is possible it originally had a stove, as it appears to be the best room, architecturally speaking.

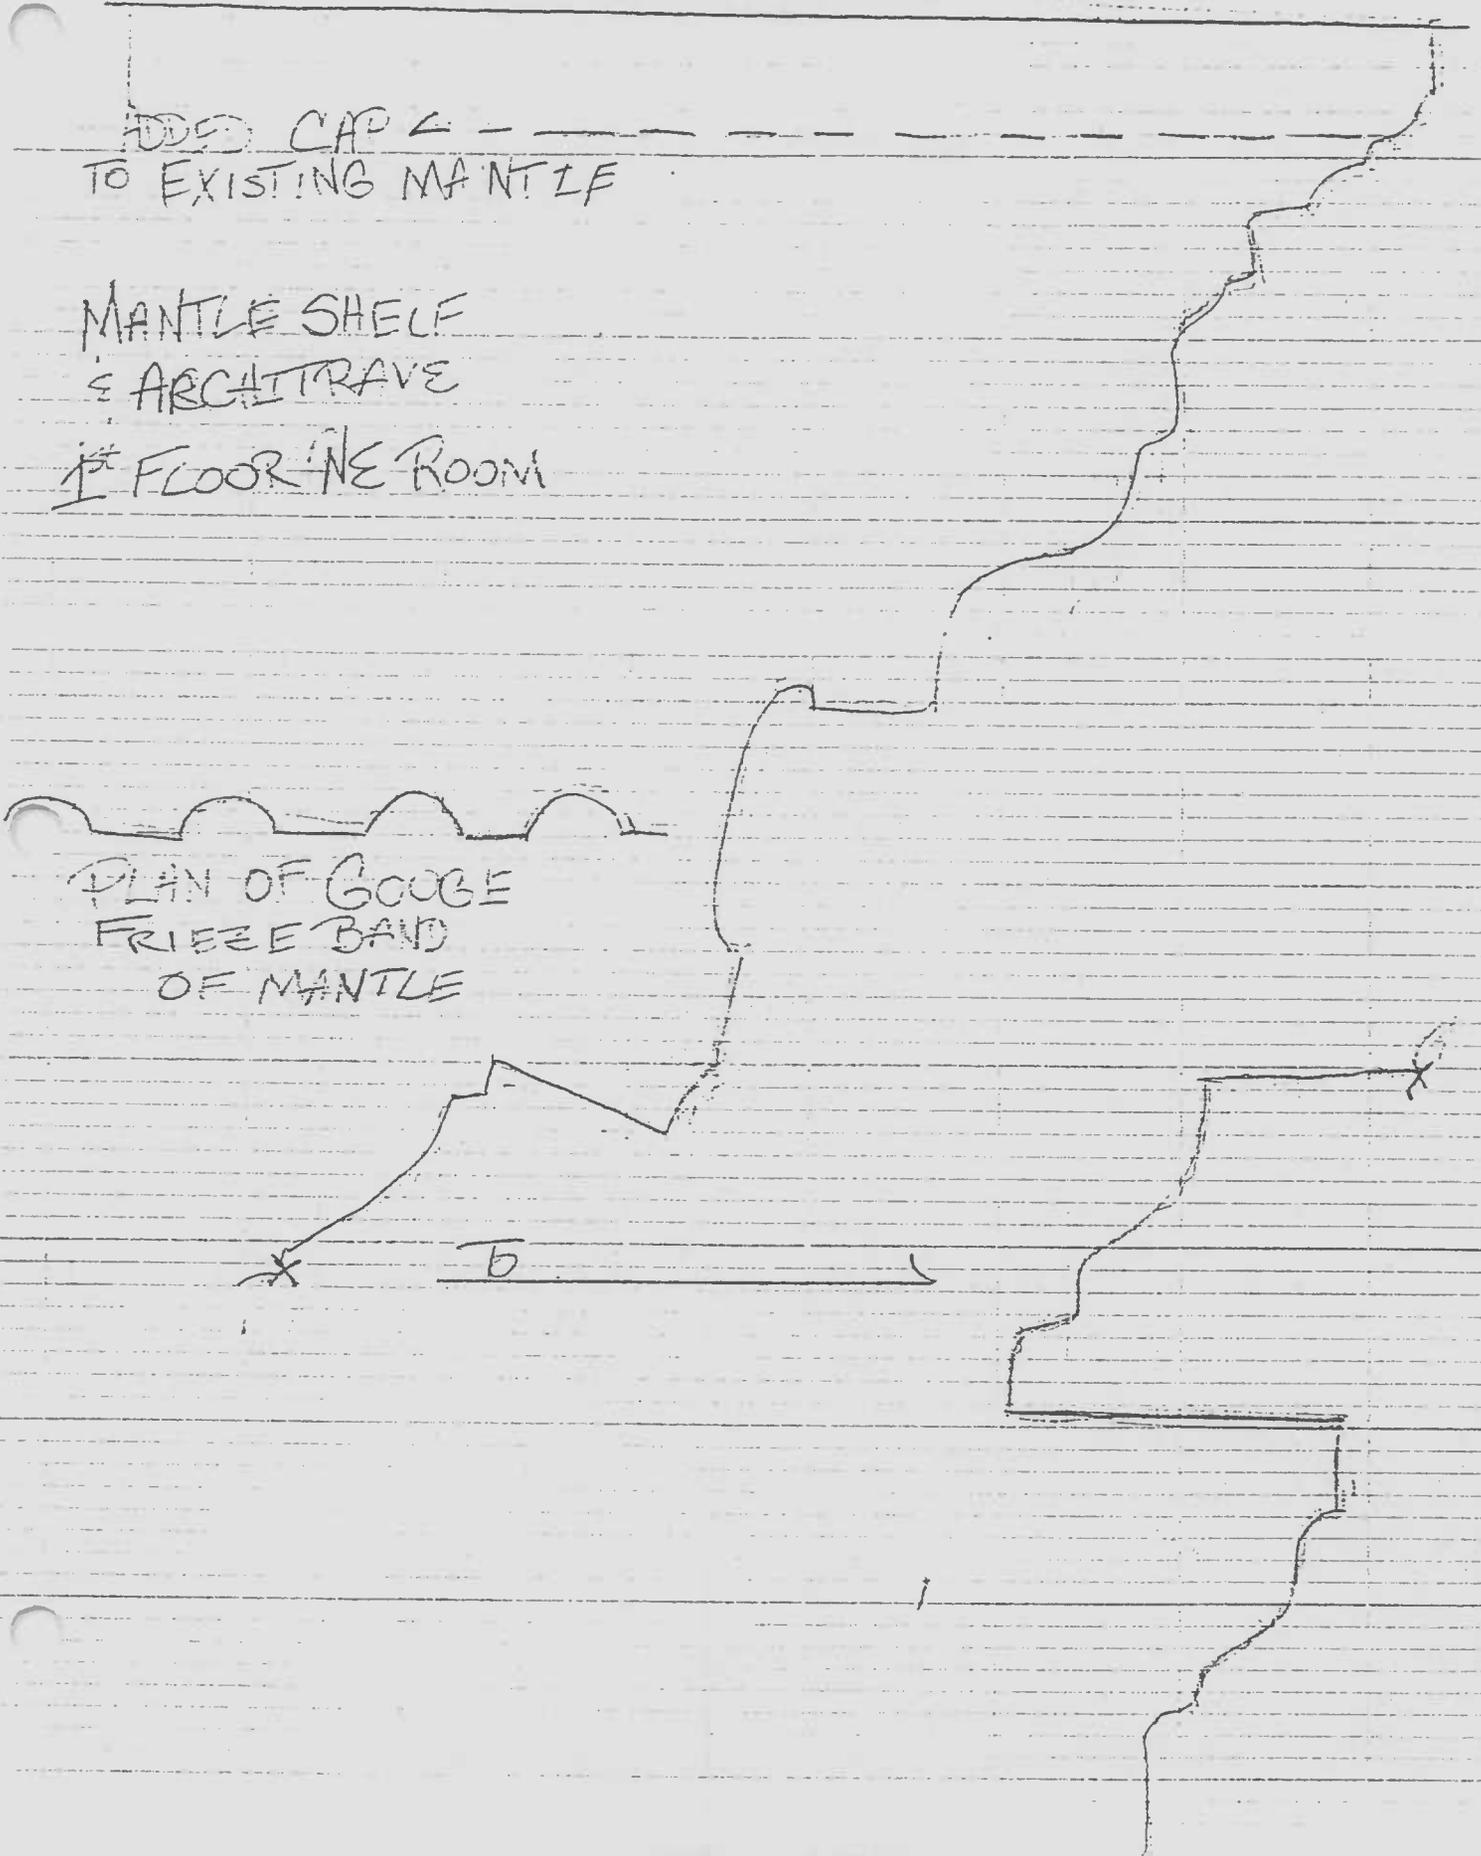
4550 Baptist Rd - CARR-1581
Moulding Profiles

ADDED CAP ← - - - - -
TO EXISTING MANTLE

MANTLE SHELF
& ARCHITRAVE

1st FLOOR NE ROOM

PLAN OF GOUGE
FRIEZE BAND
OF MANTLE

The northeast room has the same flooring and chair rail as the southeast room. The window jambs have flat sunk panels. Move to elsewhere. The southeast room window panels have fields. The window on the east elevation appears to have originally been a door, as the trim is cut through on both sides and the frame does not match the north window. There is a corner fireplace in the southeast corner, the brick work here is now exposed. It has a

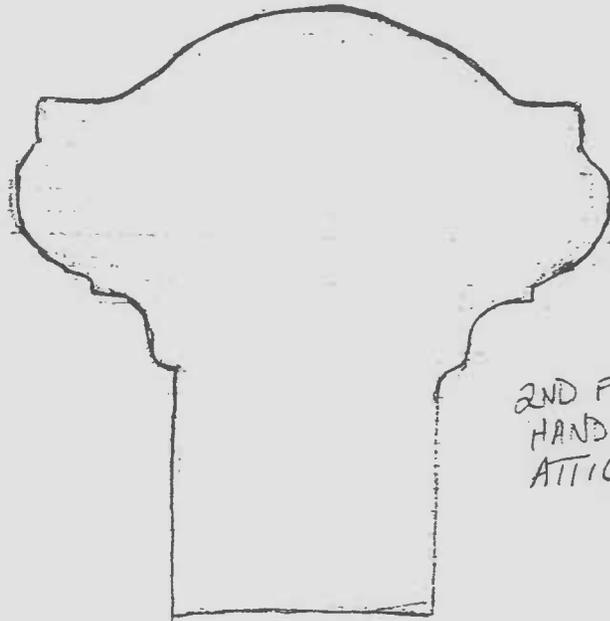
4550 Bapstead Rd - CARR-1581
Moulding Profiles

2ND FLOOR PASSAGE
HAND RAIL FOR
ATTIC STAIR

NE CHAMBER
2ND FLOOR
CROWN MOLDING PROFILE
CLOSET

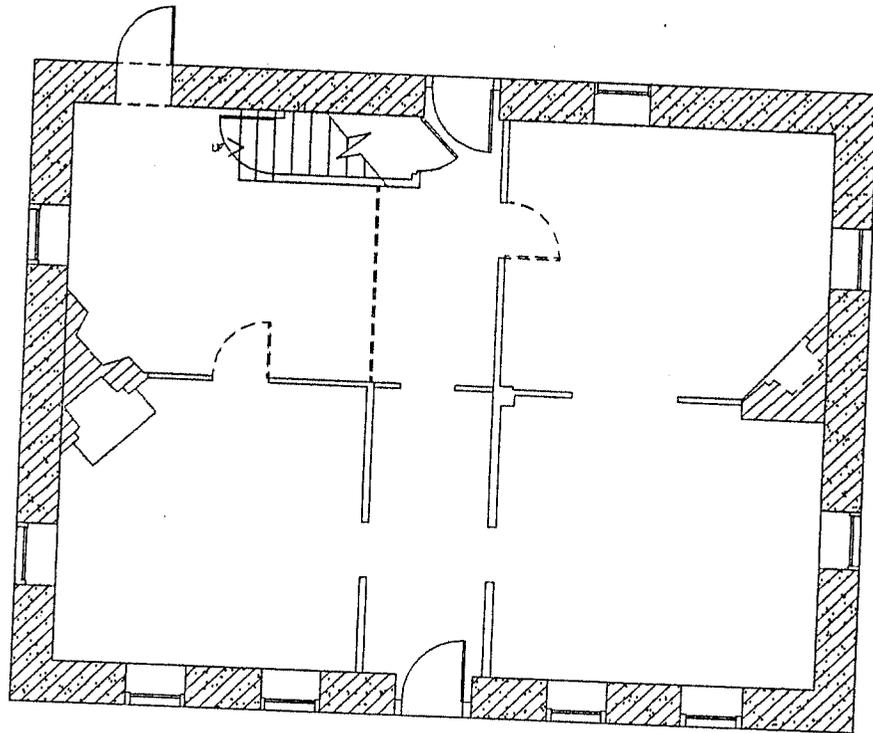
FIRST FLOOR PLAN

MEASURED BY KEN SHORT AND BARB LILLY

The first story has a center passage double pile plan, the center passage is narrow and does not have a stairway. However, it appears that the floor plan has been altered and the stairway moved so that the stairway was probably originally at the rear of the center passage. The passage has new oak flooring that runs east/west. The doorways to the front rooms have been rebuilt and have new architrave that matches the rest of the first story doors. The passage is one room deep with a wall and doorway to the front rooms have been rebuilt and have new architrave that matches the rest of the first story doors. The passage is one room deep with a wall and doorway on the north end. This doorway cannot be viewed now because it is hidden behind a large piece of furniture.

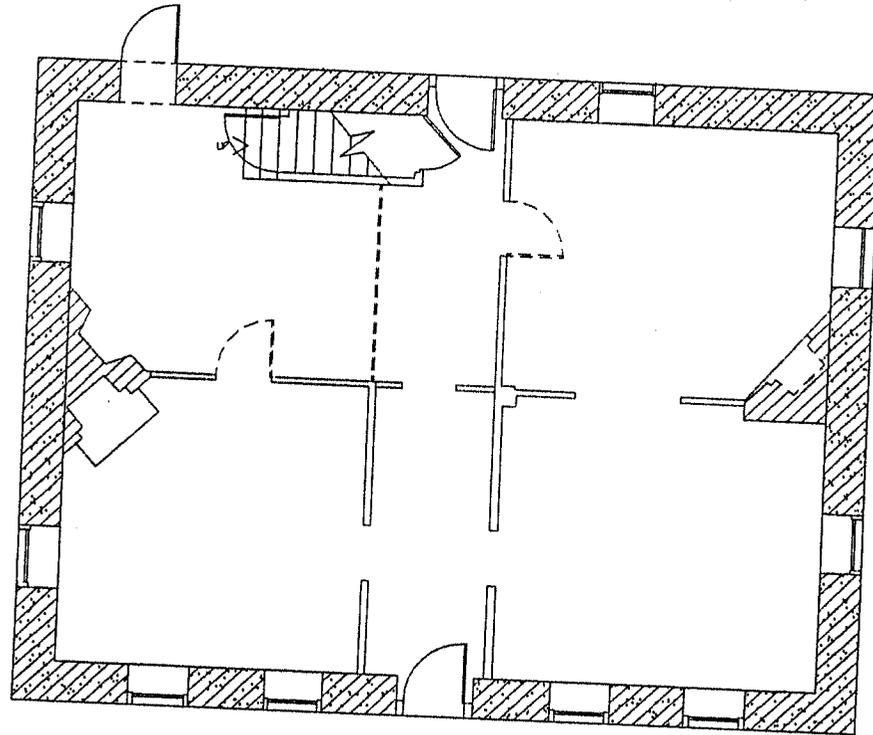
FIRST FLOOR PLAN
FEBRUARY 1997

MEASURED BY KEN SHORT AND BARB LILLY
DRAWN BY KEN SHORT
