Staff House (Building 10), Henryton Sanatorium
CARR-1622
Carroll County
Marriottsville Vicinity
1940
Public

Maryland Historical Trust Maryland Inventory of Historic Properties Form

Inventory No. CARR-1622

historic Staff House - Henryton Sanatorium Historic District

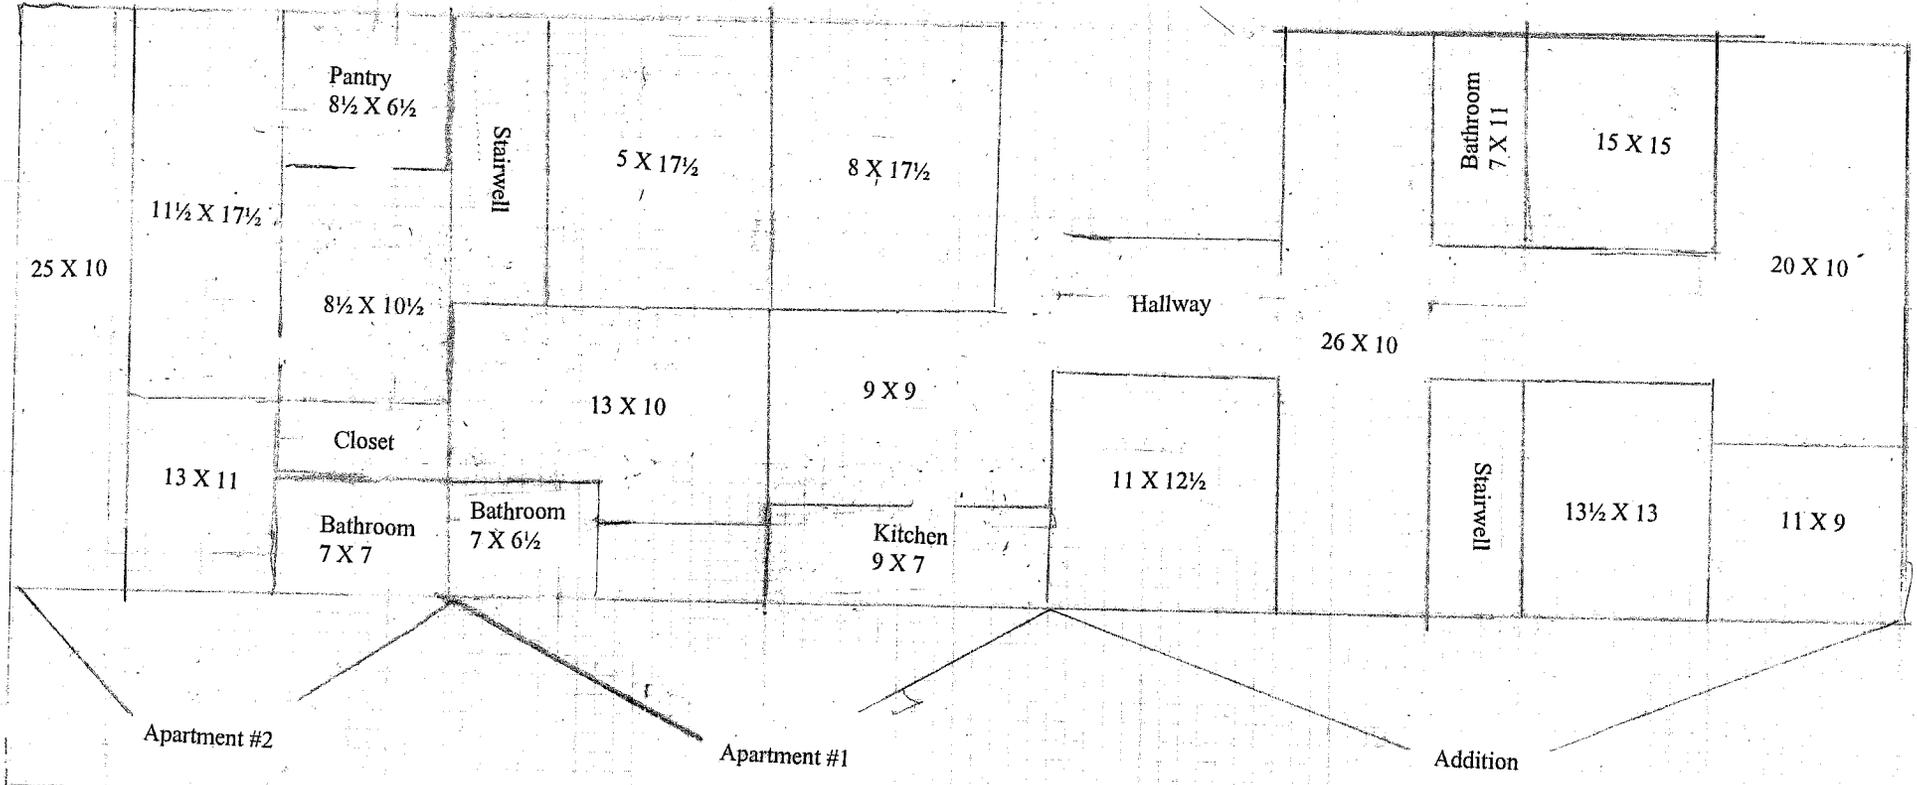
FLOOR PLAN OF STAFF HOUSE (BUILDING #10)

Measurements approximate in terms of Feet

Construction of the building began in 1938 as a staff house for white employees and was completed by 1940 (Board 1940:75). The building also incorporates aspects of Georgian Revival form and ornament popular for large public buildings during the early twentieth century, and utilized for most of Henryton's larger structures. The Staff House was completed by 1940. Additional staff housing was constructed at the hospital during this time because quarters in building #3 – Nurses' and Staff Quarters, were being used to house only the hospital's ever increasing nursing staff (Board of Managers 1940:75). The Staff House was designed to include both apartments and dormitories. The building contained two apartments on the first story, individual dormitory rooms on the second story, and a single apartment in the attic story (Riggs-Warfield-Roloson 1953-59).

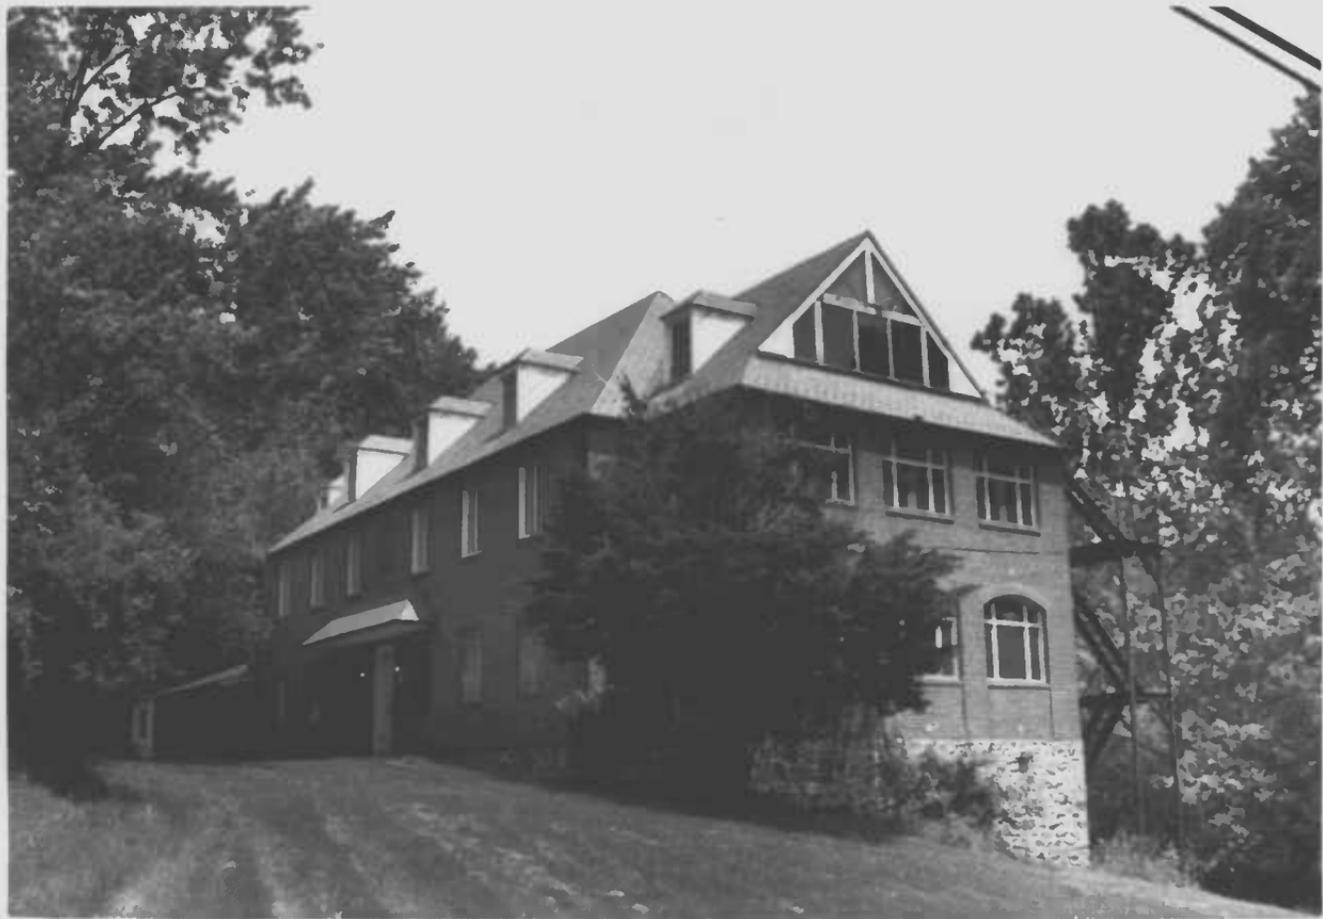
1 of 3

South + West (Front) Elevations

Northeast View

The Staff House (Building 10) consists of a two-and-one-half story brick building constructed circa 1940 with a stone foundation and a slate-covered hipped roof. The building's main block is seven bays in length and contains a hipped-roof with three hipped dormers on both its front and rear elevations. The main block's west (front) elevation contains a single-leaf wood-paneled door sheltered by a shed-roof. One-bay-three bay brick wings flank each side (north and south elevations) of the main block. Both wings have hipped dormers and gable-on-hipped roofs, with the gable end containing glazed panels. The north wing has a one-light wood door with sidelights on its front (west) elevation, all sheltered by a shed-roof hood. The glazing on the door and sidelights has been boarded-up. A one-story brick, gabled-roof addition has been added to the north side of the north wing and has a hipped-roof bay extending from its north end. A metal fire-escape has been amended to the east (rear) of the south wing. The building has good overall integrity.

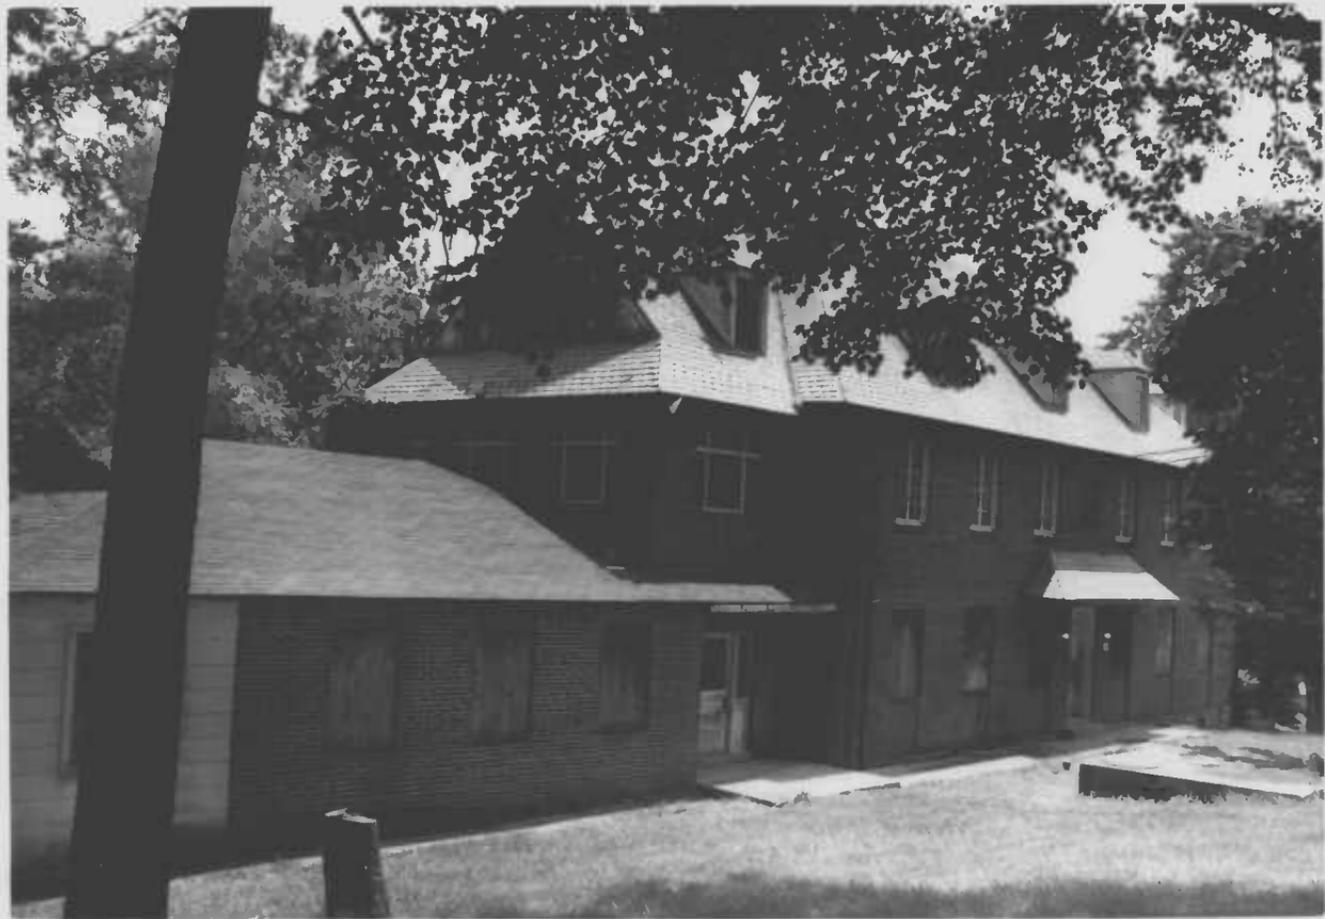
2 of 3

West (Front) Elevation Southeast view

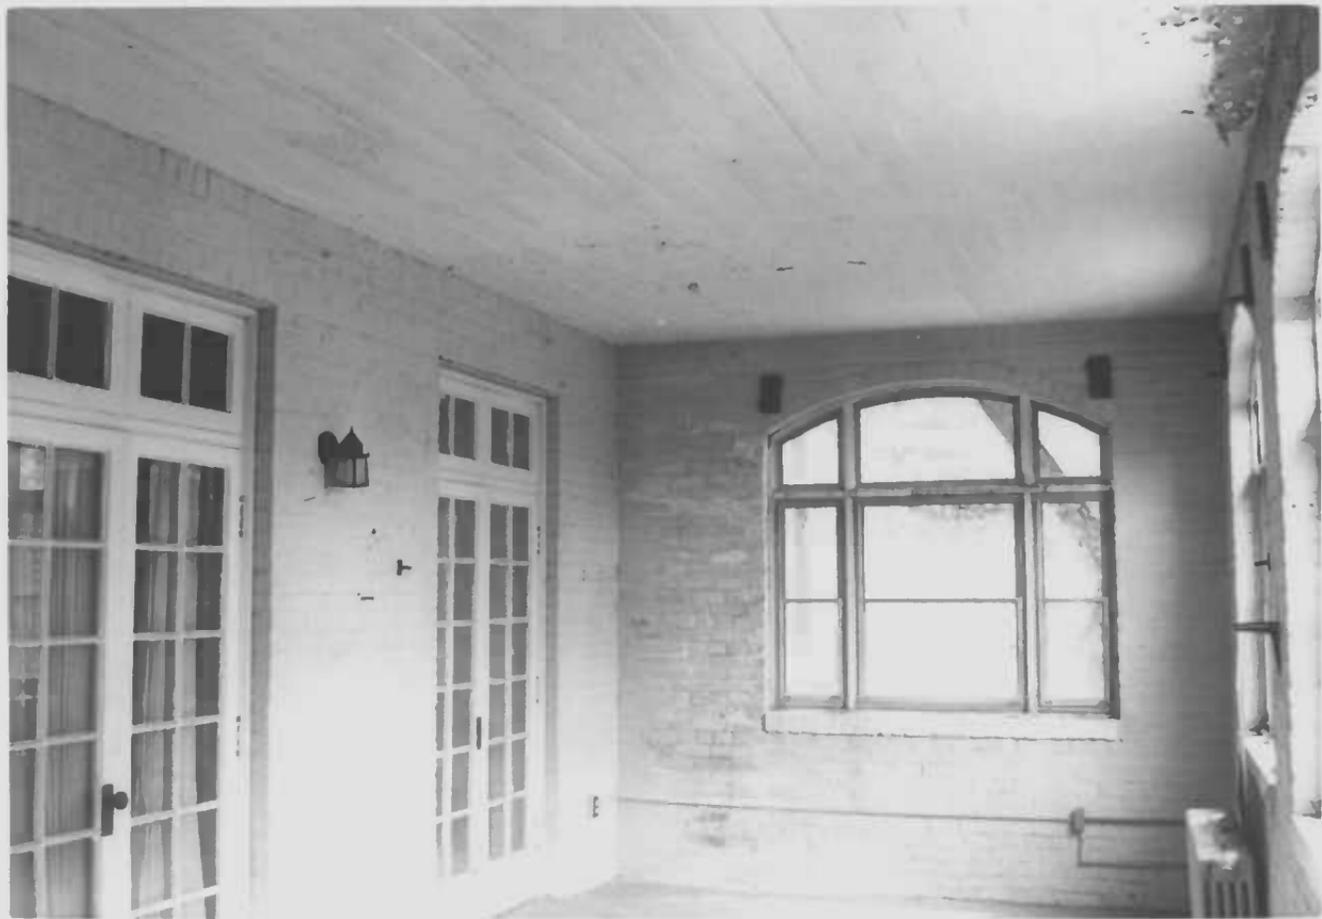
3 of 3

Interior view of 2nd Story Room at South
end of Building looking East.

The interior of the building is subdivided into small apartment and dormitory units. Many room feature segmental arched doorways with double-leaf eight-light wood French doors with segmental arched glazed transoms. Many of the interior walls contain sizable holes from purposeful destruction.
