# Maryland Historical Trust Maryland Inventory of Historic Properties Form

Survey No. 02-1032

historic Cann Stone House Ruins

Inventory Number: CE-1523  
Cann Stone House Ruins  
Cecil County, MD  
C. Mazurek  
June 1998  
Section 7.1

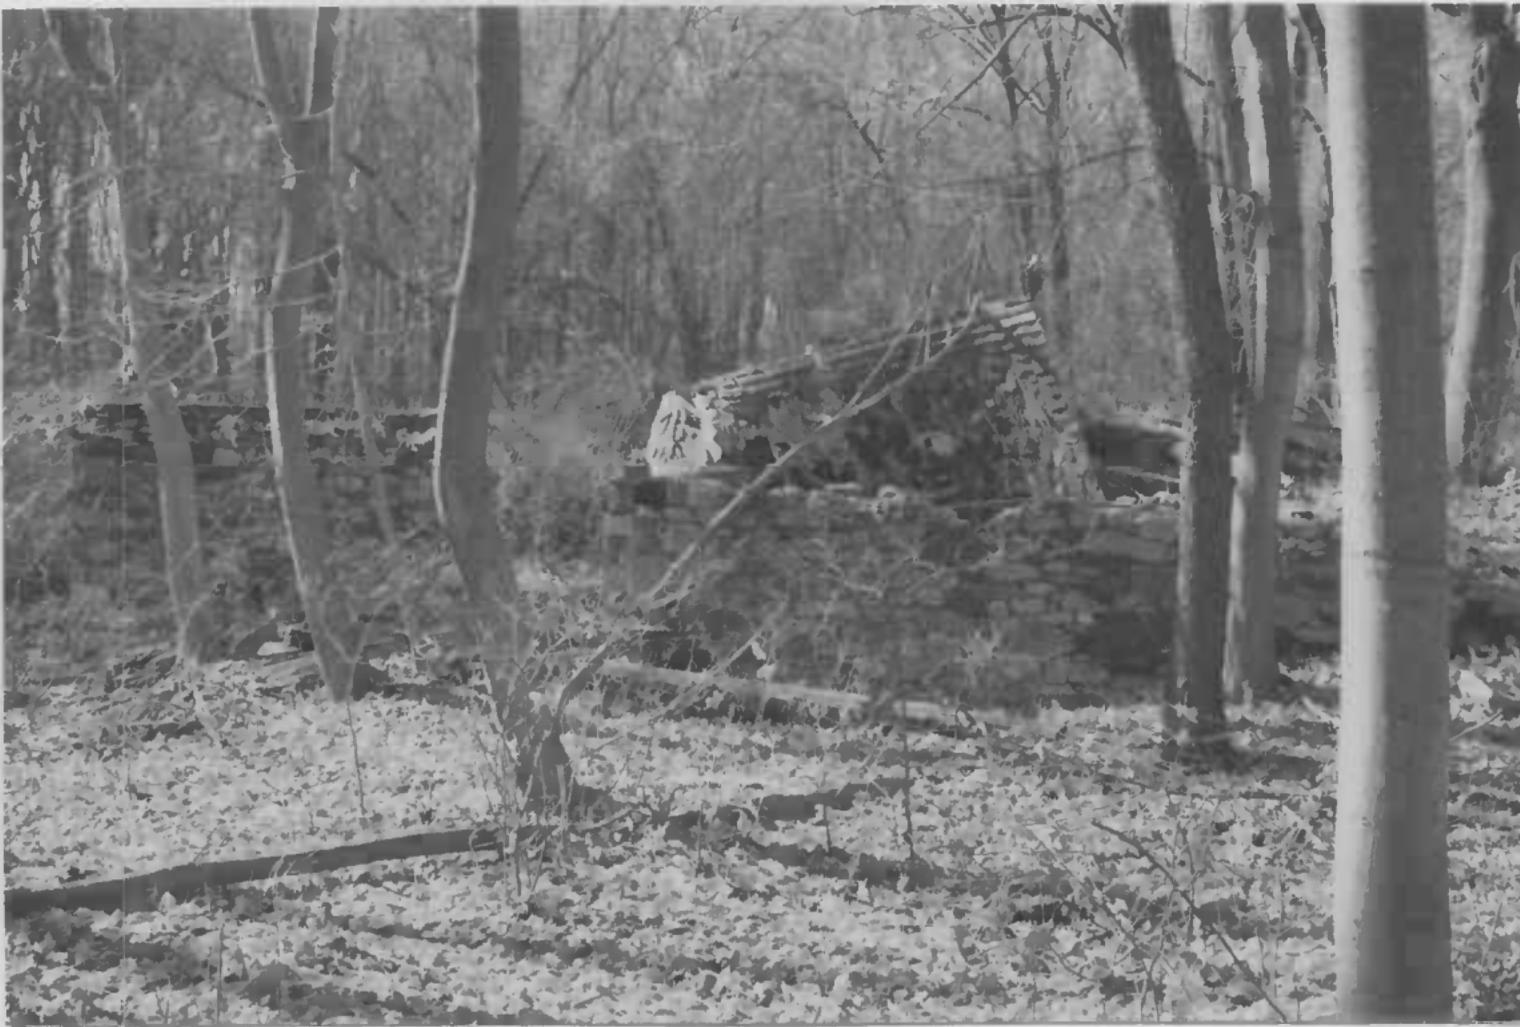
4.a

Also on the property are the remains of a structure that has a fieldstone foundation, but the upper structure is gone. It was probably a small barn.

WEST VIEW OF STONE BANK BARN

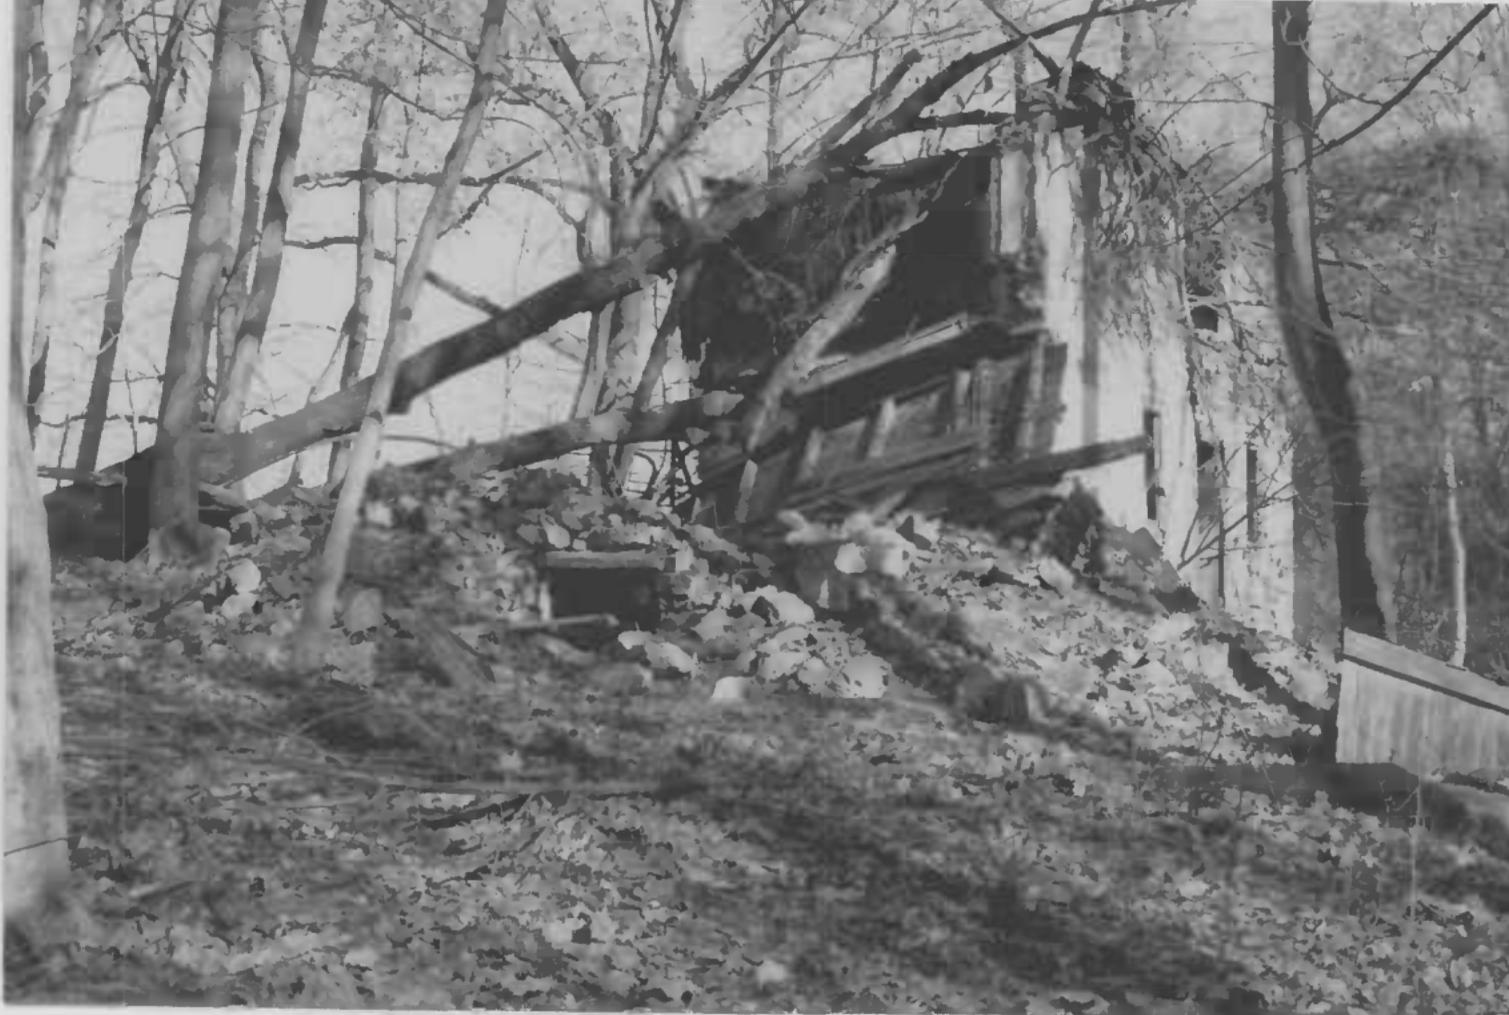
The house is two-stories tall, has an overall "I"-shaped design, and was constructed entirely of uncut fieldstone. This fieldstone also has all irregular courses and was at one point entirely covered with plaster on the exterior. The structure was built in two distinct sections and judging from past photographs both the sections were of about the same dimensions. The roof is side-gabled with a replacement roofing material of composition shingles. All windows and doors are missing, but the wood frames of these for the most part still remain intact.

The condition of the house has deteriorated severely since the loss of the roof. It also appears that it has been hit by a couple of fallen trees which has demolished one whole half of the structure. Much of the interior fabric appears to have been stripped before the house was hit by the trees.

Dept. of NATURAL RESOURCES  
NORTH VIEW OF HOUSE
