Survey No.: AA-2207

Name: Mayo School

Location: 1152 East Central Avenue, Mayo vicinity, Anne Arundel County

MARYLAND HISTORICAL TRUST
STATE HISTORIC SITES INVENTORY FORM

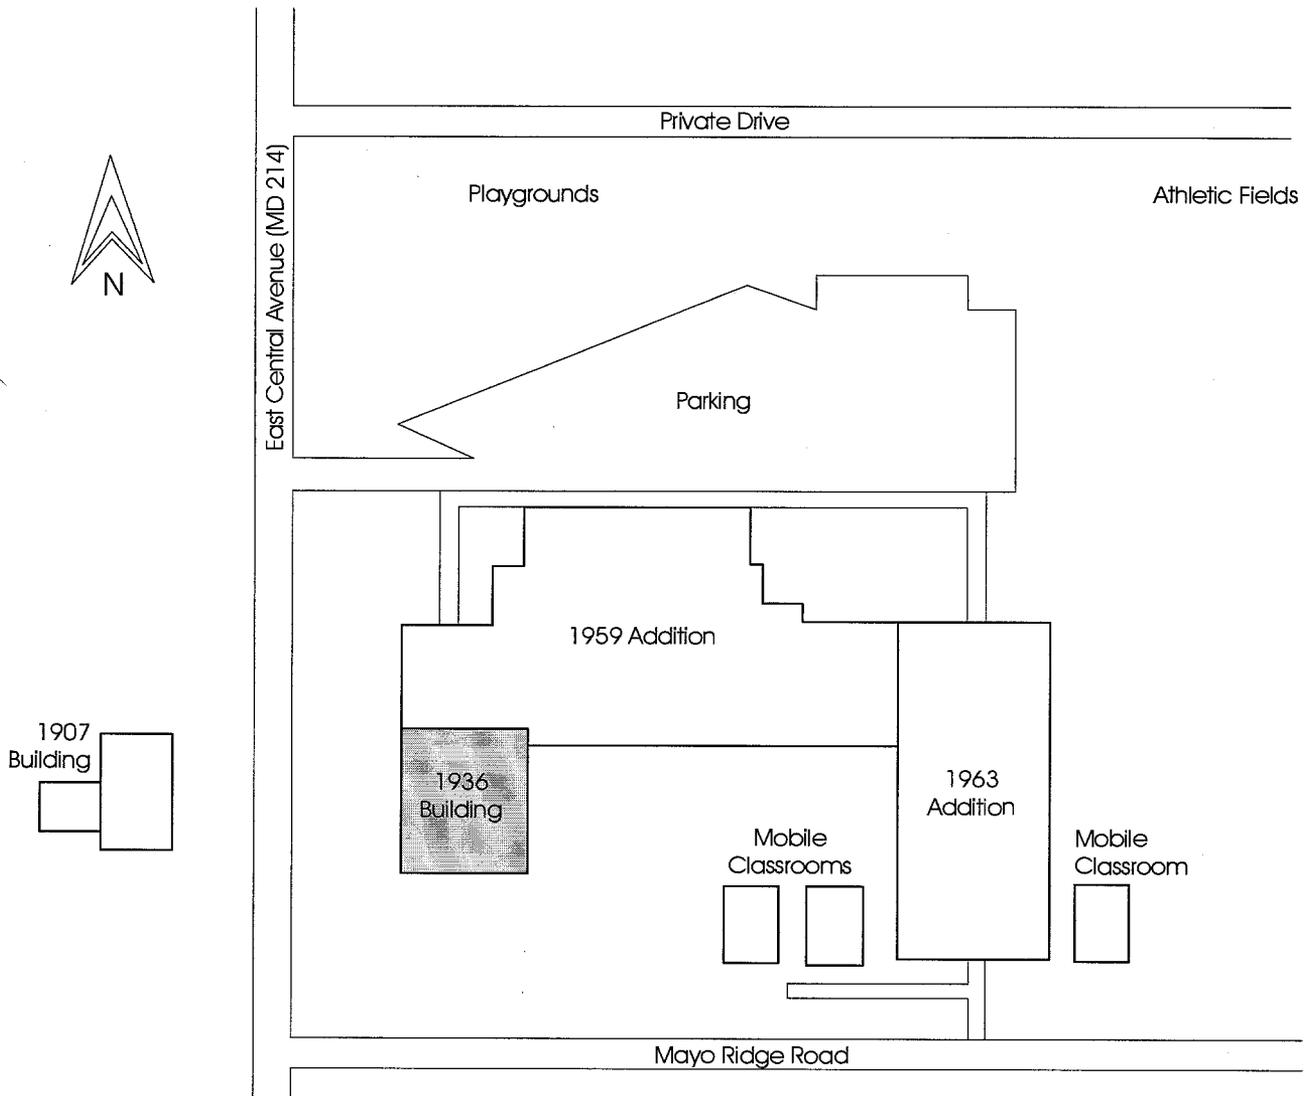
Resource Sketch Map: Site Plan

The Mayo School is on the northeast corner of East Central Avenue (MD 214) and Mayo Ridge Road in the Mayo community of Anne Arundel County. The property occupies 7.27 acres of flat, open land in a low-density residential area. The school complex consists of a 1936 school building with 1959 and 1963 additions. A parking lot and playgrounds are located to the north of the buildings, and athletic fields are located to the east. Three mobile classrooms are currently clustered at the south end of the site. An earlier school building, dating to 1907, is located across East Central Avenue to the west on a separate tax parcel.

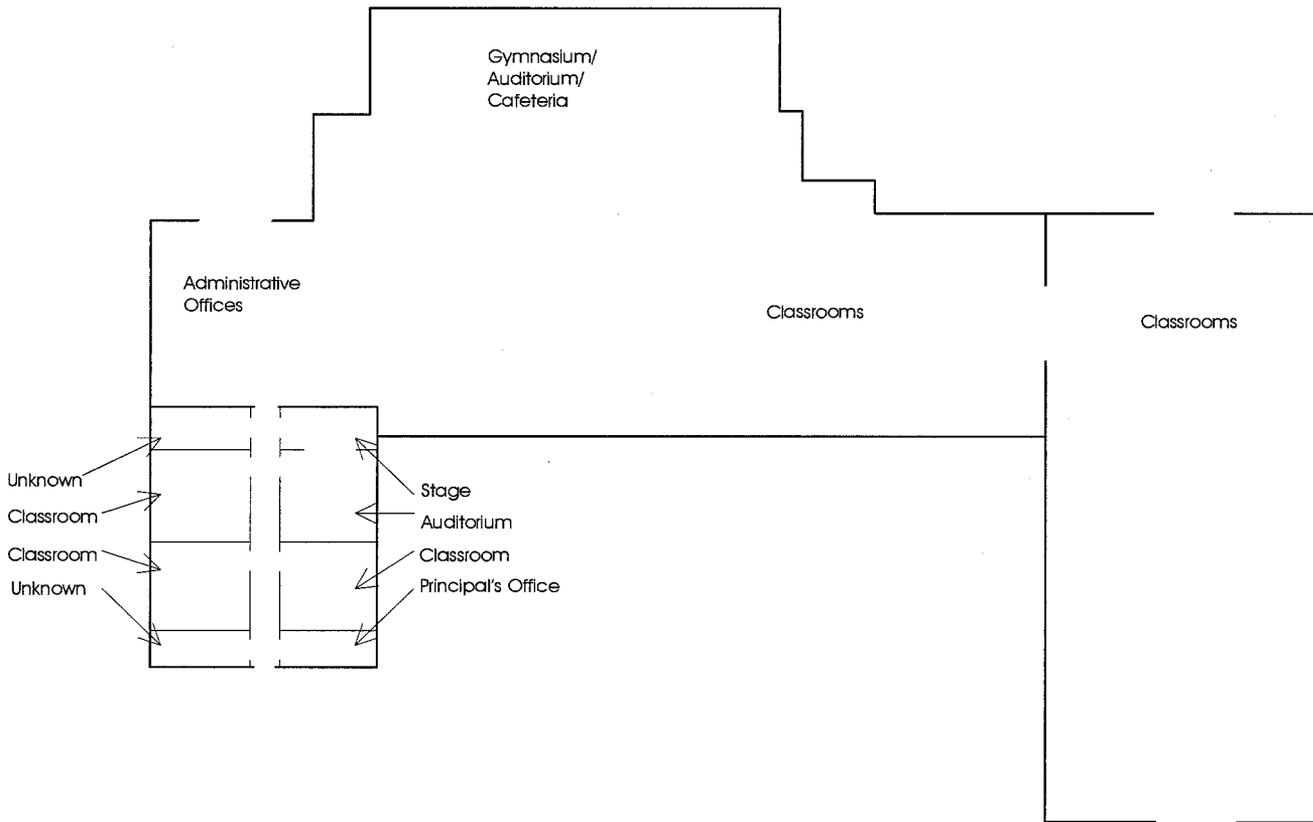
Resource Sketch Map: Floor Plan

A narrow, central passage runs north to south through the 1936 building. Two classrooms and two smaller rooms are located on each side of the passage. The small room in the northeast corner of the building was originally a stage which connected to one of the classrooms. The small room in the southeast corner was originally the principal's office. The interior of the building has a terrazzo floor, plain plastered walls, and a modern tile ceiling. The original doors have been replaced, and the transoms above them have been filled. A simple baseboard runs the length of the passage, and several original radiators remain in place. The north end of the central passage connects to the 1959 addition.

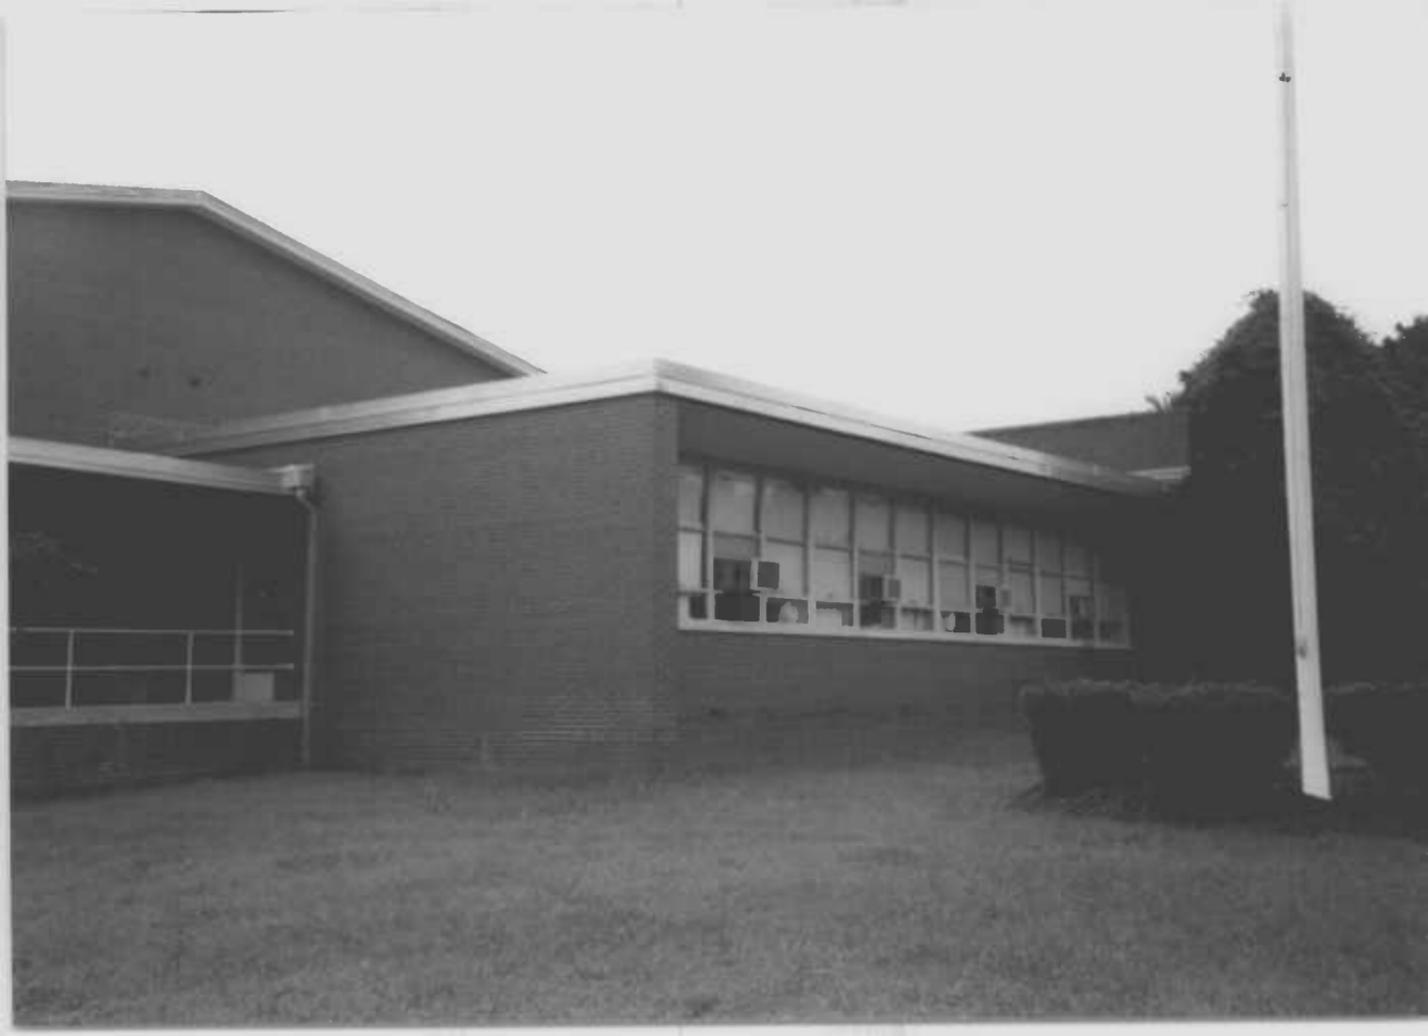
8. 3/2/99

7. INTERSECTION OF HIGHWAY 210 AND ADDITION, VIL. 6 SE

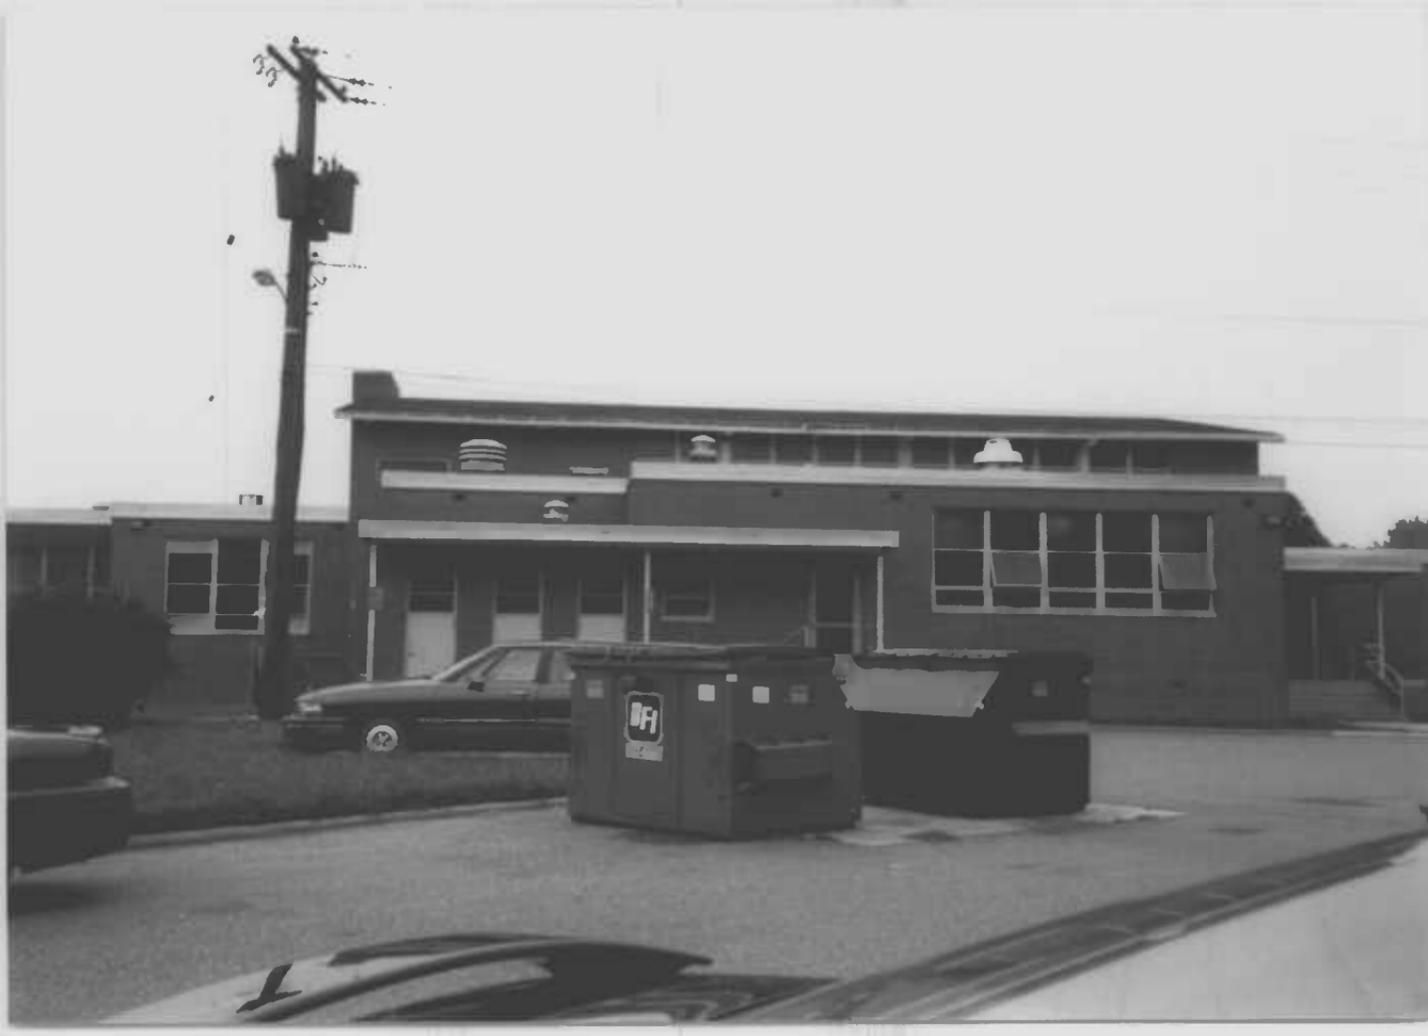
1. AA-2201
2. MPIN 50202
3. 40th ARKILL COUNTY, MD
4. JUNE DARSIE
5. 019
6. MD 2443
- 1959 GYMNASIUM AND KITCHEN, 1. ELEVATION, VIEW 3
8. 5 OF 14

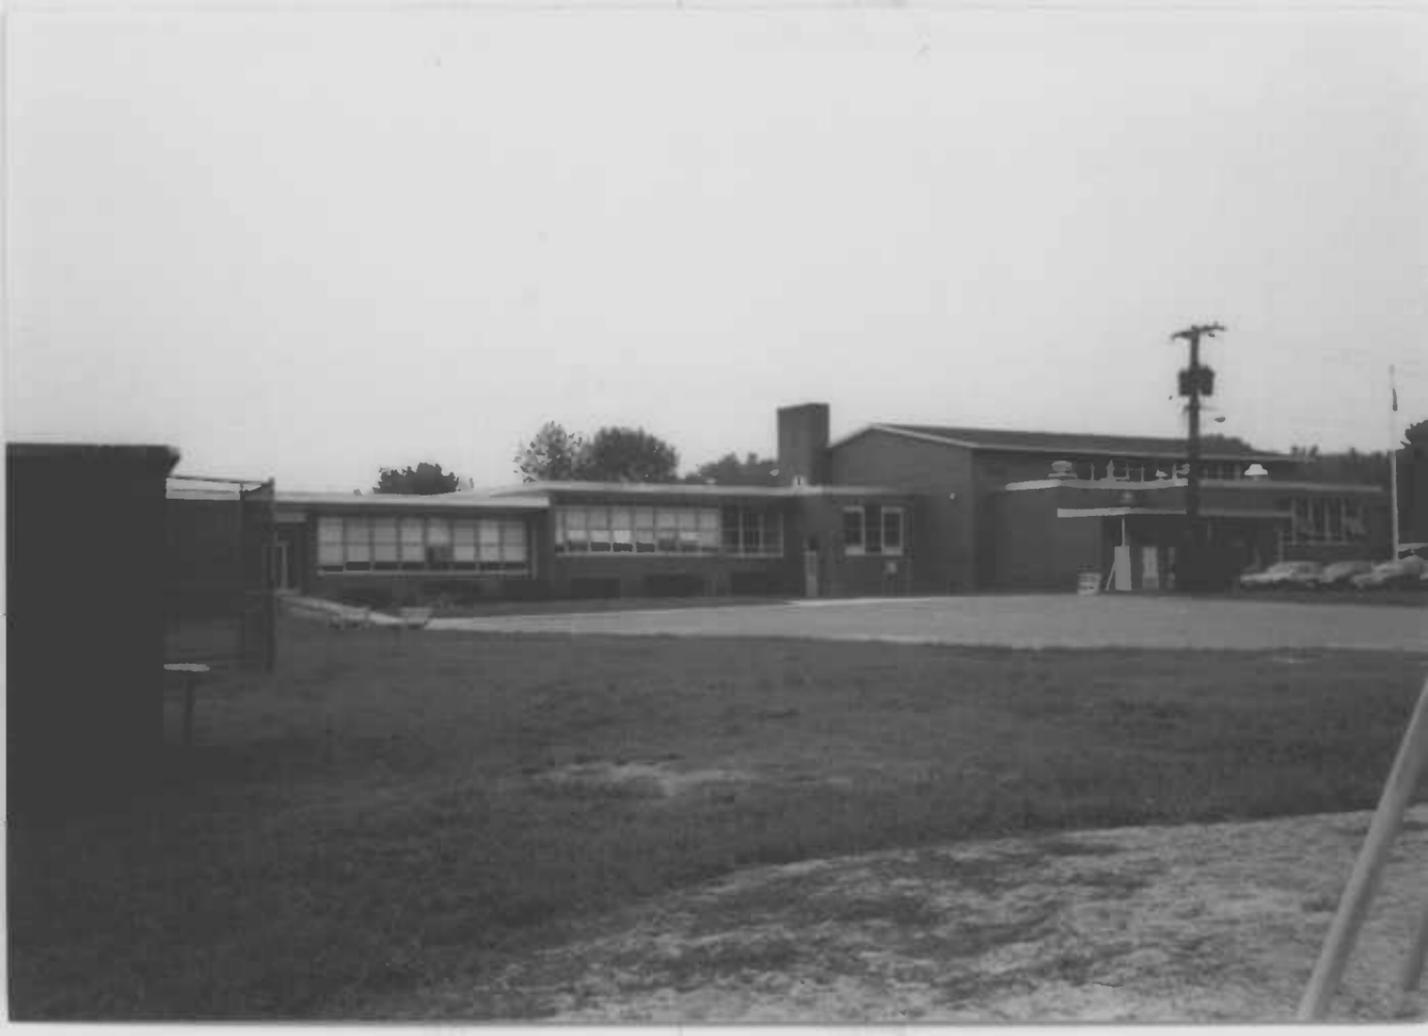
7. 1959 AND 1960'S ADDITIONS, N.W. ELEVATION, VIEW SW

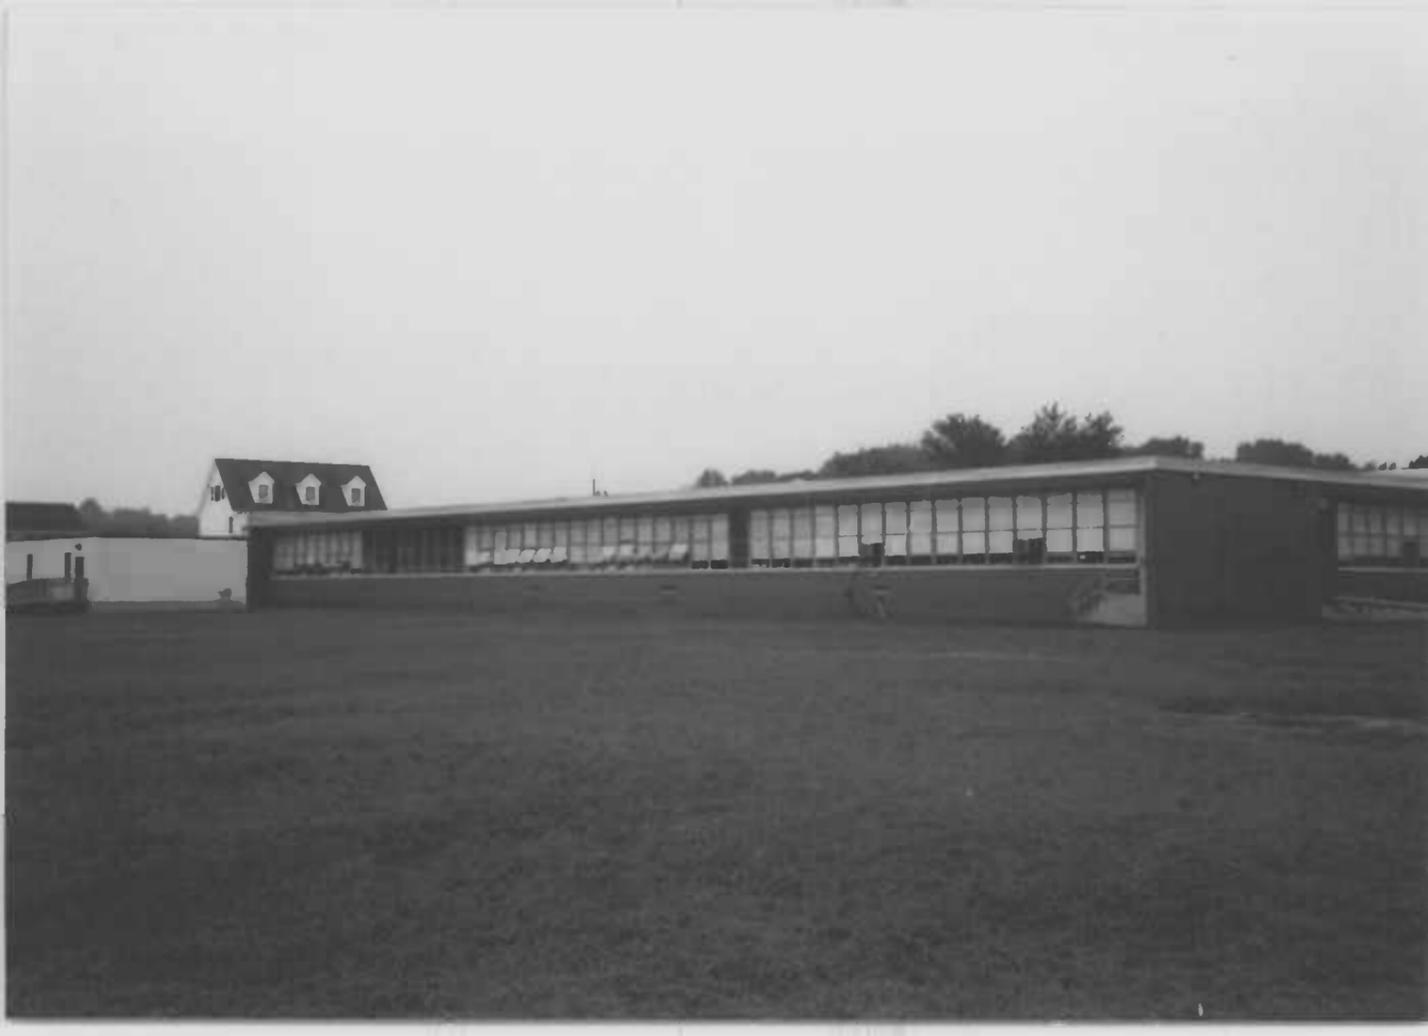
7. 1963 ADDITION, E. ELEVATION, VIEW SW

The 1963 addition extends east and south from the 1959 classroom wing. It has a central passage running north to south with classrooms on each side. Entries are located at each end of the passage. The east and west elevations of this addition have the same bands of awning windows that are found on the 1959 addition.

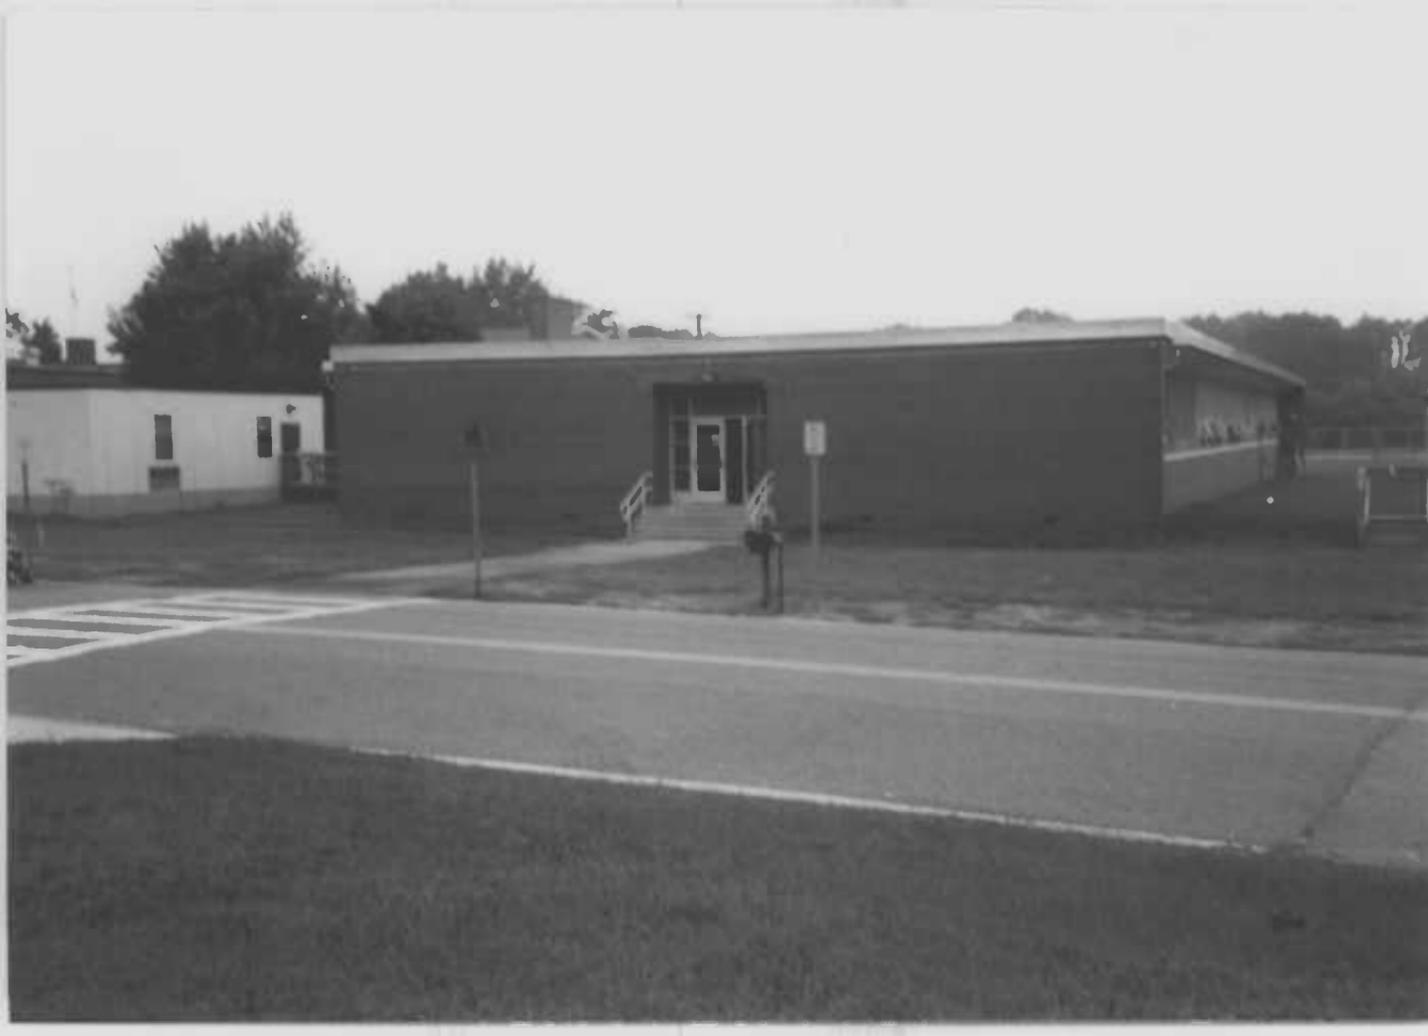
7. 1963 ADDITION, S. ELEVATION, VIEW 1 (5)

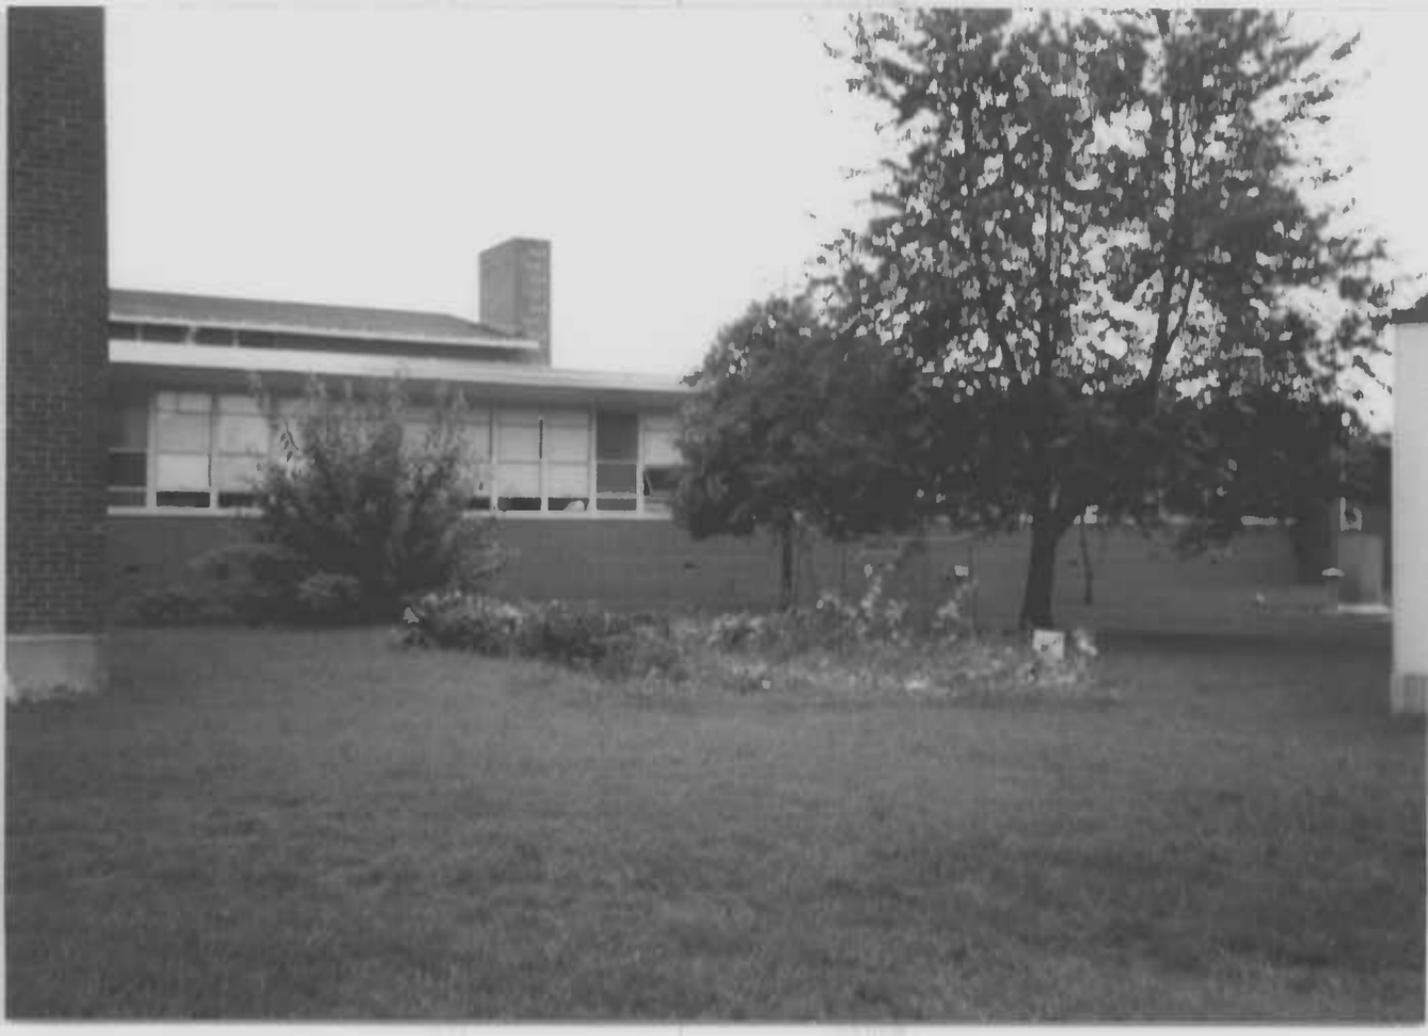
1. AA 2207
2. MAUND SCHOOL
3. ANNE ARUNDEL COUNTY, MD.
4. JOHN DARSE
5. 9/29
6. MD 0443
7. 1959 ADDITION S. ELEVATION, VIEW N.E.
8. 9 OF 14

The 1959 addition consists of administrative offices, a gymnasium/auditorium/cafeteria, and a group of classrooms. The administrative wing extends north from the 1936 building. The wing is constructed of brick and has a low, flat roof. A recessed band of 3-light awning windows stretches across the west elevation. An entry is located on the north elevation. The gymnasium/auditorium/cafeteria extends east from the administrative wing. Also constructed of brick, it is the tallest part of the school complex and has a low-pitched gable roof. A flat-roofed kitchen and service area extends south beneath the clerestory on the north wall of the gymnasium. A small classroom wing extends east and wraps the south wall of the gymnasium. The classroom wing is stylistically identical to the administrative wing and has bands of windows on the north and south elevations.

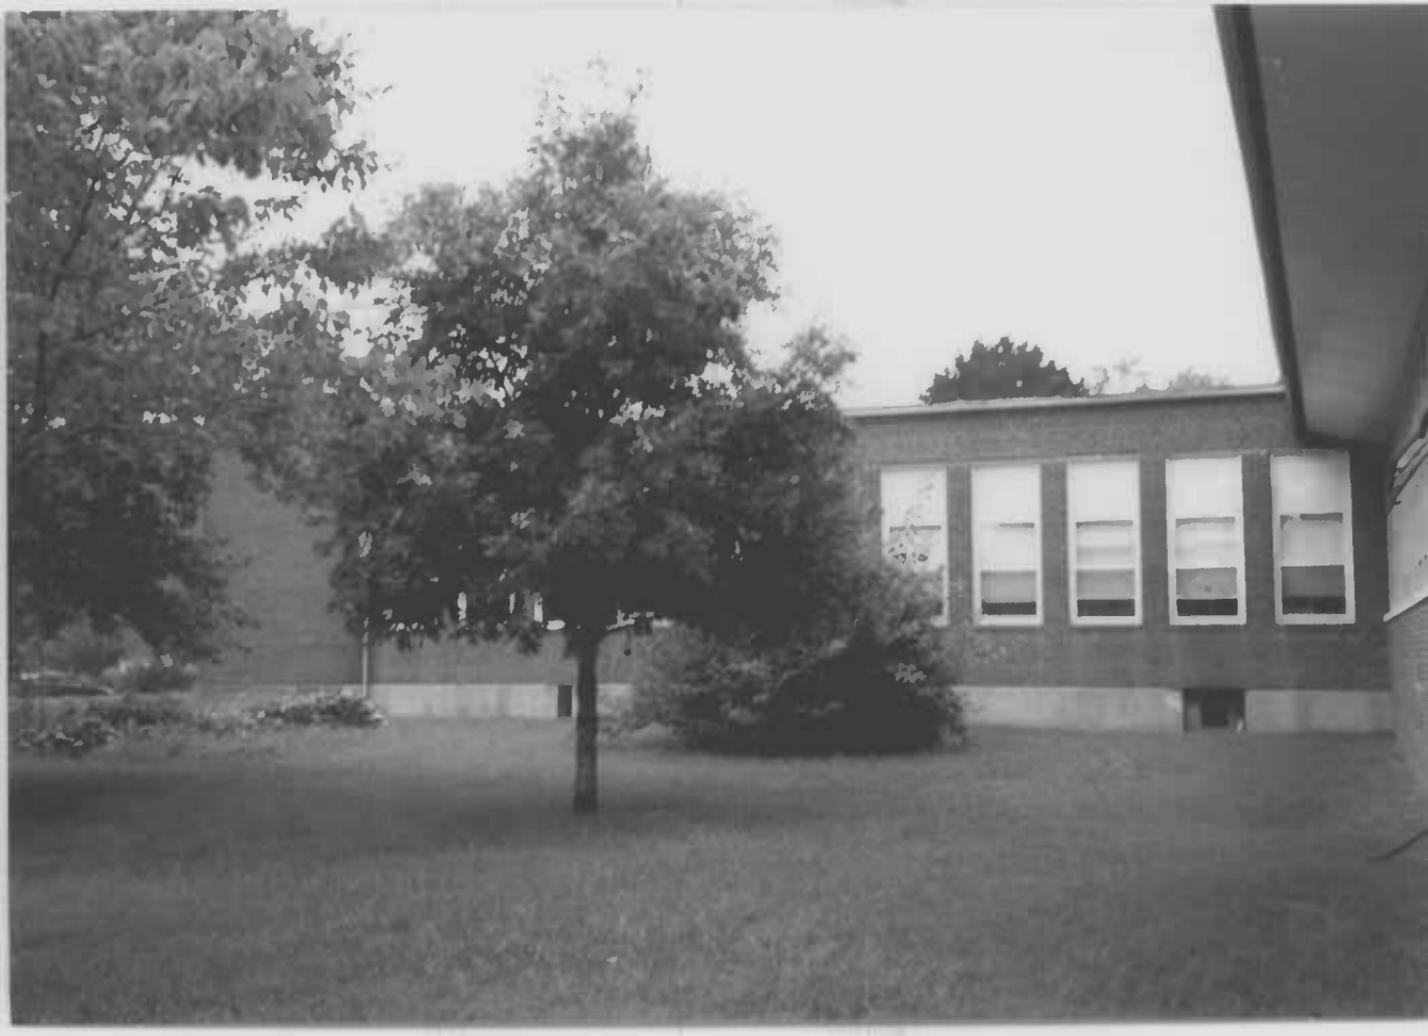
1. AA 2201
2. MAHO SCHOOL
3. ANNE ARUNDEL COUNTY MD
4. JUNE DARSIE
5. 9/99
6. MD SHPO
7. 1936 BUILDING, E. EDUCATION, VIEW W
8. 10 of 14

The west elevation of the 1936 building has 10 windows symmetrically arranged into two groups of five. The north elevation of the building is now obscured by the 1959 addition. The east elevation is identical to the west.

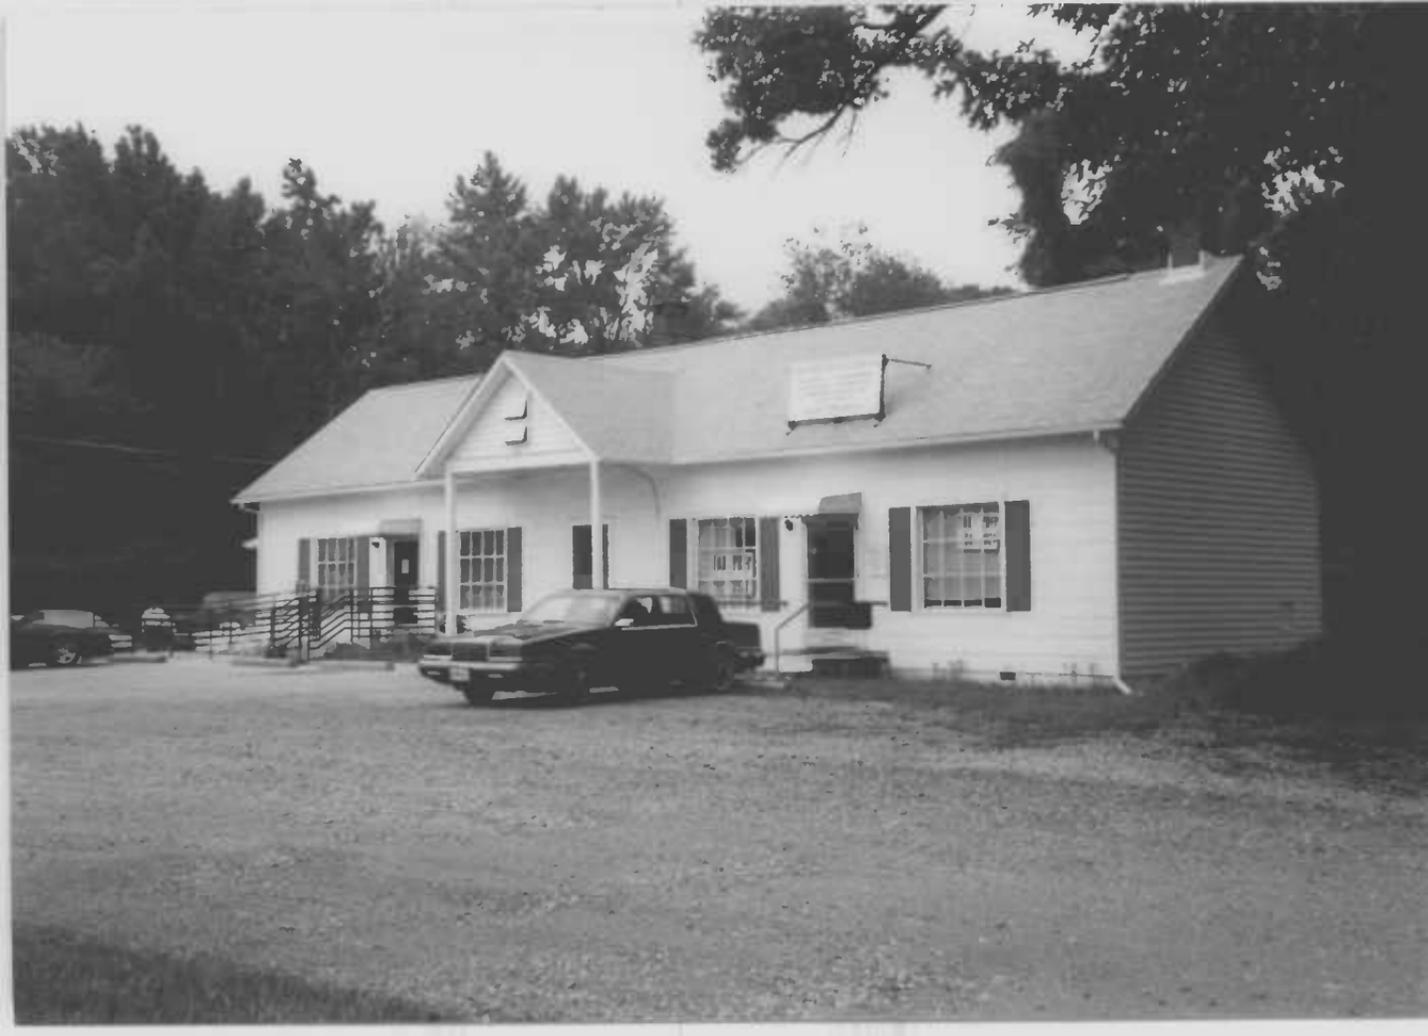
1. AA-2207
2. MARY SCHOOL
3. ANNE ARNOLD SCH 10, 120
4. JUNE DAVIS
5. 9/99
6. M9 SHFO
7. 1927 BUILDING, VIEW. SHF
8. 12 OF 14

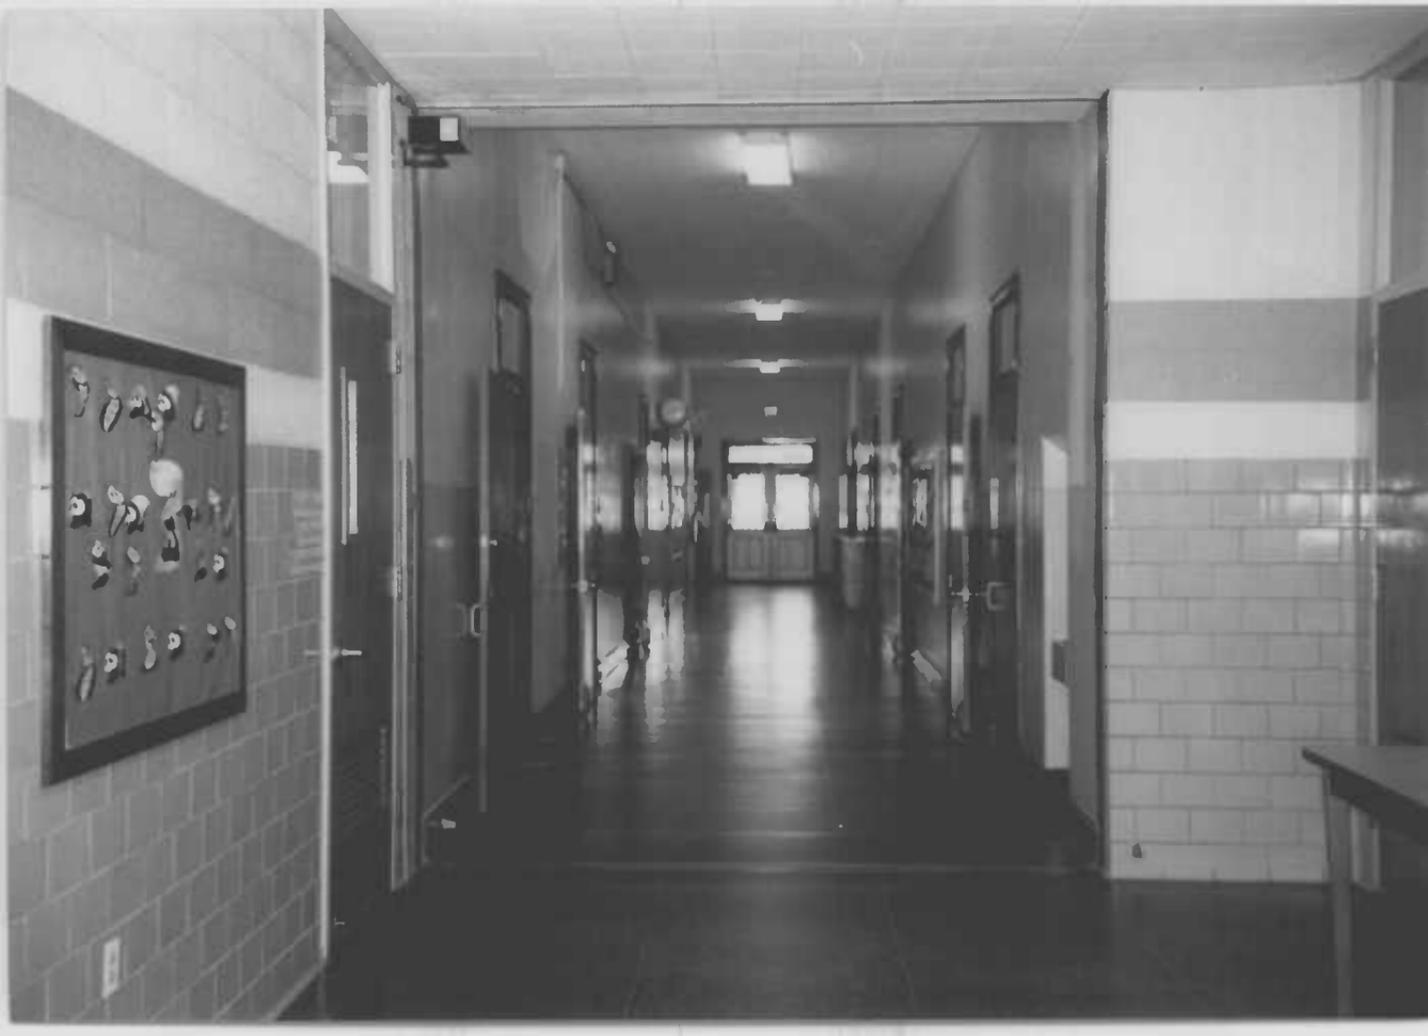
1. 1A-2287
2. MAHO SCHOOL
3. DUNN PROVINCE COUNTY, ME
4. JUNE 1954
5. 1997
6. MO 2492
7. CENTRAL PASSAGE, 1930 BUILDING, VIEW 5
8. 14 of 14

The hall has an original terrazzo floor, original plaster walls, and original baseboards. The baseboards are plain with cyma reversa base molding and quarter round shoe molding. The modern dropped ceiling has modern light fixtures. Modern doors lead from the hall to the rooms. The original beaded door frames remain intact, but the 1-light transoms above them have been filled. An alcove in the north end of the hall contains a modern water fountain. The original doors remain in the south end of the hall, however the entry in the north end of the hall has been completely removed.

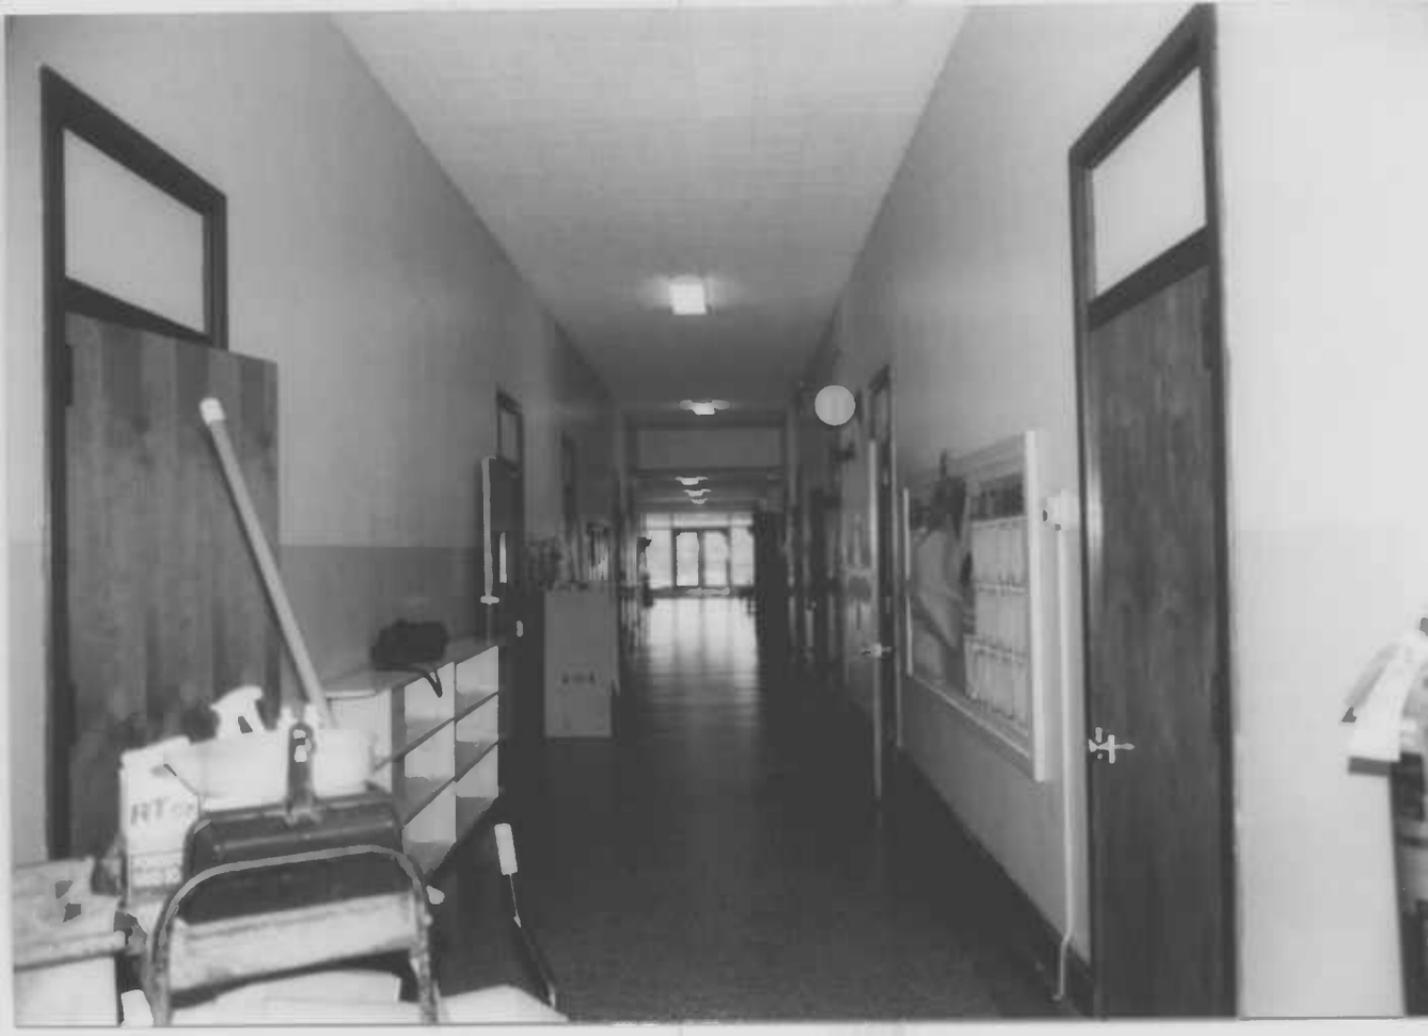
1. AA 2201
2. Wayne School
3. Anne Arundel Co., MD
4. 100 = 200
5. 1122
6. 7-10 2000
7. Center Hall, MD
8. 2 of 15

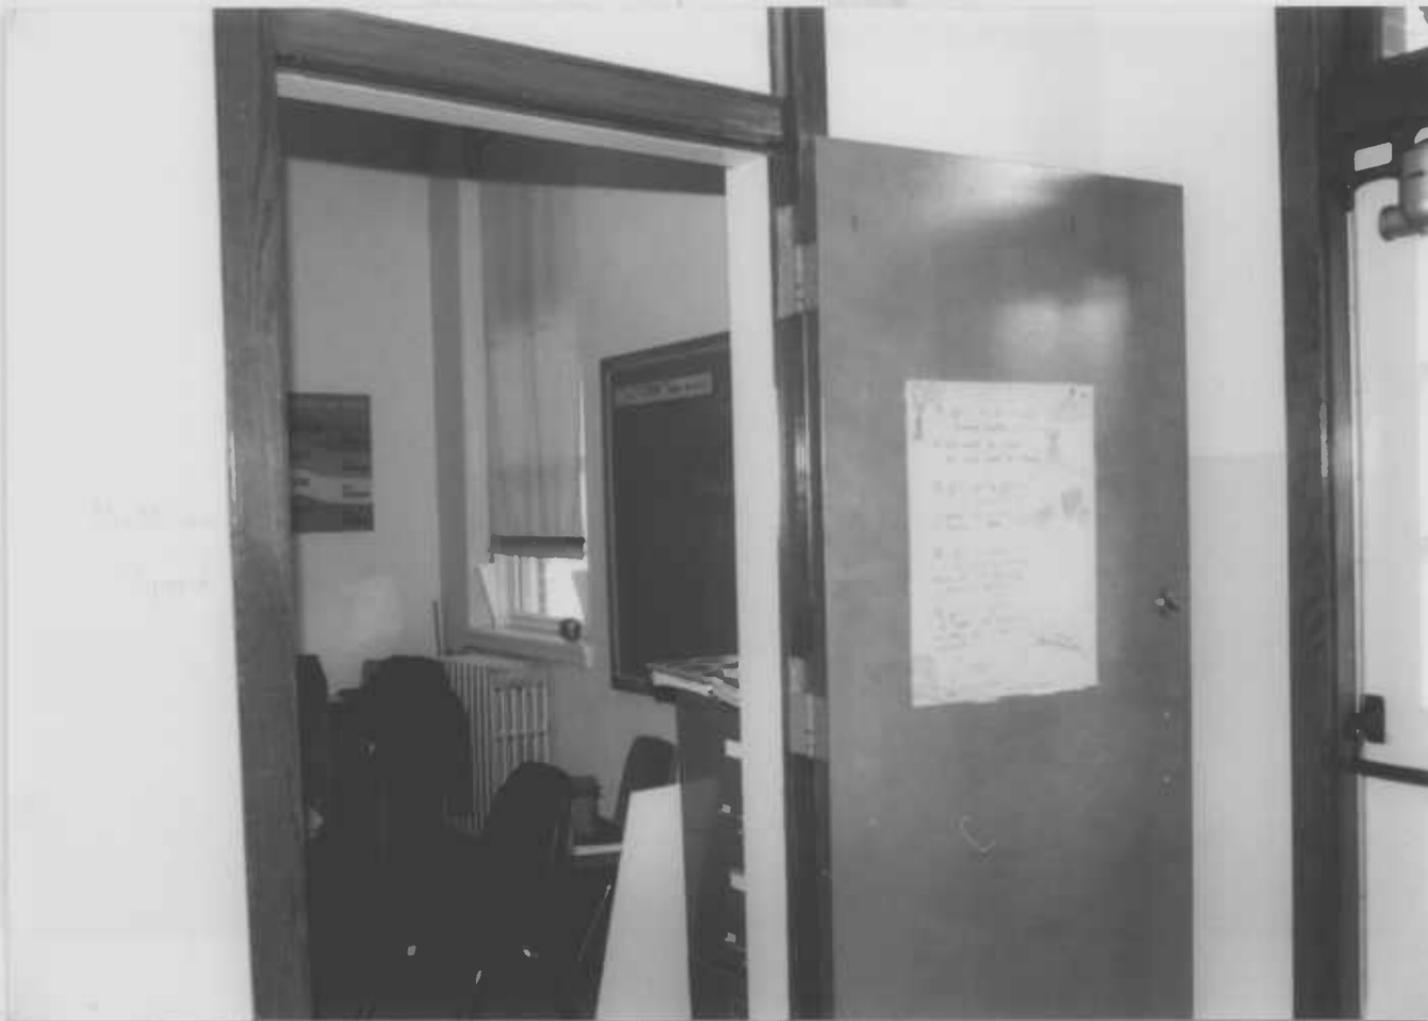
8. 3 of 15

7. can be phoned in office

The former principal's office, now used for tutoring, has a carpeted floor, original plaster walls with baseboards, and an original plaster ceiling with modern light fixtures. An original window frame and radiator occupy the south wall. A modern vent is located on the east wall.

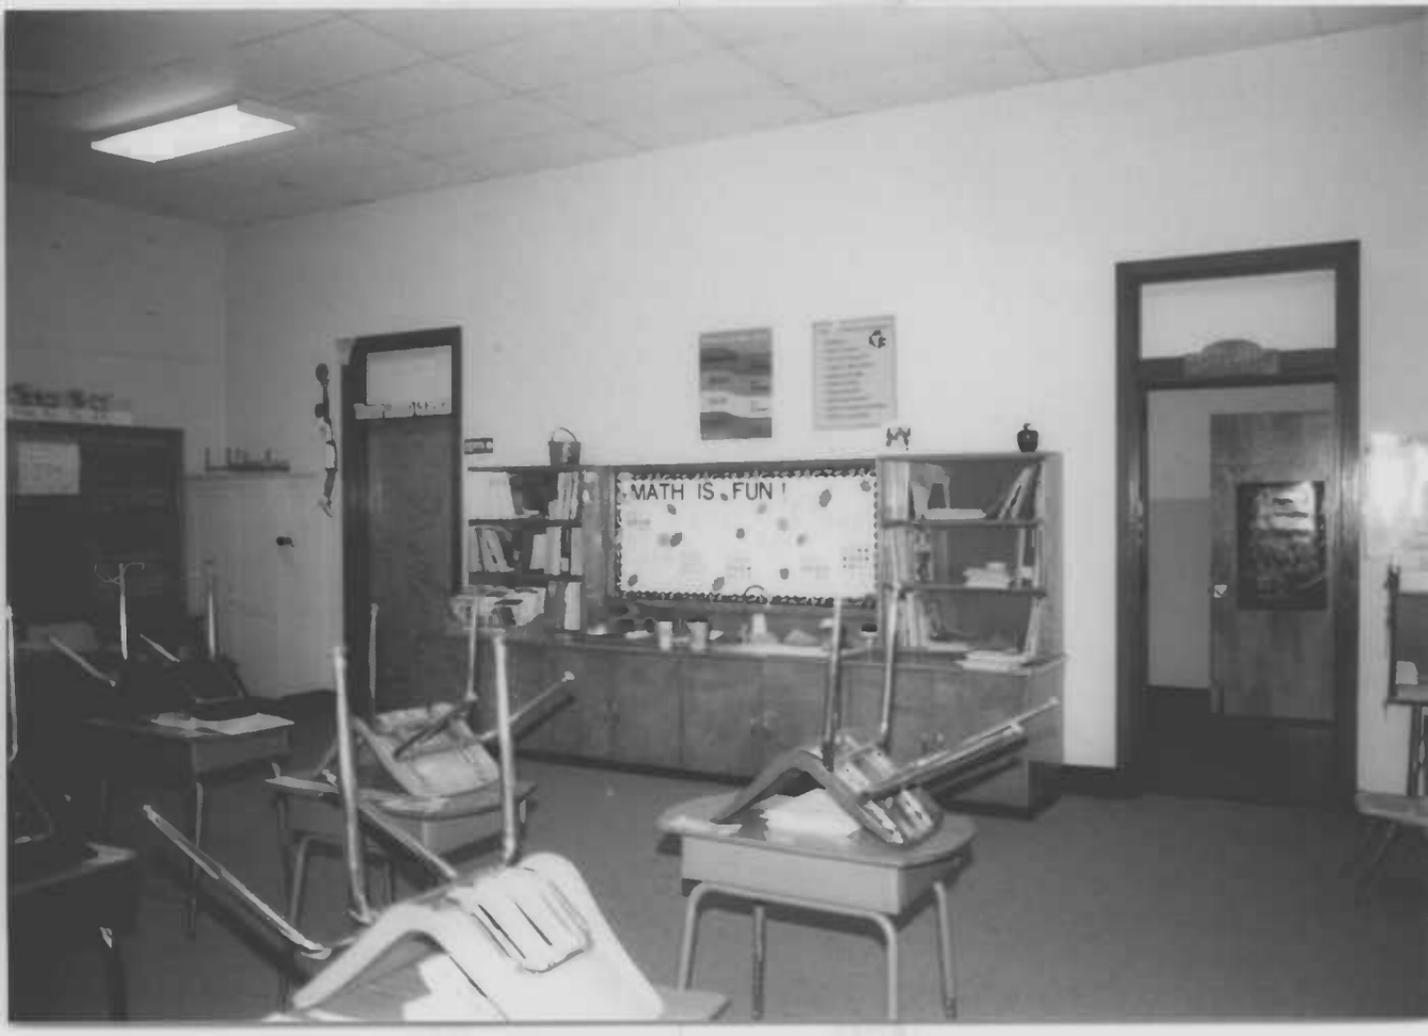
1. AA 2300
2. 11/19/94
3. Anti-Air 24 1 2 11
4. Julie Döring
5. 11/94
6. MD SHD
7. Southeast 01. 12. 1994 SHD
8. 5 of 15

The southeast classroom has a carpeted floor and original plaster walls with baseboards. The dropped ceiling has modern light fixtures. The window frames and radiators remain intact. The classroom also contains one original bookcase and a simple closet. The chalkboards and all other furnishings appear to be of a later date.
