Survey No.: AA-2207

Name: Mayo School

Location: 1152 East Central Avenue, Mayo vicinity, Anne Arundel County

MARYLAND HISTORICAL TRUST
STATE HISTORIC SITES INVENTORY FORM

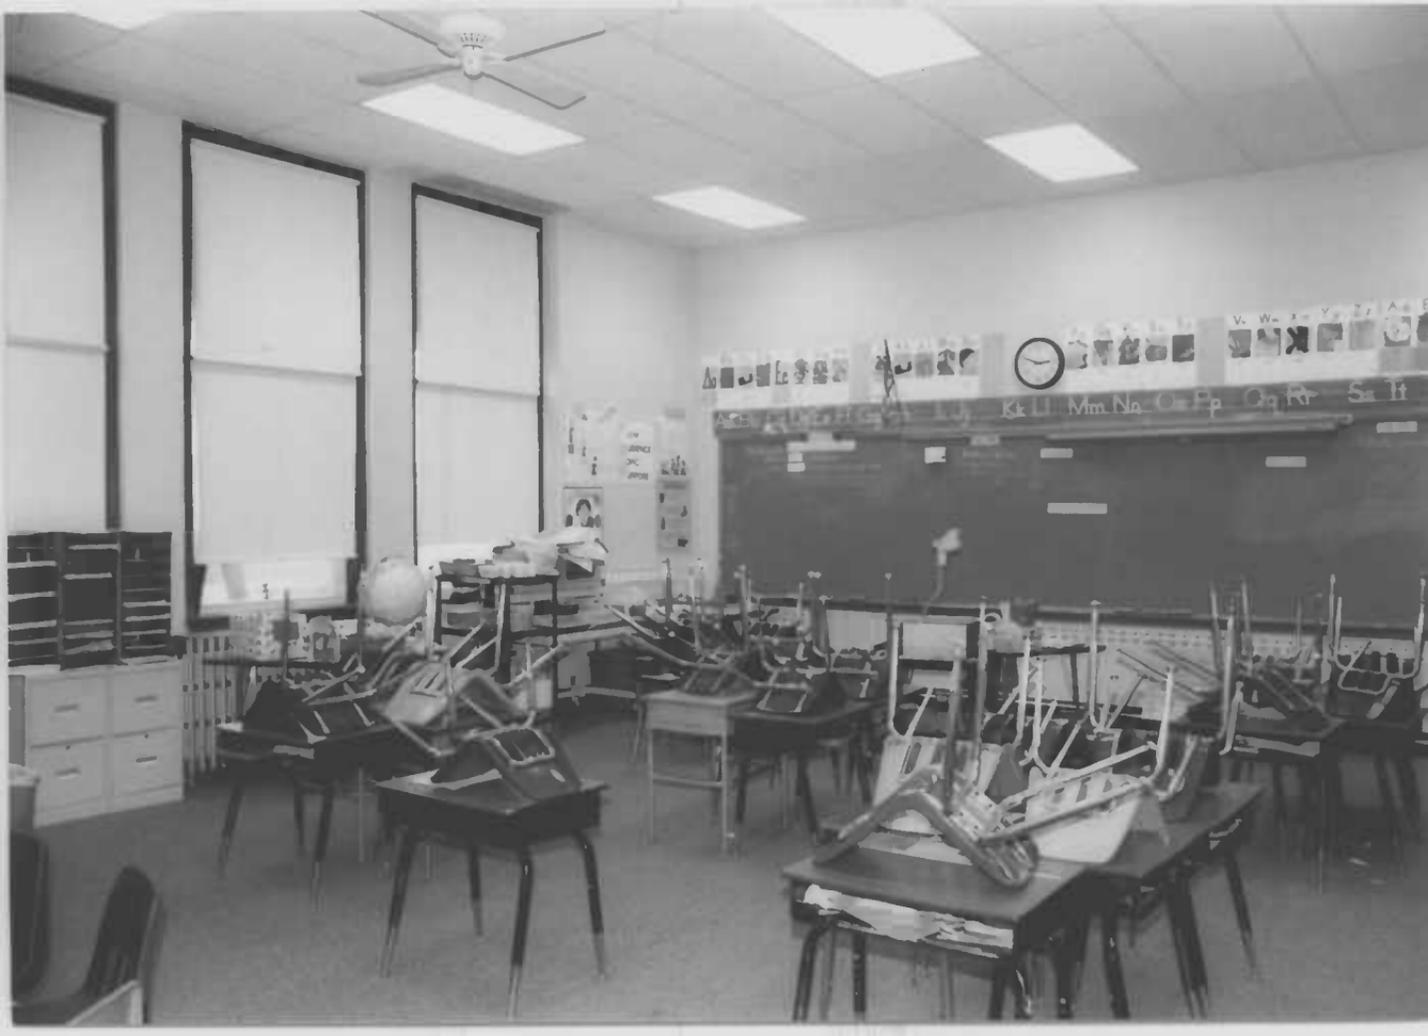
1. RA-2207
2. Mayo School
3. Anne Arundel Co., MD
4. Late 19th C.
5. 1/24/11
6. MS SH 2
7. *Fumar didiformis* / Northeast classroom, View SE
8. 6 of 15

The former auditorium, now the northeast classroom, has a carpeted floor, original plaster walls with baseboards, and a dropped ceiling with modern light fixtures. The window frames and radiators remain intact along the east wall. This room has no original built-in furnishings or closets. The stage, which formerly opened along the north wall, has been completely covered so that no visible evidence of it remains in the classroom.

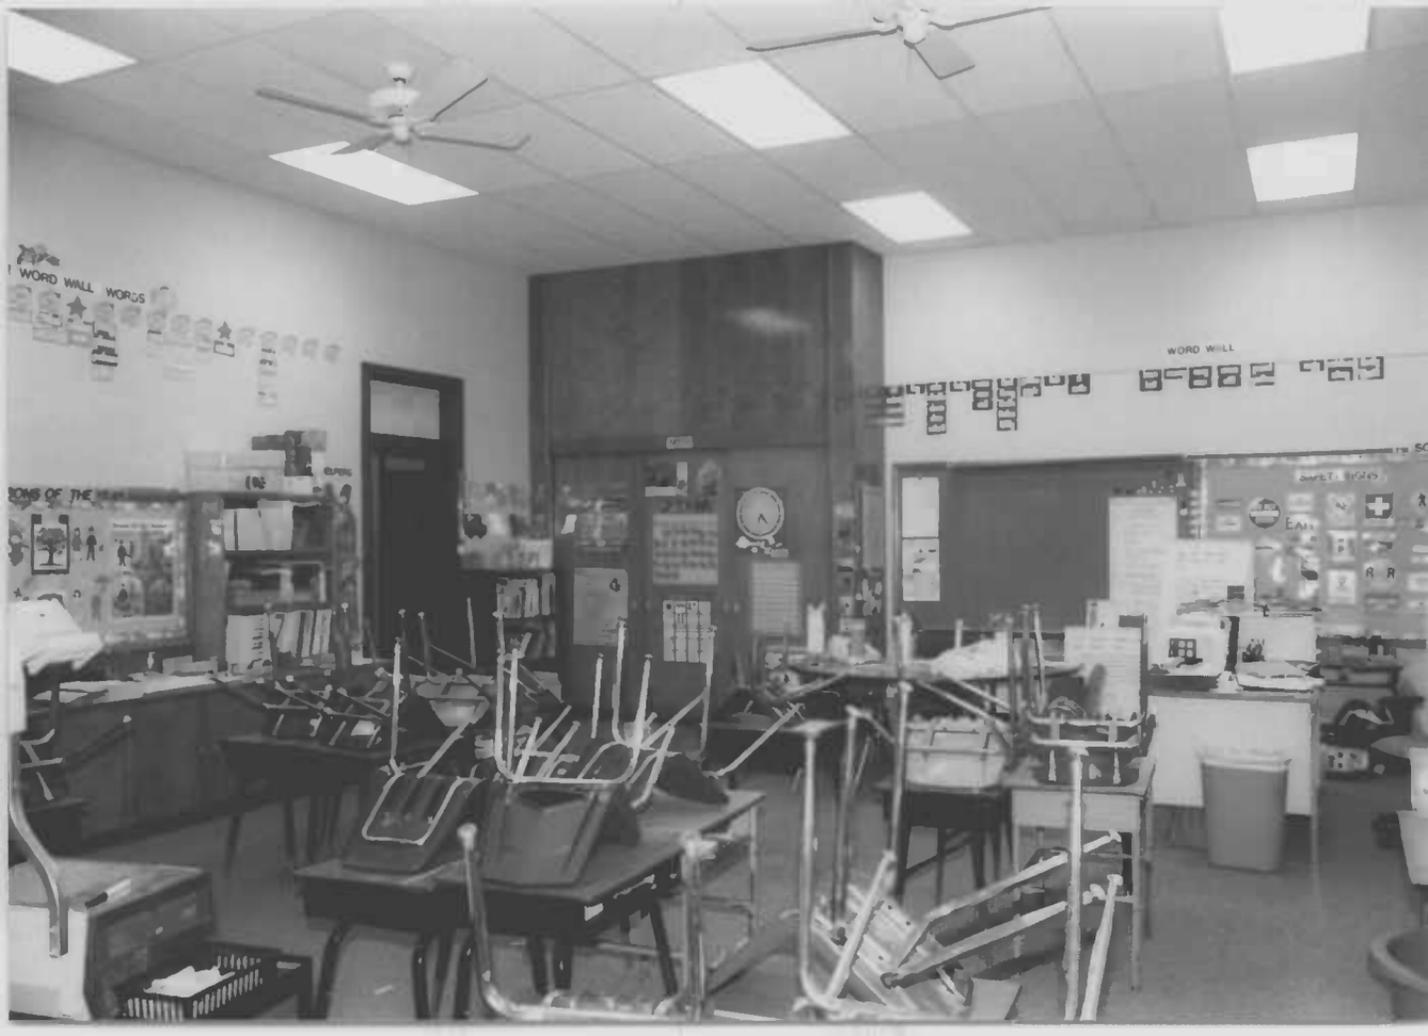
7. Former auditorium / Northeast classroom, large NW
North wall was formerly open to stage

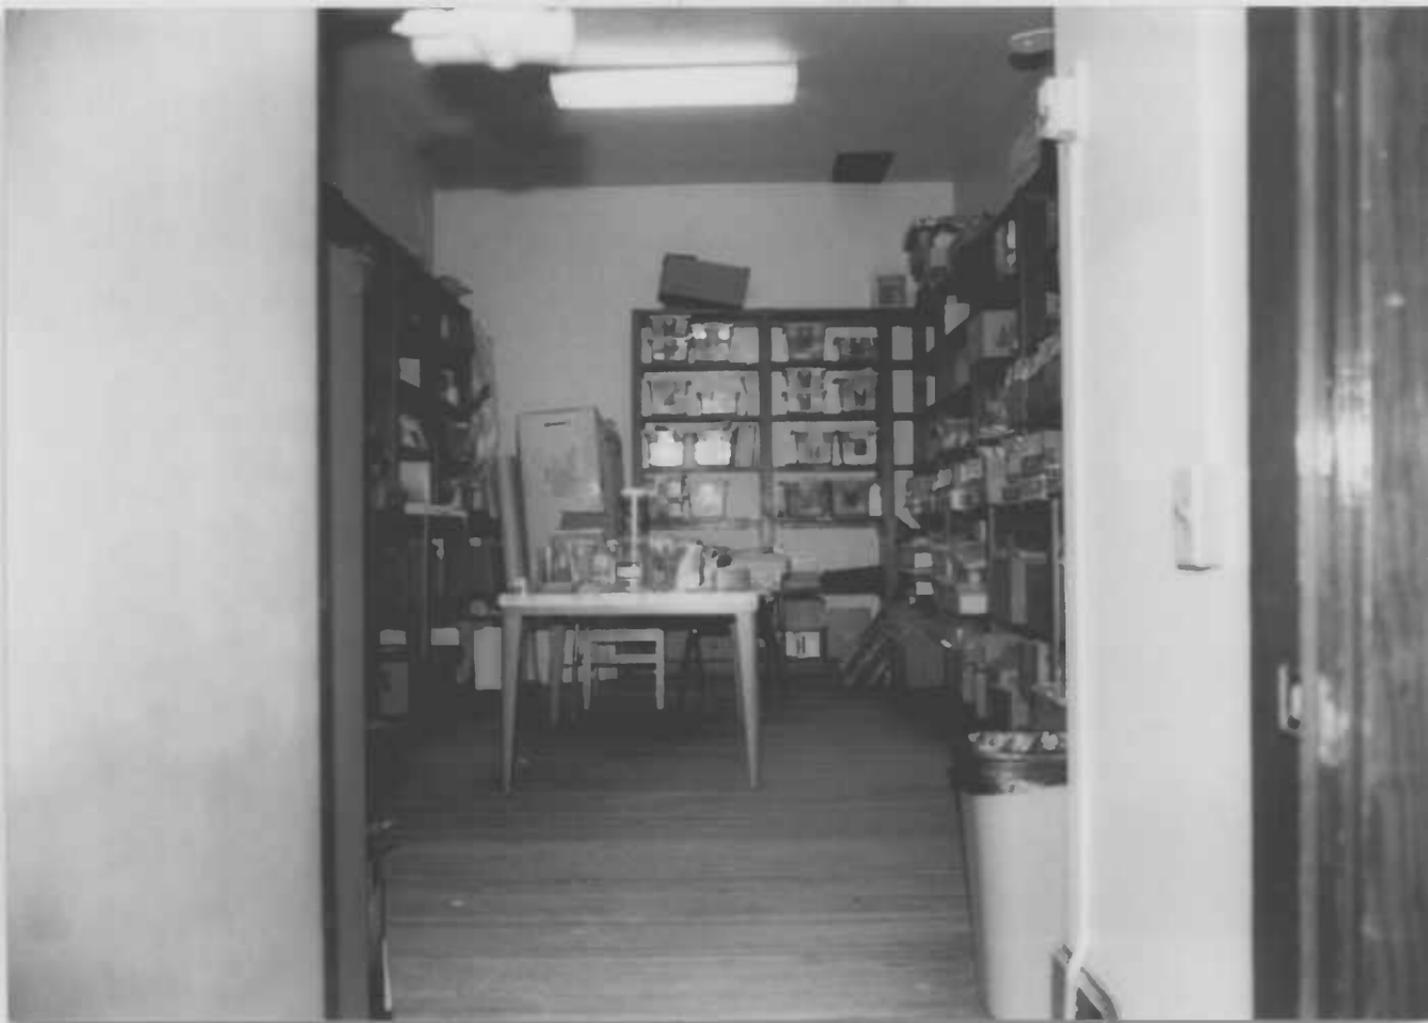
1. AA 2207
2. Mayo School
3. Anne Arundel Co., MD
4. Julie Duce
5. 11/29
6. MD 0121
7. Former Clays, Road E
South wall was formerly open to and facing
2. 4 of 15

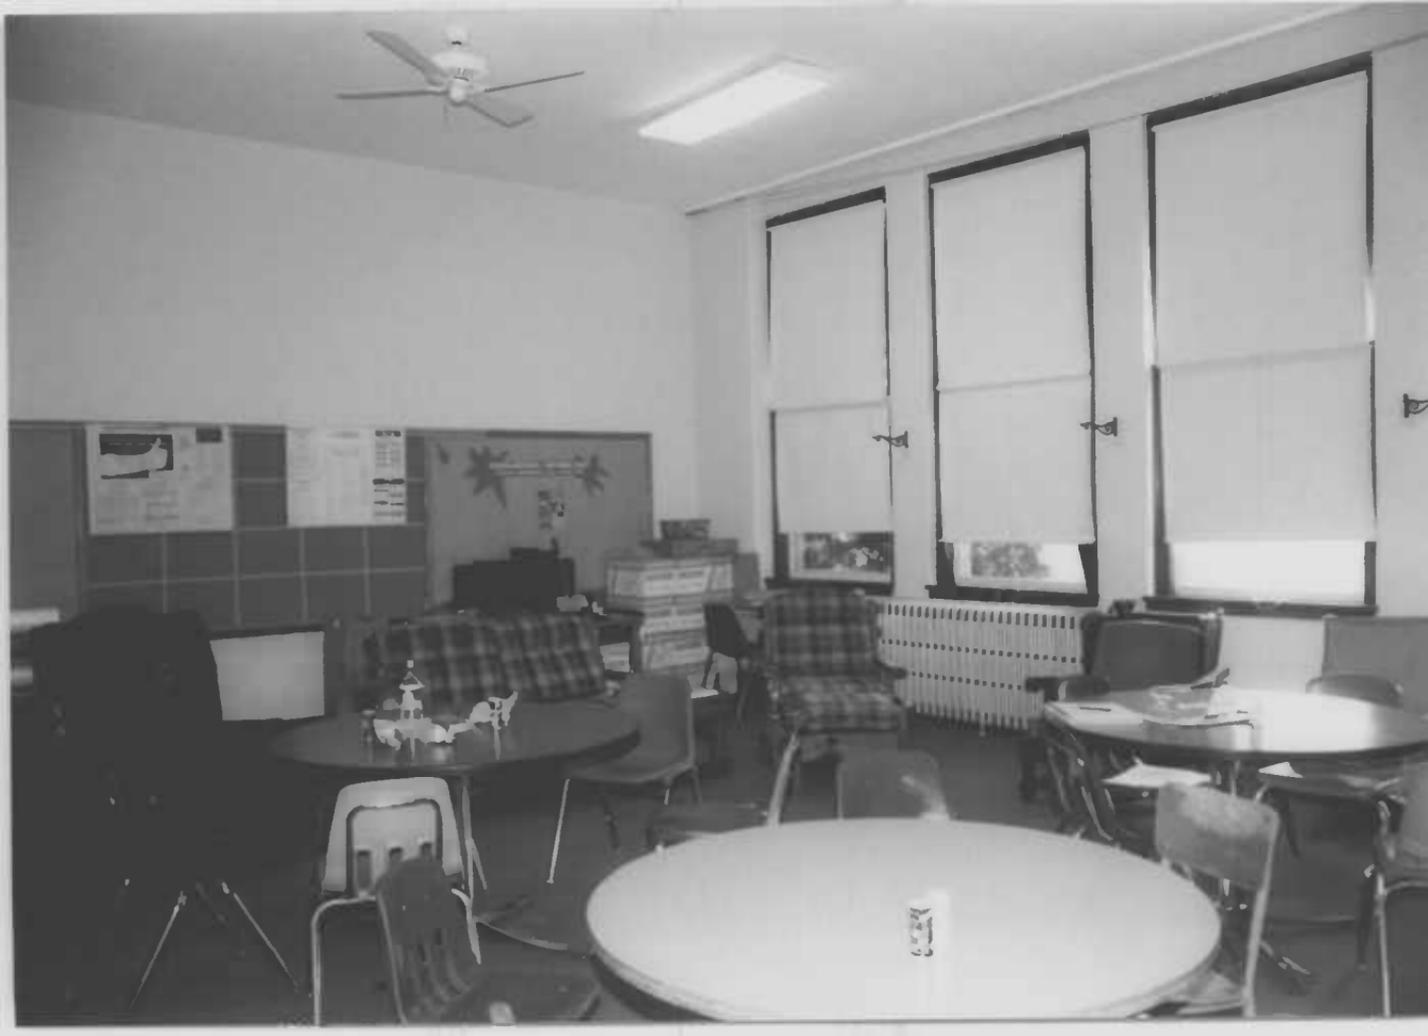
7. Northwest Classroom, View SW

The northwest classroom has a carpeted floor, original plaster walls with baseboards, and an original plaster ceiling with modern light fixtures. Original window frames and radiators remain along the west wall. The classroom also contains an original built-in bookcase and a simple closet. The chalkboards and other furnishings are later.

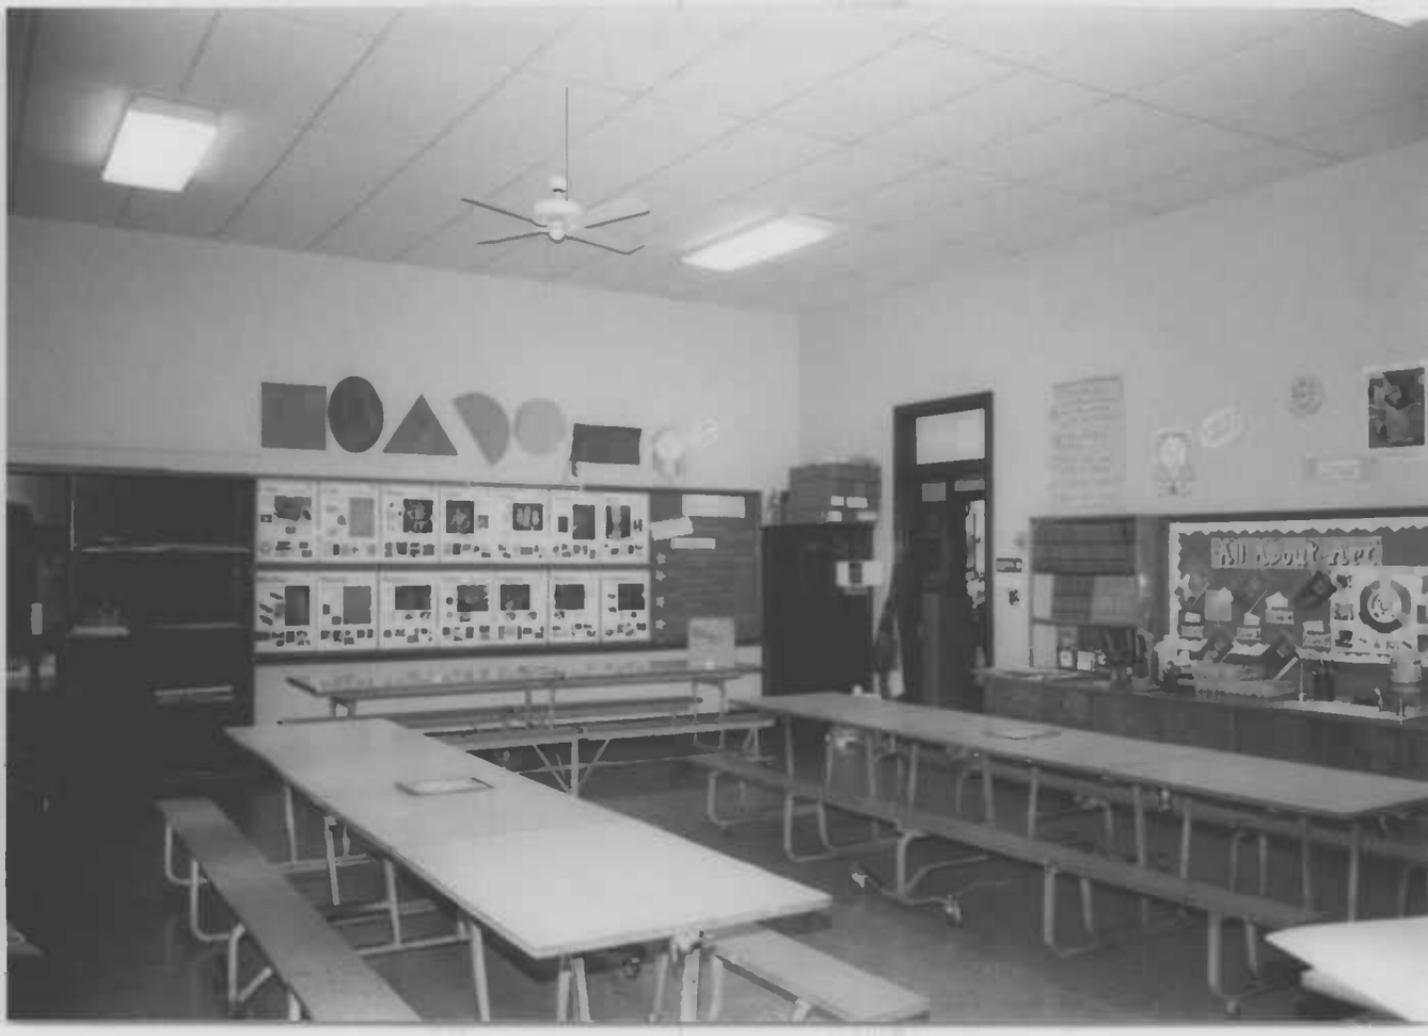
1. AA 2267
2. Maya Sanchez
3. Anne Heindel Co., NLD
4. Julie Druse
5. 8' 20"
6. NLD SHPO
7. SW classroom, View: NE
8. 13. 27. 15'

The southwest classroom has a modern tile floor, original plaster walls with baseboards, and a dropped ceiling with modern light fixtures. The original window frames and radiators remain intact. The classroom contains one original built-in bookcase and a small closet. The chalkboards and other furnishings are later.
