**MARYLAND HISTORICAL TRUST
NR-ELIGIBILITY REVIEW FORM**

Property Name: Ensor (Terveer) House Inventory Number: BA-2936

Capsule Summary

7. Description

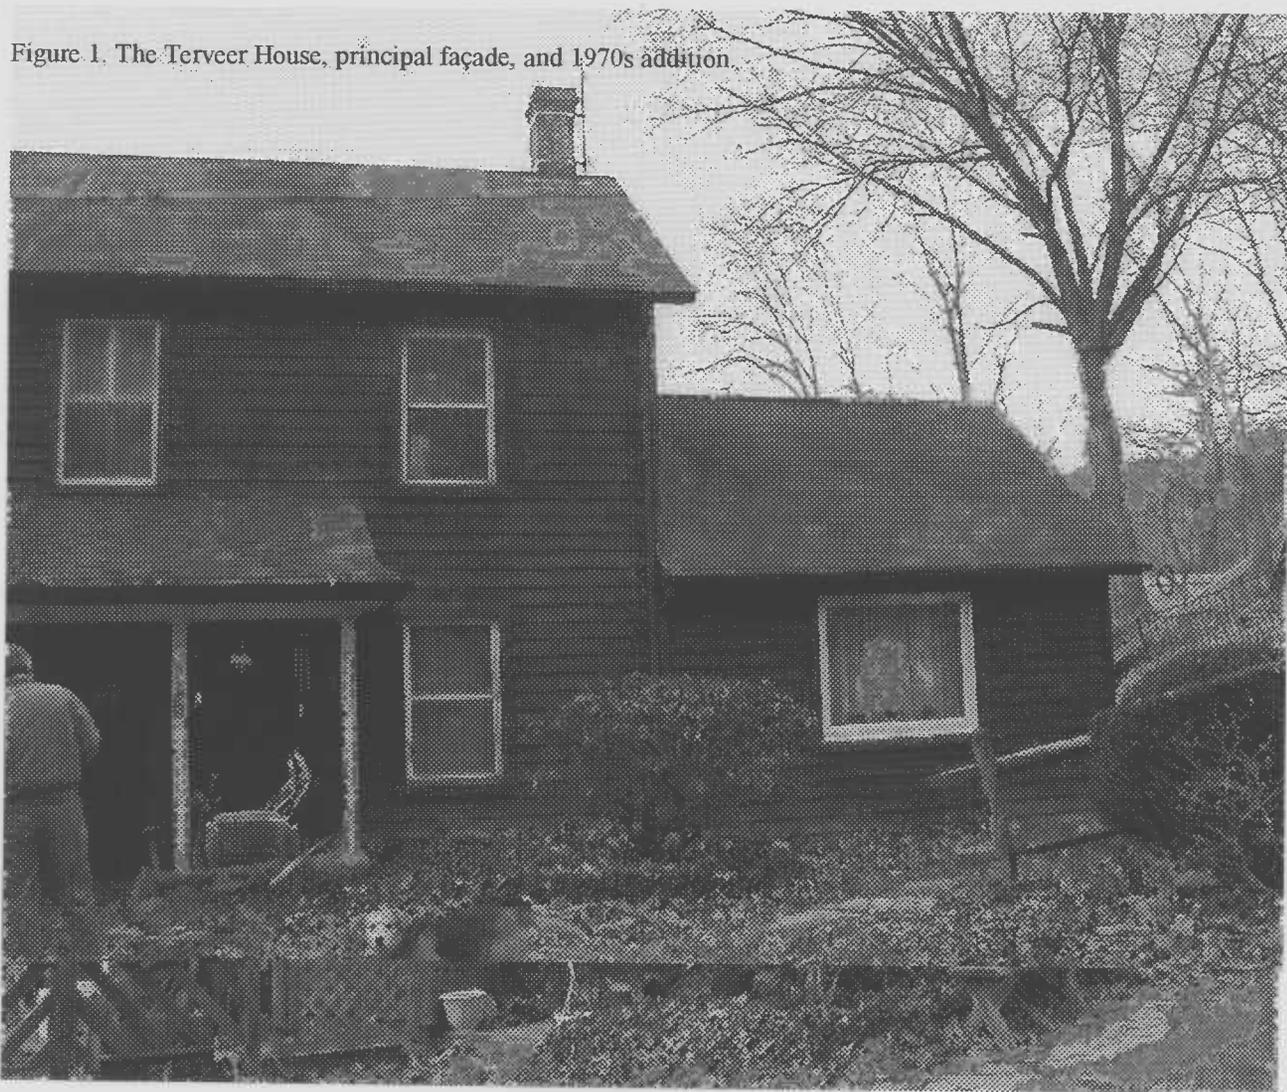
Figure 1. The Terveer House, south and east (principal) facades. Note addition and second floor central window.

Additions, replacement siding and roofing, nearly total window replacement, coupled with a modern gentrified yardscape and rusticated modern garage, detract from the ensemble of materials, design motifs, and overall character of this building that would otherwise have marked it as a good example of fin-de-siècle vernacular architecture in the Chesapeake Basin. The site lacks those qualities that would make it eligible for inclusion into the National Register of Historic Places under criteria A through D, 36CFR60.

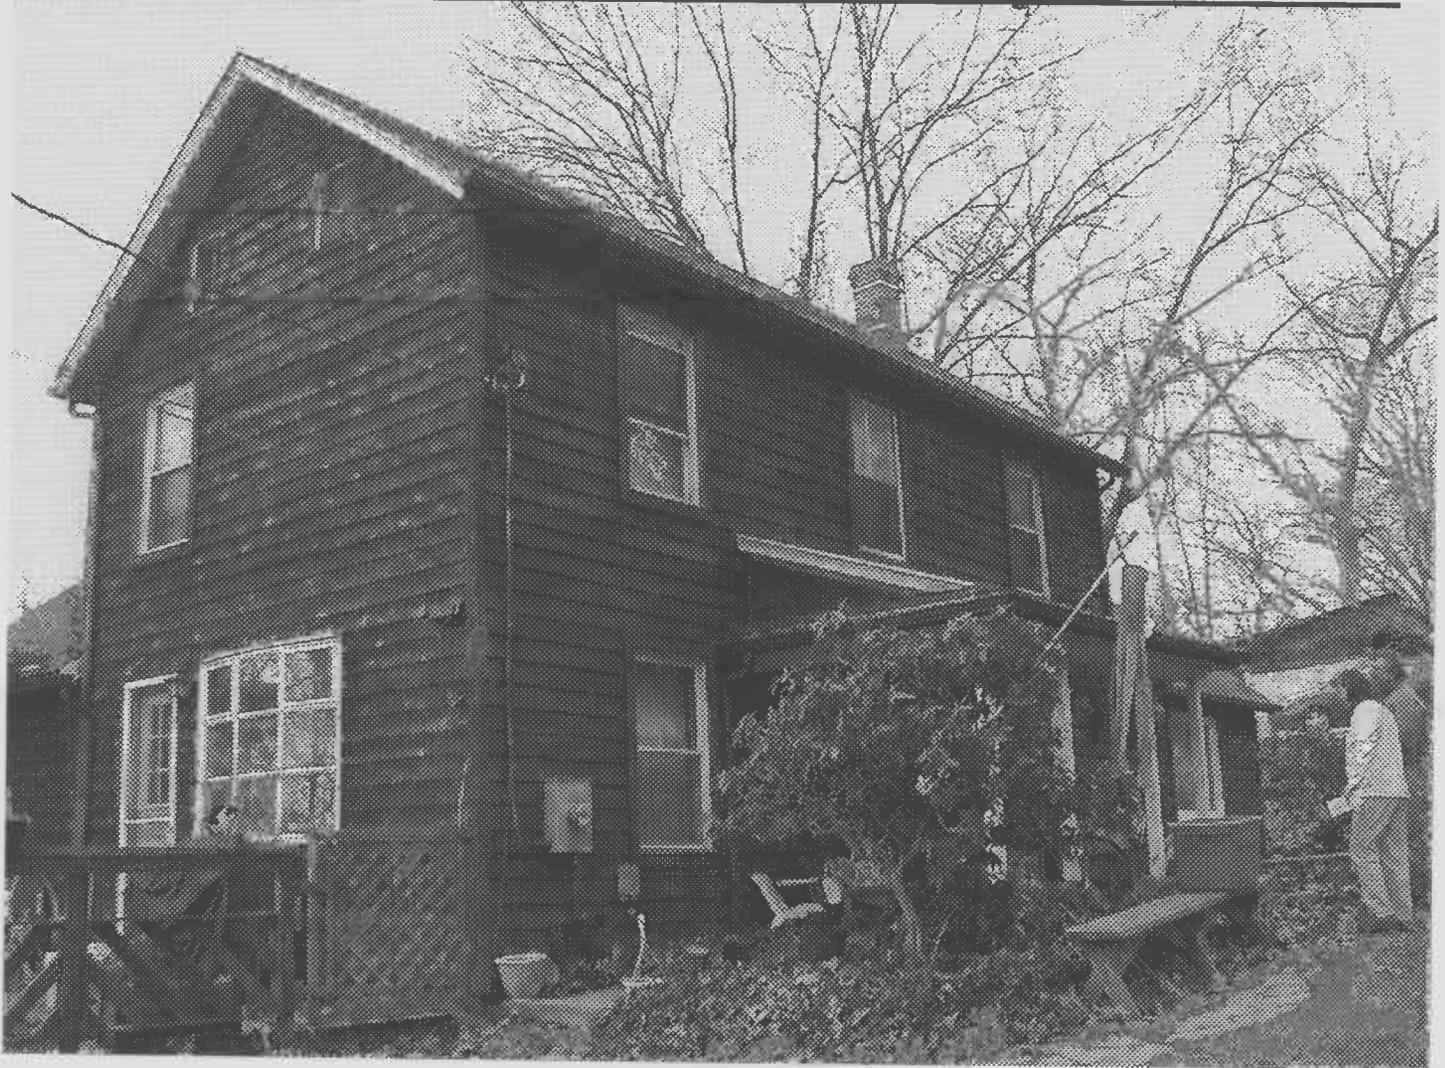
Figure 2. The Terveer House, south and east (principal) facades. Note bay window and deck.

This late 19th-century dwelling occupies a steep slope, fronting on Ensor Mill Road (uphill) and commanding an expansive view of the valley from the rear of the building. It is a simple vernacular farmhouse constructed on stone foundation with a 3-bay, central entrance, two-room deep plan, 2-stories, and a simple shed-roofed entry porch; the latter a recent addition constructed of milled dimension lumber on a wooden board deck. The interior end stove chimney has been repointed but the cap retains its original flared corbelled finish. Asphalt shingles replaced the original shake roof and nearly all of the windows have been replaced with 1/1 double-hung sashes, the central second floor 2/1 double-hung window excepted. Shake siding covers what probably was a horizontal siding and plain board moldings frame each of the windows. A large one-story addition, erected by the current owners (1972+) extends off the north façade. There is an earlier rear ell not directly accessible, but renovated at the same time as the remainder of the building. A divided light bay window and elevated deck have been installed on the south façade.

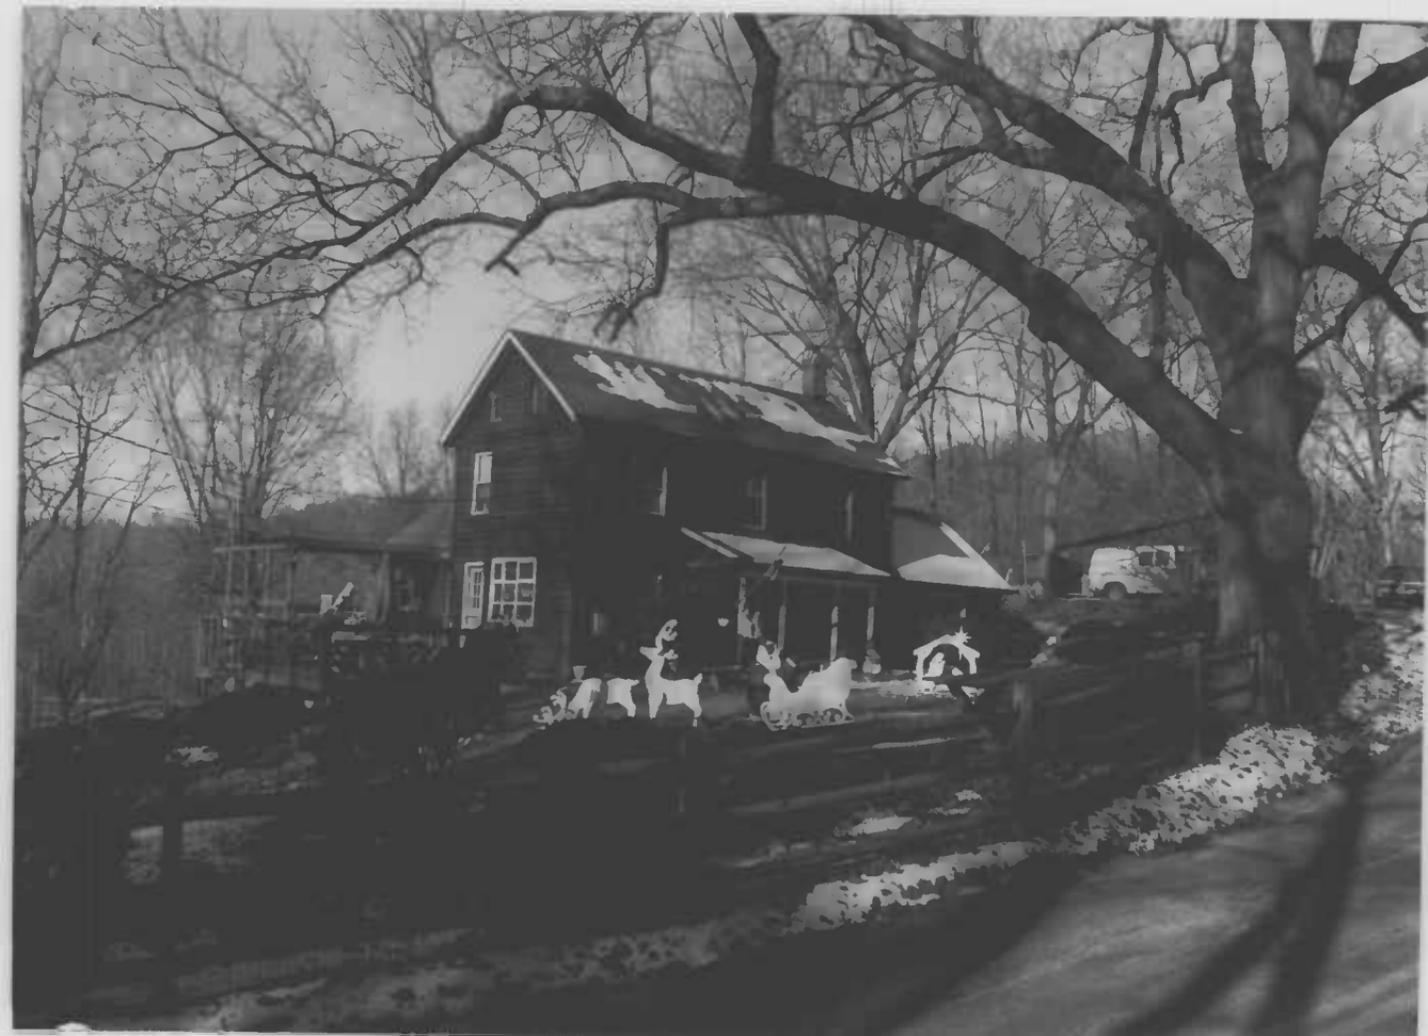
BA - 2936

View of Ensor House from Ensor Mill Road.

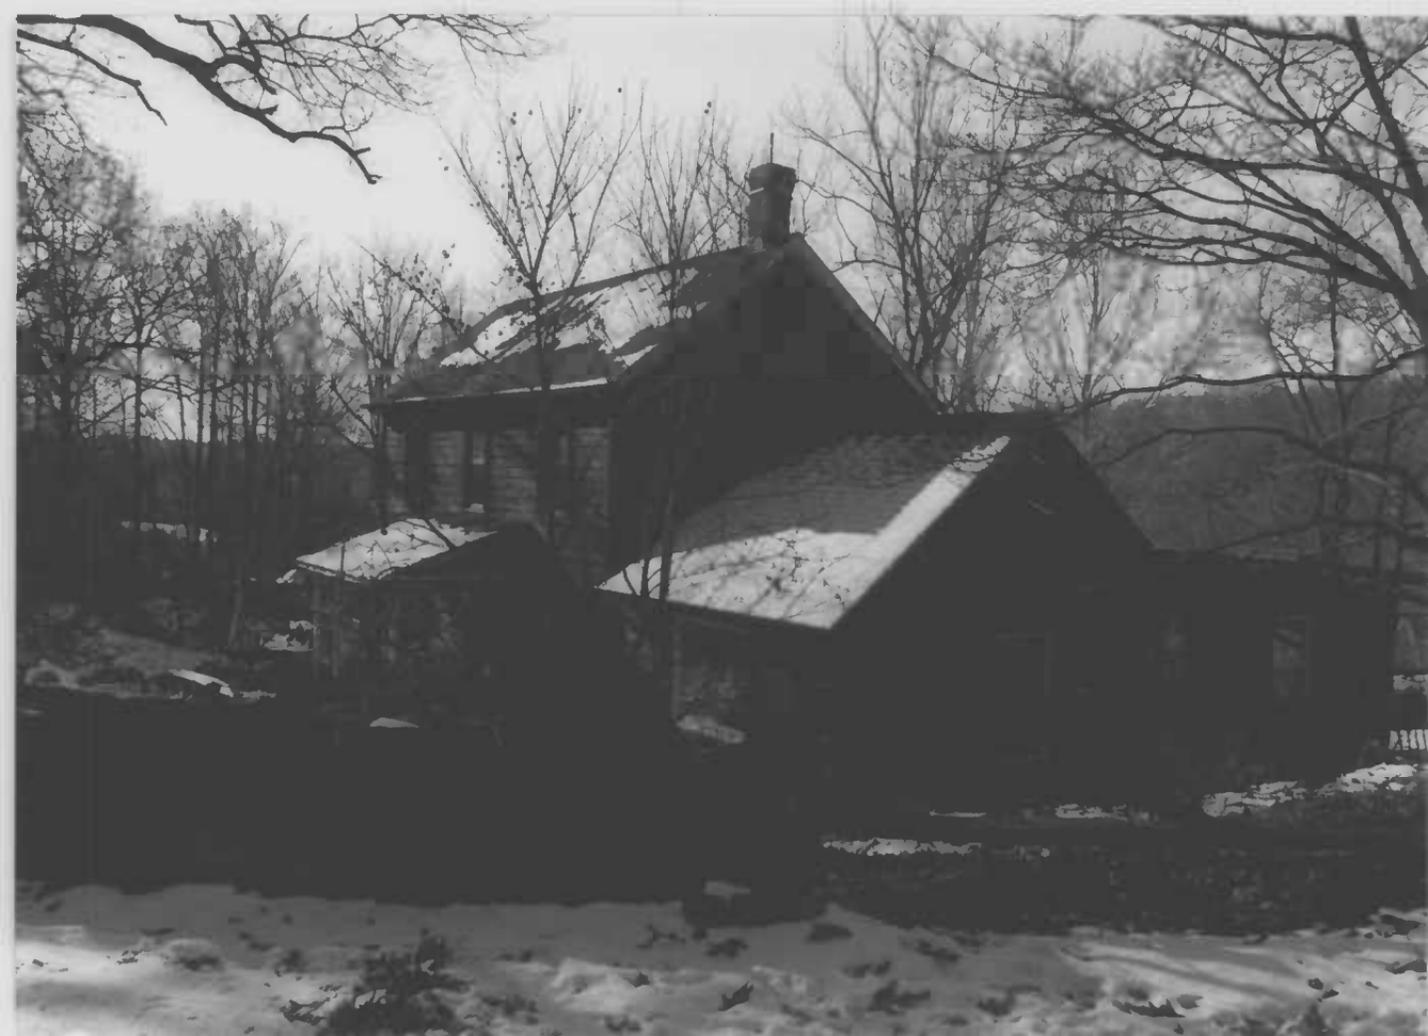
BA - 2936

View of Ensor House facing southwest.
