BA-3078

10517 Liberty Road  
Randallstown vic.  
Private  
c. 1875-1910

## Maryland Inventory of Historic Properties Form

other A. H. Callow House

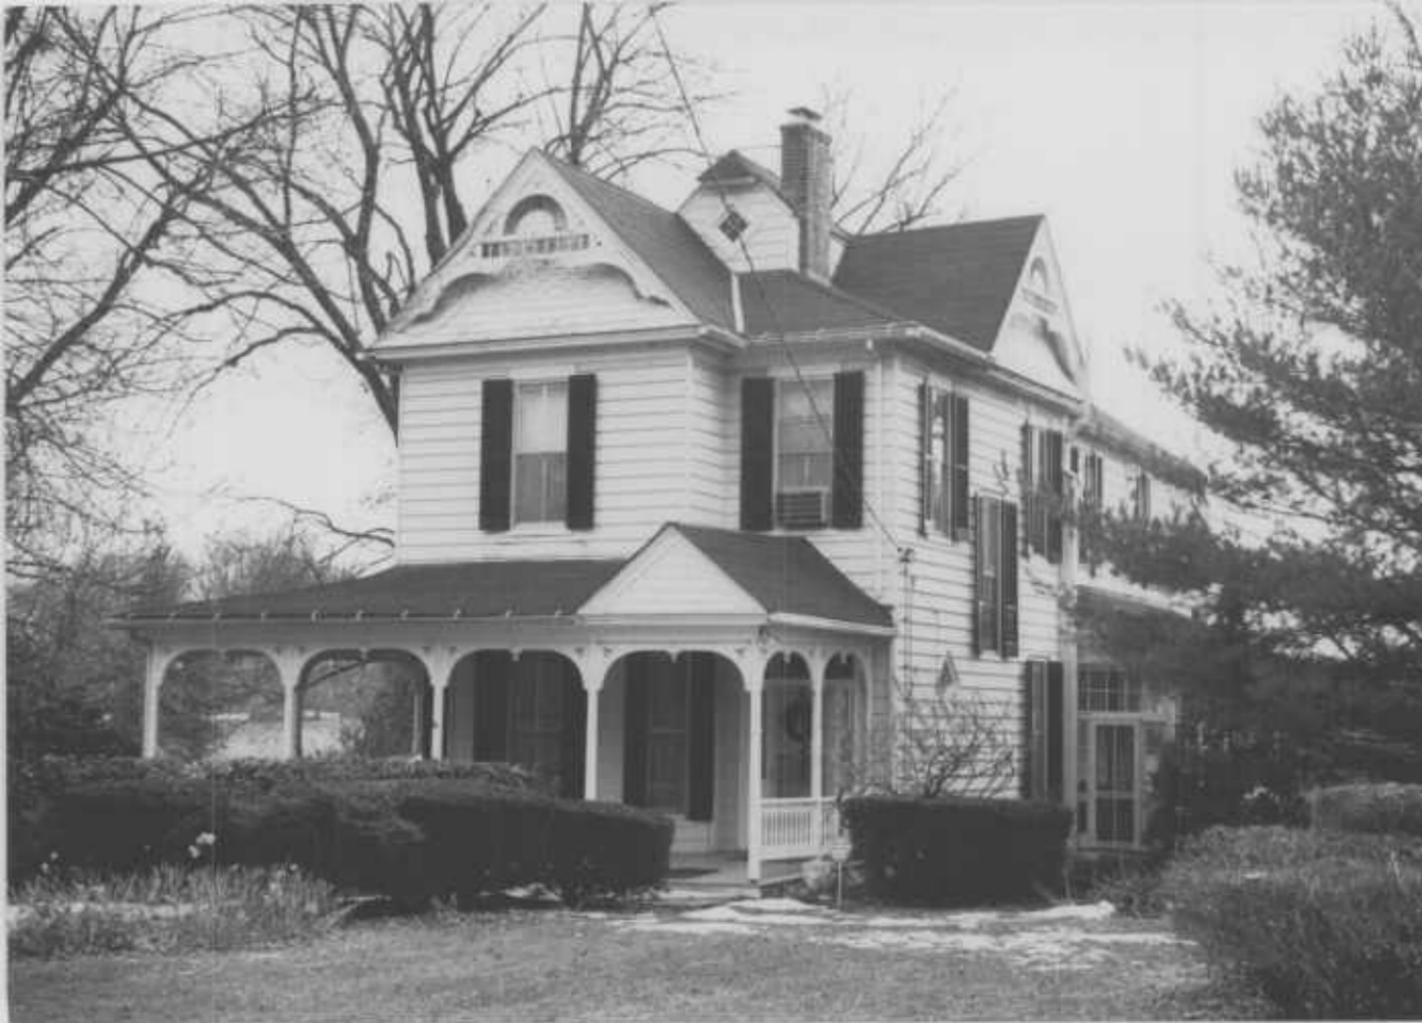
1/2

The first story of the west elevation has a diamond Queen Anne sash in the north bay, a one-over-one sash in the north-center bay, and a new enclosed porch covering the two south bays. There is a door in the center of the east two bays in the house. The second story has four one-over-one sash, and there is a similar sash set between the north and north-center bays, between the first and second stories. Above the north-center bay is a gable that is identical to the gable on the north elevation.

N. & W. ekeus

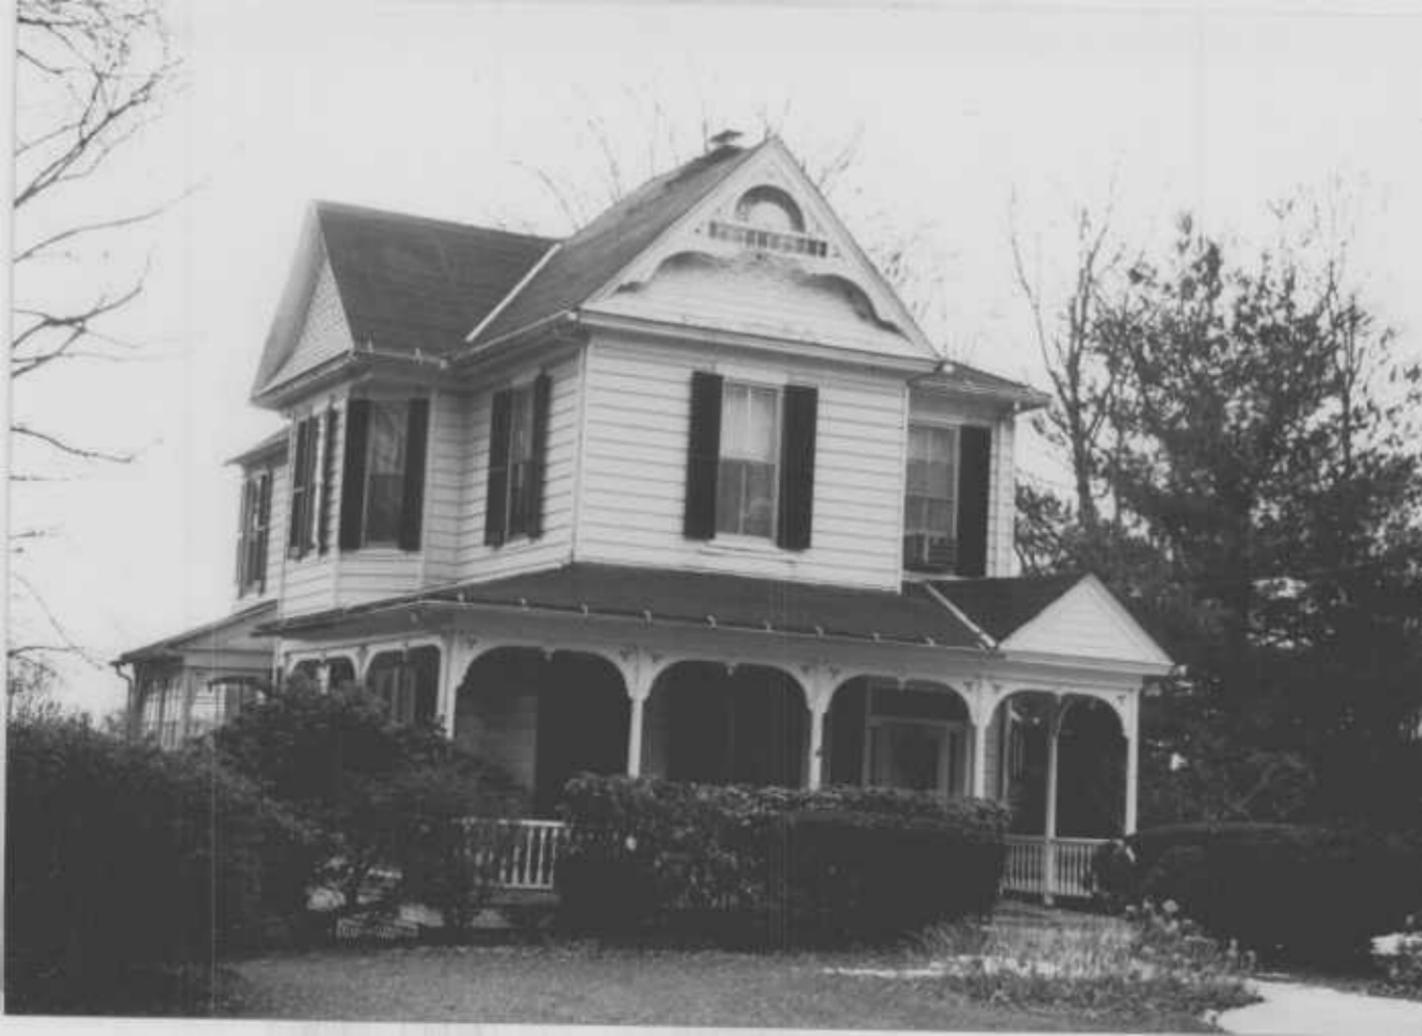
2/2

The house at 10517 Liberty Road faces north toward the road and is a 2 ½-story, two-bay by a four-bay frame structure with aluminum siding. It has an ell plan with cross-gabled roofs that have asphalt shingles. On the north elevation, the first story east bay is a three-sided bay window with a one-over-one sash with exterior blinds in each side. The west bay is a doorway with sidelights of three lights each, and a transom. There is a one-story porch that wraps around part of both sides of the ell and has a hip roof with asphalt shingles, round posts with large jig-sawn brackets, and drop pendants in the center of each pair of posts. These pendants join the brackets together. The railings have turned balusters. The west bay of the porch, where the steps are located, has a gable added to the roof with stick work in it. The second story has a two-over-two sash in both the east and west bays. The gable end has wood shingles, some of the courses having staggered butts. There is also a jig-sawn bargeboard with spindle work here. Just west of, and behind, the gable is a dormer window with a jerkin head gable. It has a diamond sash with four lights, and the jerkin head projects forward above this sash. There is an interior brick chimney on the west side of this dormer.

On the east elevation, the north-center bay is a three-sided, two-story projecting bay window with a one-over-one sash in each side of both stories. Above it is a gable end with the same shingles as the north gable. The bargeboard is missing, as it came down in a storm according to the owner. The north bay has no opening on the first story and a one-over-one sash on the second story. The south bay has a one-over-one sash on both the first and second stories. The south-center bay has a door on the first story and a one-story, one-bay porch with a shed roof and the same details as the north porch. This porch is now enclosed with windows.

E. & N. elevs
